To: Chair Alan Kurtz and the Members of the Champaign County Board  
From: Van A. Anderson, Deputy County Administrator of Finance  
Subject: Update: Satellite Jail Concrete Wall Panel Cracking Investigation  
Date: August 21, 2014

Re: Satellite Jail Exterior Wall Cracking  
WJE No. 2014.4772

At the request of Dana Brenner, Champaign County Facility Director, we conducted a brief evaluation of exterior wall cracking at the Champaign County Satellite Jail (Jail), located in Urbana, Illinois. The scope of this evaluation included a review of various construction documents and photographs provided by Mr. Brenner, and a roughly 2 hour site visit. This letter summarizes our findings and opinions.

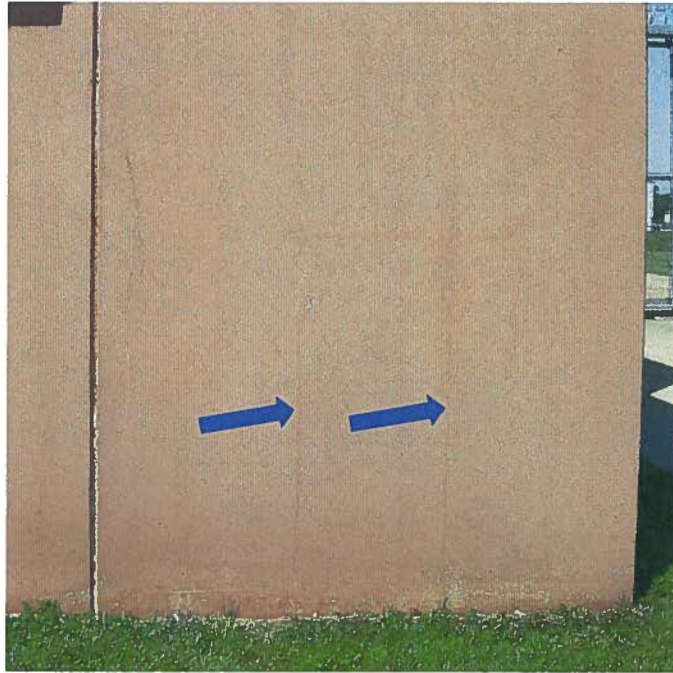
Figures 5 and 6 show vertical cracks similar to what was observed at the same locations on several panels. These vertical cracks align with vertical prestressing strands in the outer wythes of the wall panels. Figures 7 and 8 illustrate this alignment. When selected cracks were scanned with a metal detector, aligned embedded reinforcement was indicated in each case. In some locations, efflorescence staining (whitish deposits) was observed along portions of the vertical cracks (Figures 6 and 7). Efflorescence results from the deposition of dissolved materials by water that evaporates after exiting the crack.

There are a few mechanisms that could account for the vertical cracks shown in Figures 5 through 8, and similar cracking observed elsewhere. The one most common in our experience is corrosion of the underlying prestressing strands. When steel corrodes without restraint, the corrosion products occupy a much greater volume than the steel that was lost. When the creation of corrosion product is restrained, expansive forces are developed. Corrosion of reinforcing steel embedded in concrete can create enough expansive force to fracture the surrounding concrete, especially when the steel is near a concrete surface. Corrosion-related cracking, delamination (planar separations between sections of concrete) and spalling (dislodgement of sections of concrete separated from the surrounding material) of reinforced concrete elements are very common occurrences.

Figure 5 - Vertical cracks aligned with prestressing strands (arrows; Brenner photo)

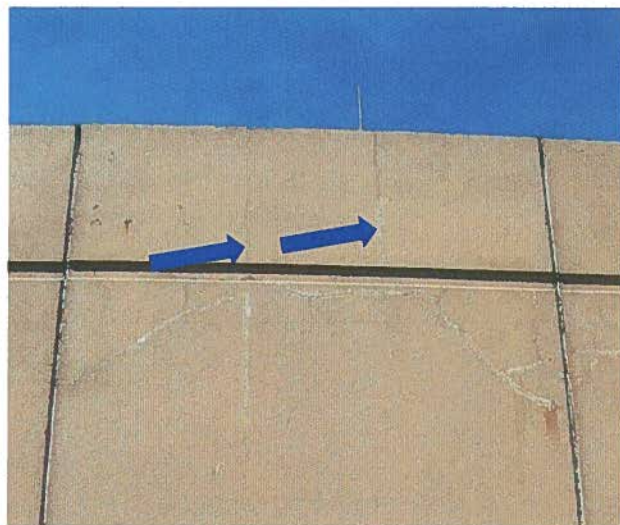
Horizontal cracking across the tops of panels, and apparent water staining, are shown in Figure 12. Mr. Brenner reported that there had been leaks in the roofing in the vicinity of these cracks. Similar cracking was noted in a few other panels (e.g., Figures 6 and 7).

Figure 6 - Vertical cracks aligned with prestressing strands (arrows; Brenner photo)

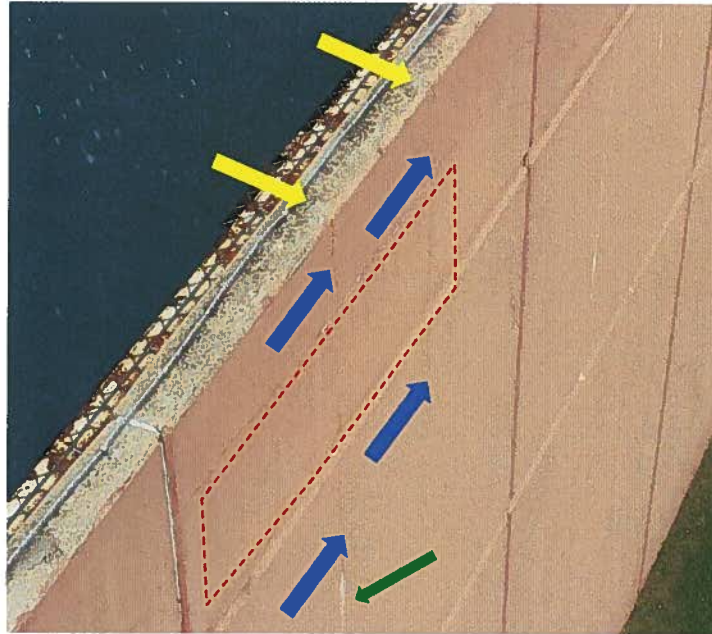
Figure 7 - Vertical cracks aligned with prestressing strands (blue arrows). Strand ends at top of panel covered with cementitious material (yellow arrows); and efflorescence staining indicating substantial water flow from lower end of one crack (green arrow). Darker staining is visible below much of the horizontal crack (within red outline)

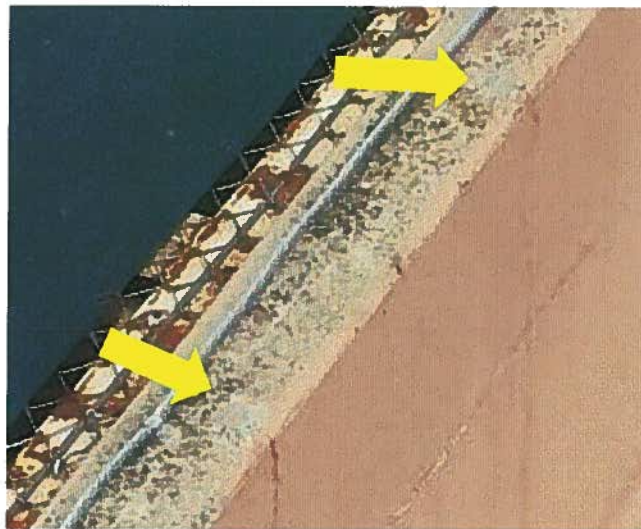
Figure 8 - Enlarged portion of Figure 7 showing cementitious strand covers (arrows)

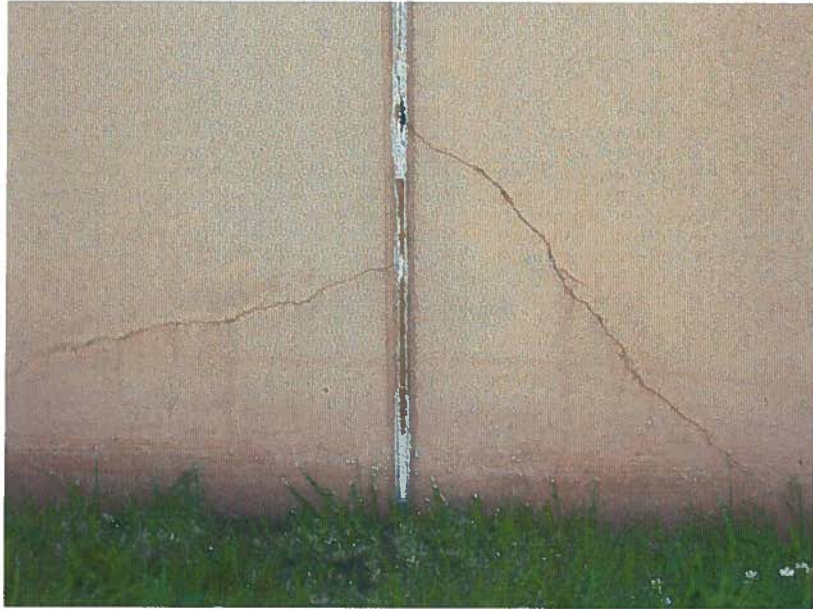
Figures 9 and 10 show cracks at the lower corners of panels. Such cracking occurred in many panels. At several vertical panel joint locations, corner cracks in each panel intersected the vertical edge of the associated panel at essentially the same location, a condition which is shown in Figure 10. Efflorescence staining was noted at some corner cracks. At two locations, the metal detector was oriented horizontally and passed over the upper, nearly horizontal, portions of each crack. In each case, the device indicated an embedded metallic element in line with the crack.

The corner cracking noted in the lower regions of many panels can also come from many sources. In some instances, a corner crack comprised an angled extension of a vertical strand crack. In most cases, the corner cracks were unrelated to strands, but appeared to coincide with other embedded steel elements, possibly steel mesh wires. If horizontal mesh wires terminated near the vertical panel edge surfaces, moisture getting past the sealant could reach the wire ends relatively easily. In our experience, mesh wires are not typically large enough to create damaging expansive forces when they corrode. However, the mesh used in these panels had relatively large wires (W2.5), and the cracks that were examined with the metal detector did appear to coincide with an embedded metallic element.

Given the several potential sources of wall panel moisture and the evidence of substantial moisture ingress and egress, freezing of trapped water may have been responsible for some of the cracking that is not aligned with strands. If water built up in the space between wythes, freezing could cause damage to the weaker outer wythe.

Figure 9 - Cracks at panel corners; and breach in joint sealant (Brenner photo)

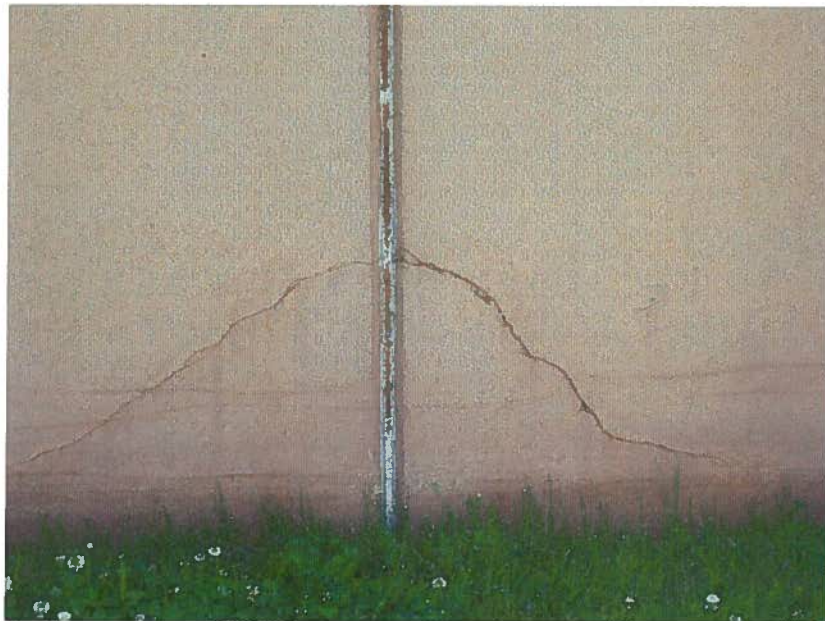
Figure 10 - Aligned cracks at panel corners (Brenner photo)

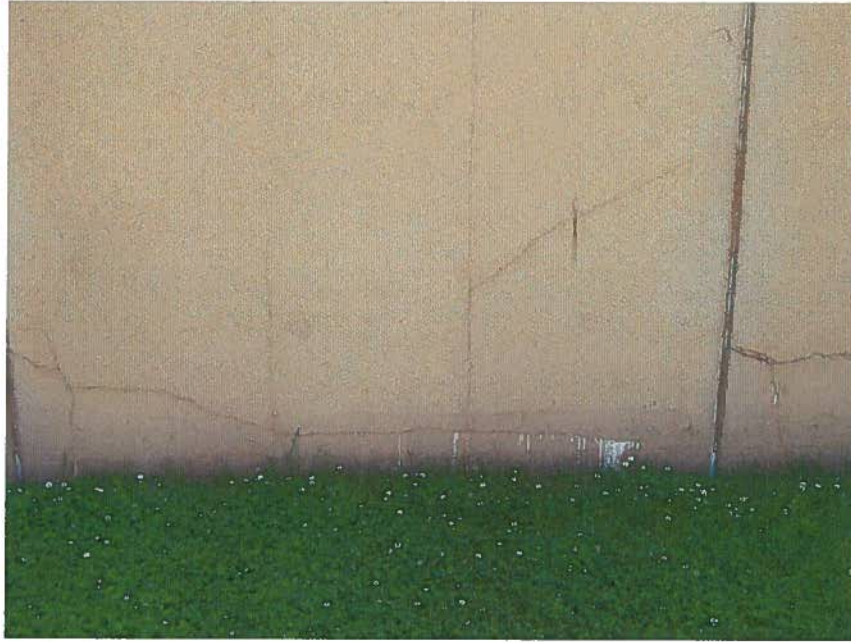
Figures 11 shows corner cracking, vertical cracking aligned with strands, and horizontal cracking. Efflorescence staining is visible along various portions of the lowest horizontal crack. Horizontal cracking similar to what is shown occurred at a few locations.

There are at least two plausible mechanisms for creating the horizontal cracking noted in the exterior wythes. The first is corrosion of embedded steel studs used to anchor structural elements to interior faces of the panels. If the steel studs attaching the steel elements used to connect to the abutting roof deck corroded enough to crack the concrete, and lift the upper portion of the panel relative to the lower portion, this could cause cracking through to the exterior surface. Roof leaks were reported adjacent to the cracked panels shown in Figure 12. Some of the horizontal cracks noted in the upper portions of the panels forming the east wall of the outdoor recreation area also appear consistent with this mechanism. There is a continuous steel angle along the tops of each panel in this area, and no roofing or other means of keeping rain water off the panel tops. There are also several areas of apparent water staining along these cracks.

Figure 11 - Various types of cracking in a wall panel, and efflorescence (Brenner photo)

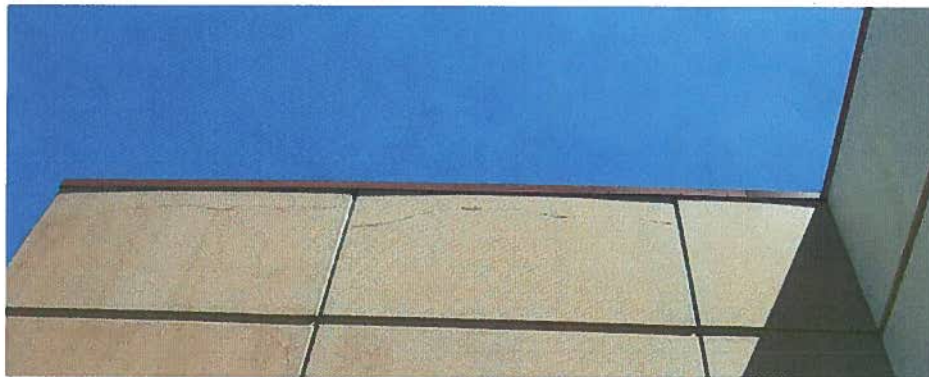
reported that he believed this to be the case. Mr. Brenner indicated that the roofing system was original as well. As noted above, Mr. Brenner also noted there had been roof leaks in the area adjacent to the panels shown in Figure 12.

Figure 12 - Horizontal cracking at the tops of panels. Vertical stains are visible below some portions of the cracks (Brenner photo)

As we discussed during the site visit, it would be prudent to treat the observed cracking, repair known roof leaks, cover the tops of currently uncovered panels, and replace panel joint sealant so as to reduce the amount of moisture getting into the exterior walls.

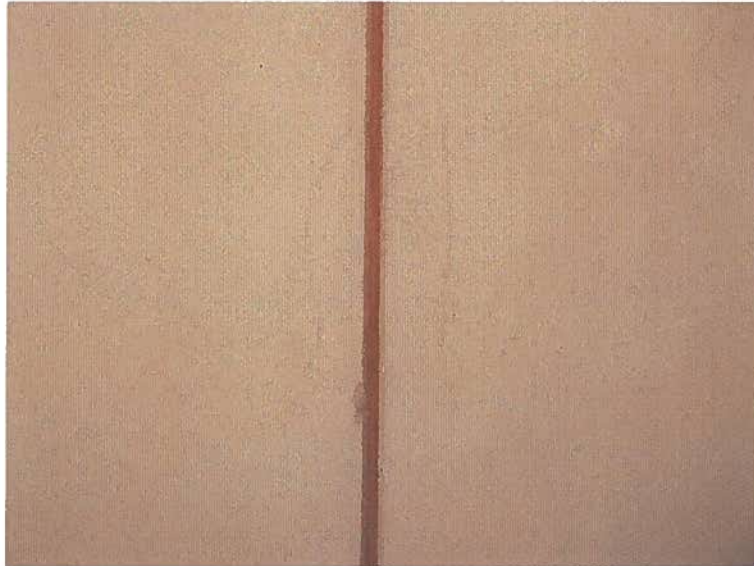
Short, vertical cracks located on each side of a vertical joint were seen at many locations, an example of which is shown in Figure 13. The metal detector was used at a few such locations, and in each case, portions of one of the cracks appeared to align with a prestressing strand, while the other was located inboard (further from the joint) of the nearest strand.

Figure 13 - Short vertical cracks on each side of vertical panel joint (Brenner photo)
