Facilities Assessment Report

November 19, 2015

County of Champaign, Illinois

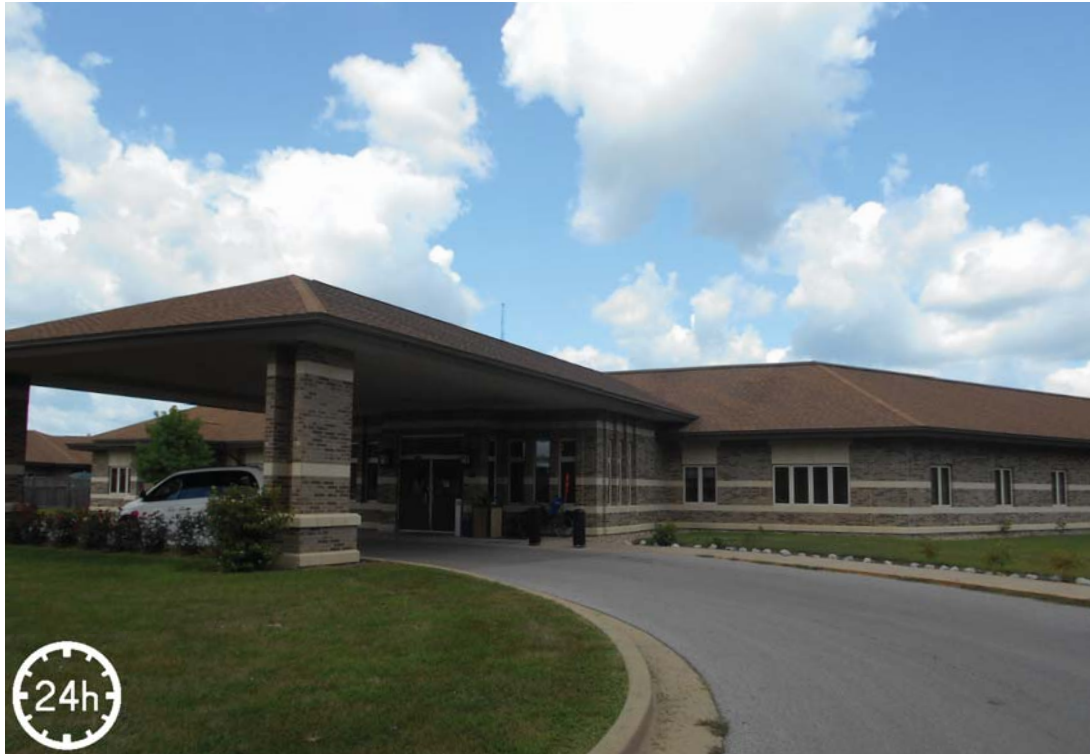
Observation Highlights:

- This building has a back-up generator.
- Brick masonry requires cleaning, minor re-pointing.
- Metal materials on and around exterior deteriorating and staining concrete.
- Exterior soffit panels missing, exposing non-weather resistant materials.
- Cosmetic scratches and damage to interior doors and frames.
- Interior flooring in good condition, minor staining and wear from normal use.
- Wall finishes in generally good condition, some impact damage and scratches.
- Tile floor and base in kitchen damaged and cracked. Some missing grout.
- Ceiling tiles in generally good condition, some water stains and damaged tiles.
- Existing nurse’s call system has reliability issues and should be replaced.
- The return air system has several operational and control issues.

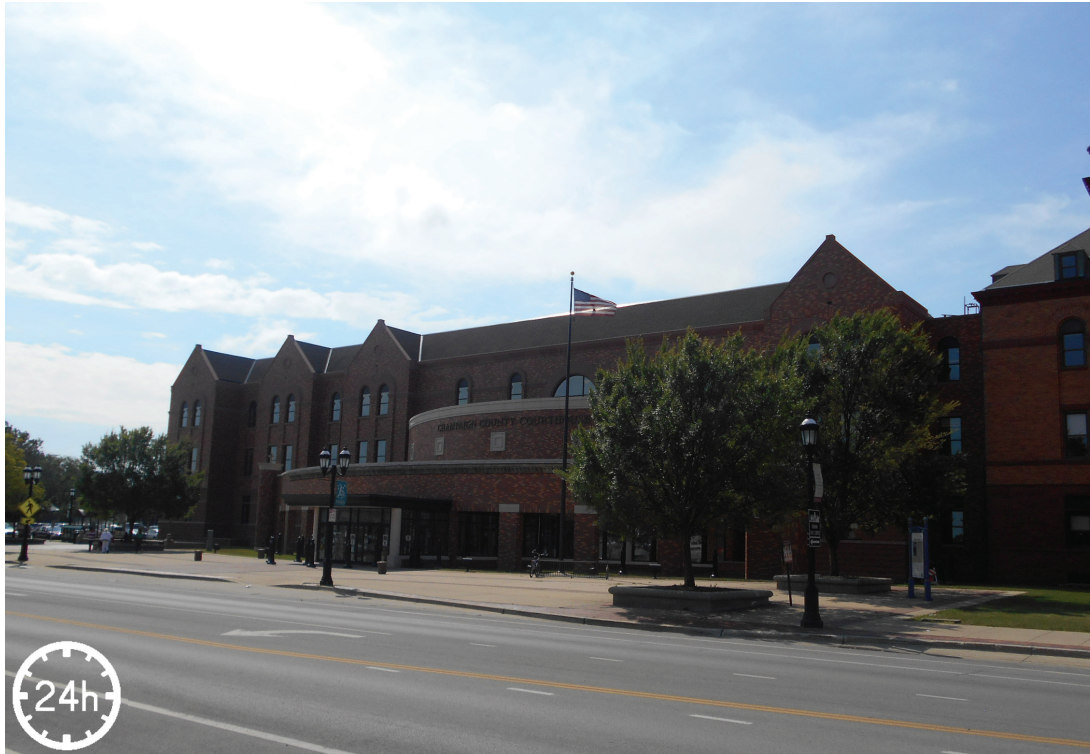
Courthouse Addition

Observation Highlights:

- This building has a back-up generator.
- Interior walls and surfaces in good condition, minor drywall damage.
- Wall covering in courtrooms damaged and torn in various locations.
- Courtroom carpet tiles worn.
- Epoxy coating heavily worn and masonry crack in holding cells.
- Gutters and flashing dented in places.
- Standing water, moss and plants growing in roof ballast.
- Some masonry efflorescence and joint deterioration on facade.
- Scratches and some damage to interior wood doors.
- Steel mansard supporting structure needs to be painted.
- HVAC provided by air handling units, boilers, and chillers. Shared with original building.

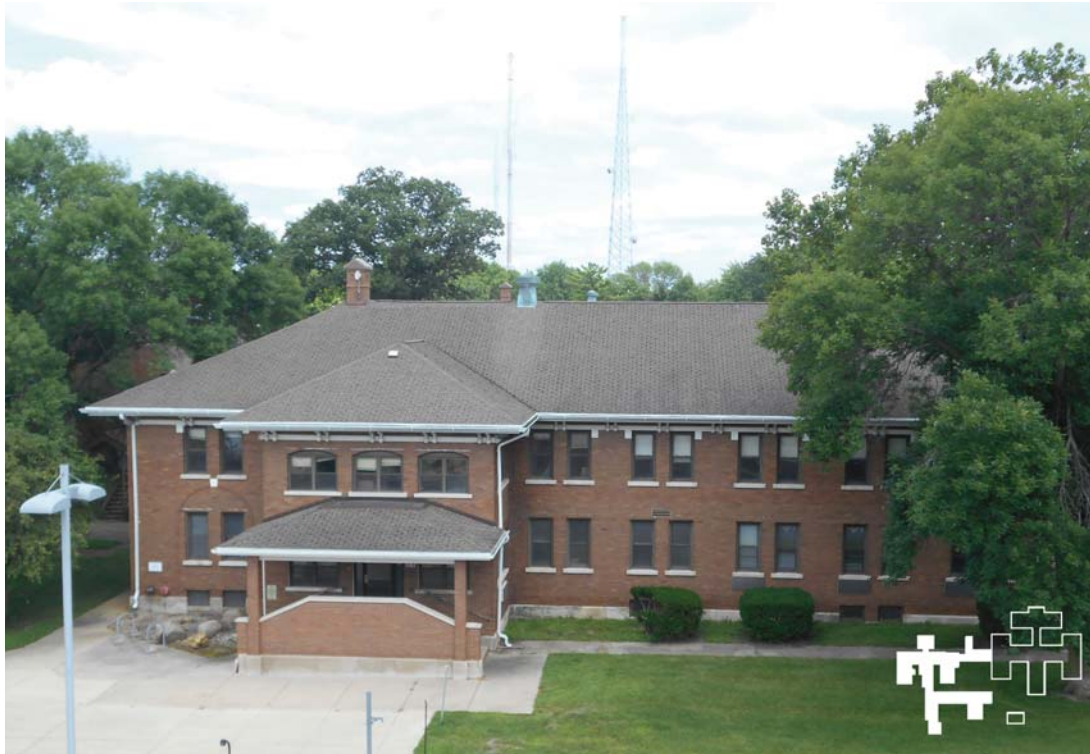
ILEAS Original Building

Observation Highlights:

- The building is in various states of disrepair as a result of limited use/abandonment.
- Most of the flooring is damaged or missing; Interior wall finishes are worn and peeling.
- Ceilings tiles and gypsum board ceilings are heavily damaged and deteriorated.
- Fire doors in basement do not meet code requirements.
- There is mold present at areas of failing roof.
- Landscaping is overgrown and encroaching on the building; organic material in gutters.
- Water infiltration and efflorescence on exterior brick.
- Asphalt roofing requires total replacement.
- Roof structure needs to be replaced in several areas.
- All MEP infrastructure requires replacement.
- Spaces served by 4 pipe fan coil units that are nearing end of useful life.

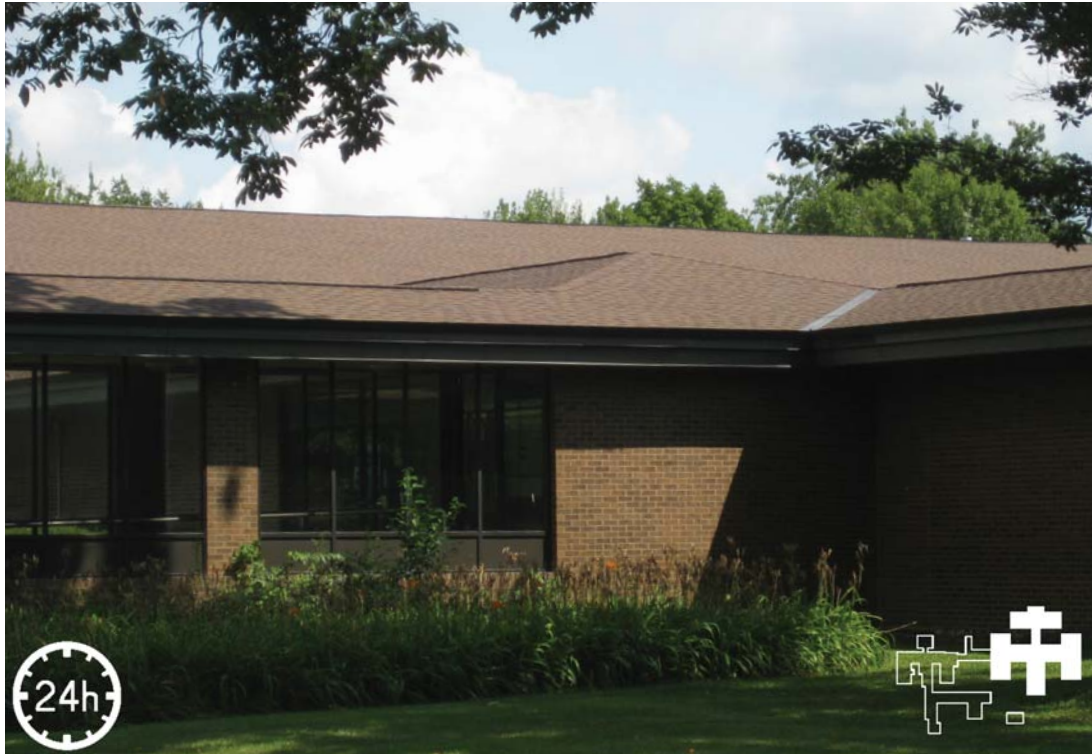
Observation Highlights:

- This building has a back-up generator.
- Exterior brick planters are cracked.
- Some exterior walkways are cracked and pose tripping hazards.
- Two wings require interior finish upgrade.
- Grout in tile flooring is stained, some tile broken on walls.
- galvanized piping nearing the end of its useful life.
- VCT is stained and damaged at tactical areas.
- Exterior stone sealant is deteriorated, signs of water penetration.
- Exterior window storefront panels, mullion end caps missing and glass is cracked.
- Organic material found inside facility.
- Spaces served by 4 pipe fan coil units that are nearing end of useful life.

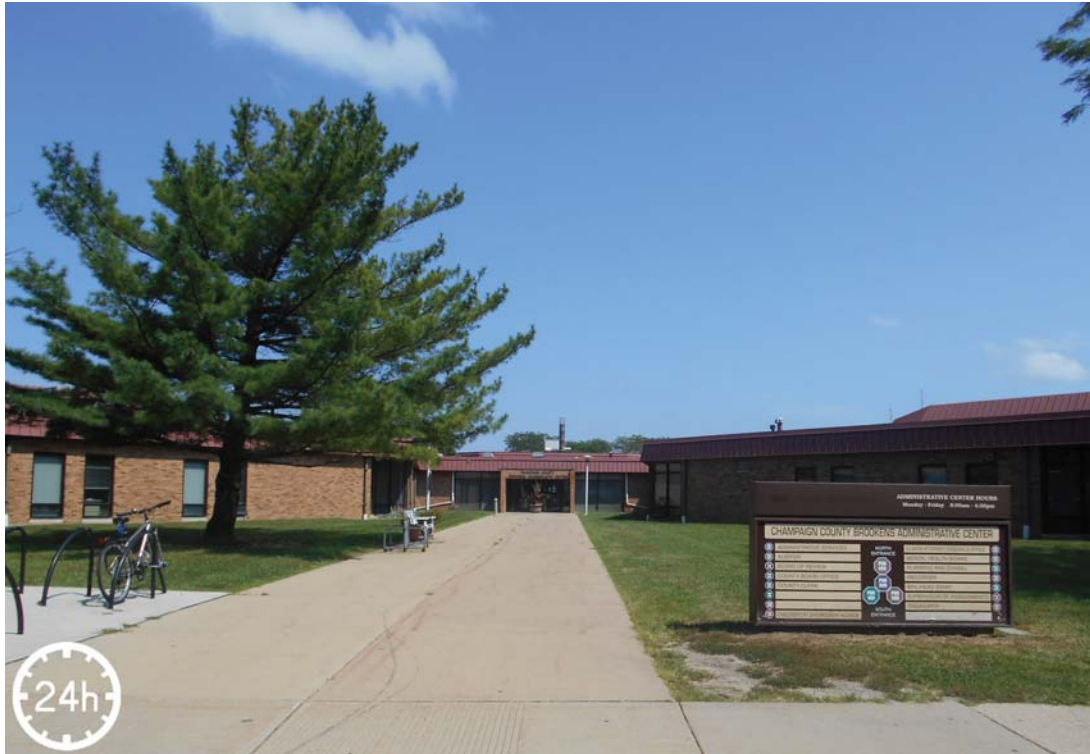
Brookens Administrative Center

Observation Highlights:

- This building has a back-up generator.
- Roof and soffit replacement needed at portion of facility.
- Downspouts are in need of repair, many are dented or loose.
- Parking lot recently resurfaced and is in good condition.
- Minor brick repair and sealant replacement required.
- Sidewalks cracked and damaged in places.
- Interior wall finishes in generally good condition.
- Exterior insulation is heavily damaged or missing.
- Roofing membrane in fair condition, Pod 100 and 200 need to be replaced.
- Served by small DX cool, gas heat RTUs nearing end of useful life.

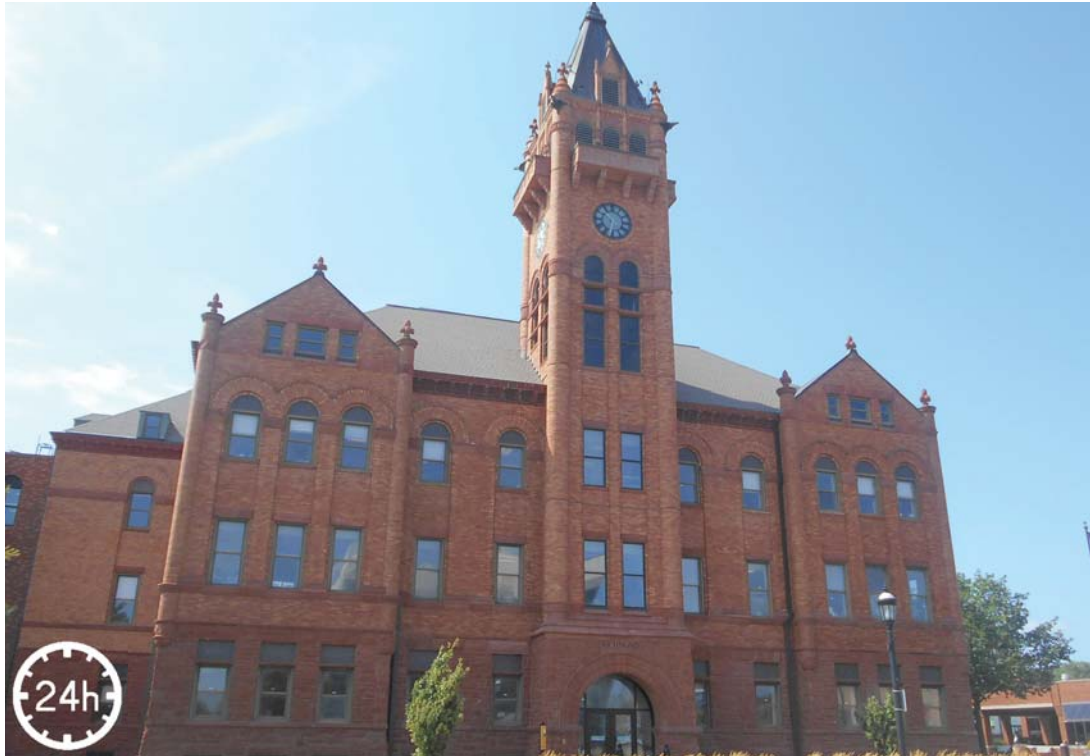
Observation Highlights:

- This building has a back-up generator.
- Stair treads worn and damaged.
- Carpet in generally good condition, stained and worn in select locations.
- Decorative marble chair rail stained and shows signs of deteriorated grout.
- Drywall finishes in good condition, some damage at corners and window jambs.
- Asphalt shingles in good condition.
- Wood steps and platform on roof heavily deteriorated and need to be replaced.
- Roof ballast missing and uneven in locations.
- Exterior brick and stone in generally good condition, some cracks and damaged stone.
- EPDM roof requires replacement.
- HVAC provided by air handling units, boilers, and chillers. Shared with addition.

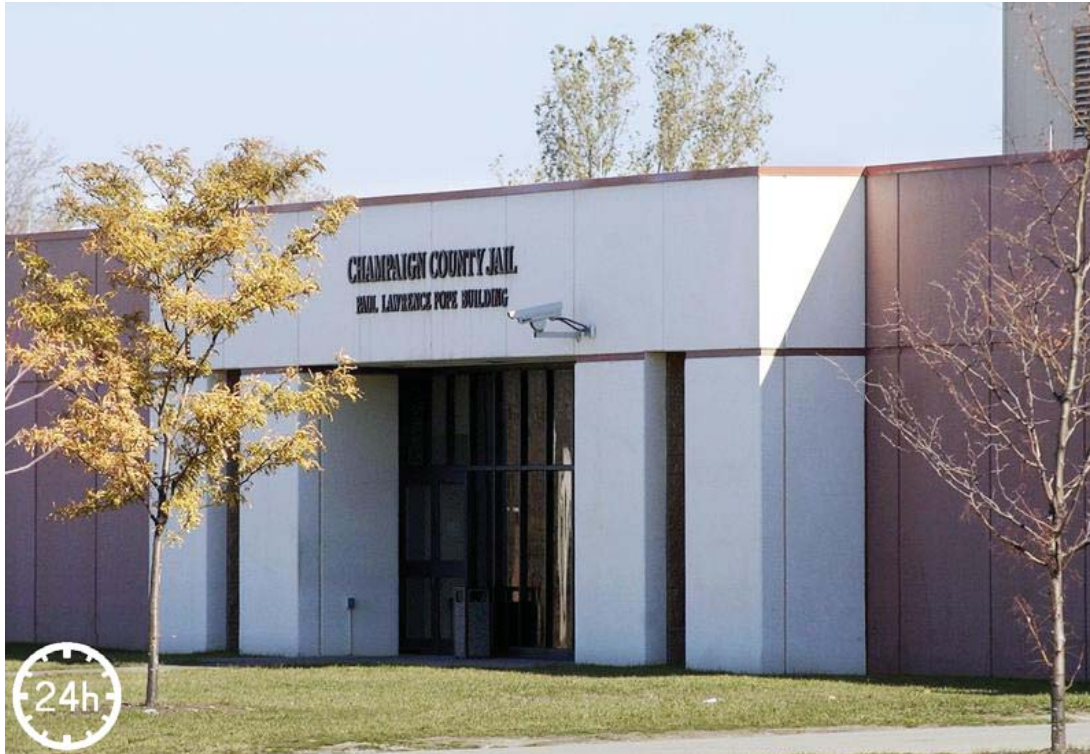
Adult Detention Facility

Observation Highlights:

- This building has a back-up generator.
- Overall the building is in fair condition.
- Interior sealed concrete is heavily worn with some large cracks.
- Metal doors are scratched and dented.
- Cell doors show signs of deterioration and impact damage.
- Floor drains are heavily rusted and filled with debris.
- Sally port doors are oversized and prone to failure.
- Security system is outdated and needs to be replaced.
- Paint finishes are worn and deteriorating.
- Carpeting and millwork is heavily worn with some staining.
- Served by four mechanical units installed in two rooftop penthouses.

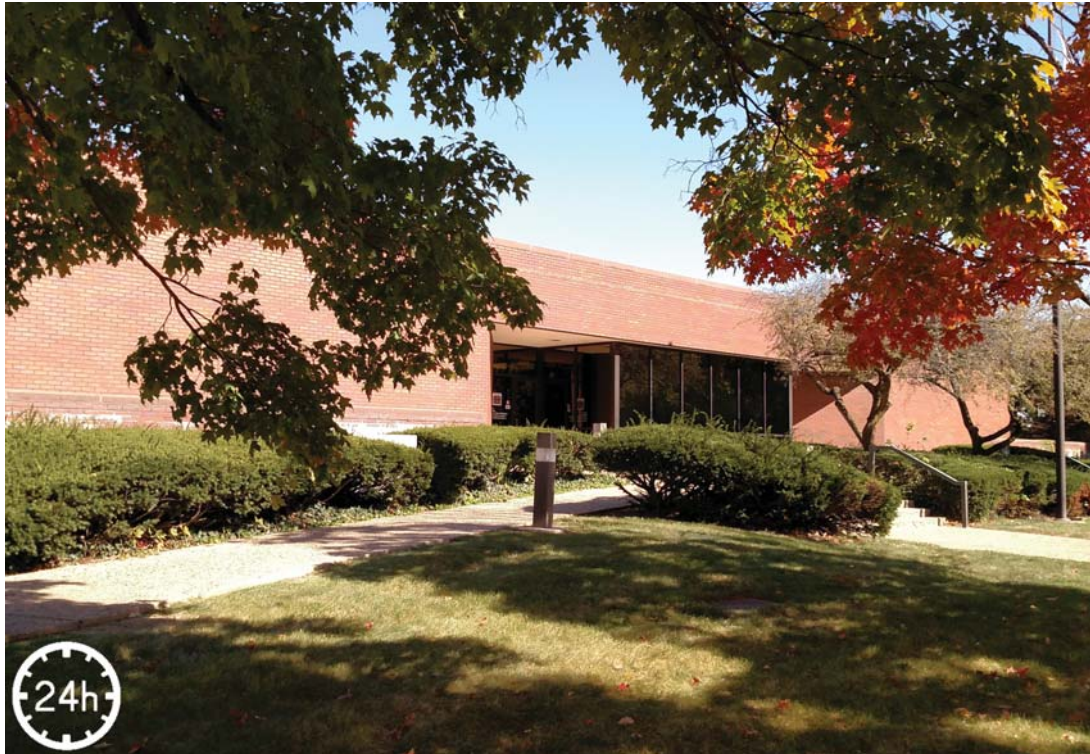
Observation Highlights:

- This building has a back-up generator.
- Original mechanical equipment requires replacement.
- Masonry joint deterioration, minor cracking, and plant growth.
- Major brick efflorescence on walls around building and screen walls.
- Stone parapet stained, possible moisture penetration.
- Exterior metal doors have deteriorated.
- Sun screen at ceiling enclosure in recreation area is heavily damaged.
- VCT adhesive failed and tiles are missing.
- Interior CMU cracked in multiple locations.
- Served by two boilers and a chiller original to building.
- Cooling tower leaks and is not used.

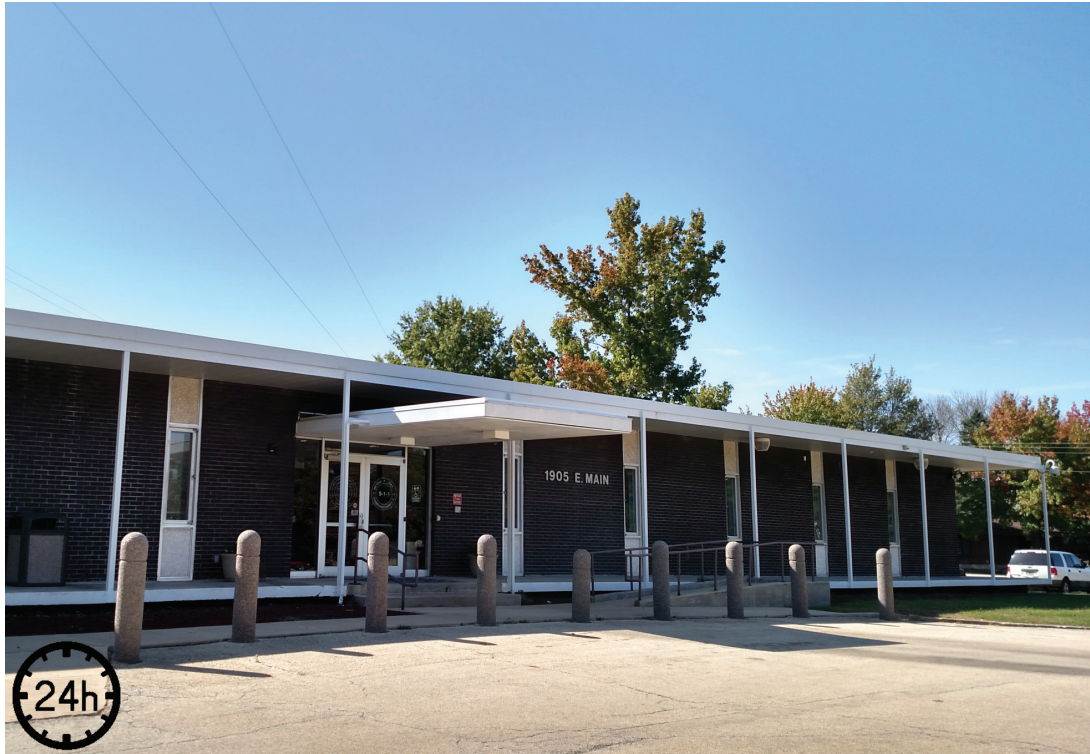
Emergency Operation Center (METCAD)

Observation Highlights:

- This building has a back-up generator.
- AHU near the end of its useful life.
- Overall, the building is in good condition.
- The interior wall finishes are in generally good condition, normal use wear.
- Carpet and VCT surfaces are in good condition.
- Exterior brick is worn, some sealant damage at windows.
- Railings along accessible ramp are deteriorating.
- Minor cracks on ramp and walk.
- Gutters in good condition, some paint peeling.
- Roof will need replacement.
- Served by AHU's and condensing units, AHU's nearing end of useful life.

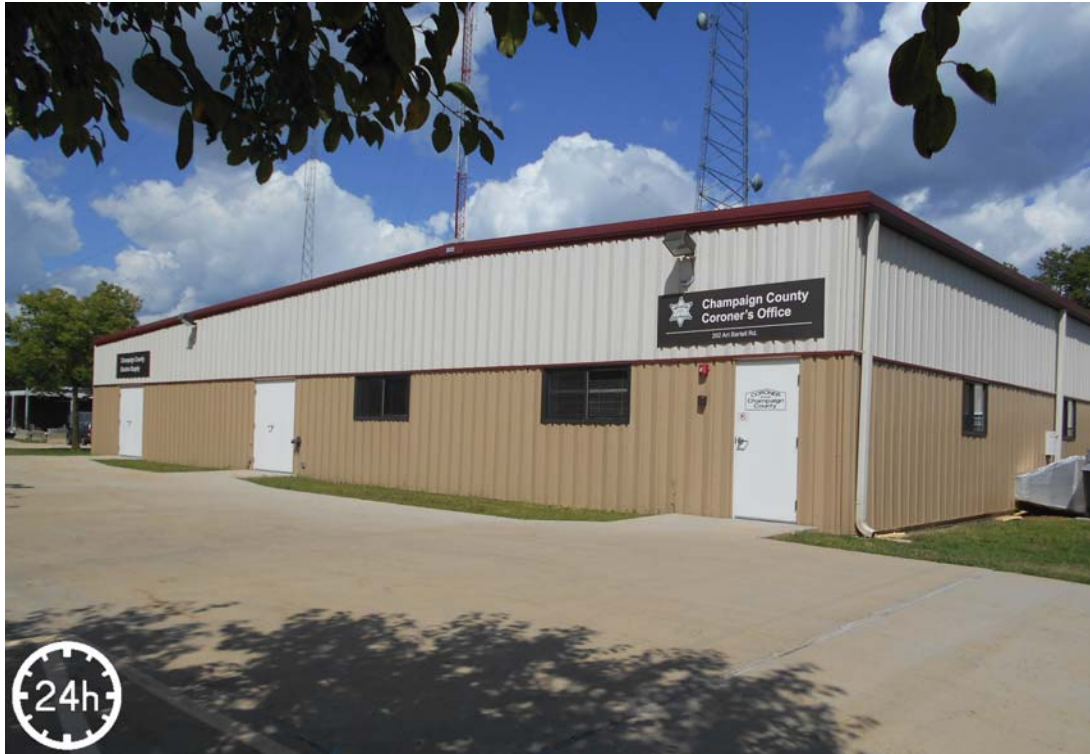
Coroner's Office

Observation Highlights:

- This building has no back-up generator.
- The building is in generally good condition.
- Ceiling tiles show signs of minor water damage.
- VCT flooring is worn and scratched in places of heavy use. Some joints are separated.
- Drywall is in good condition, minor scratches and cosmetic damage.
- Interior doors show signs of wear and some damage to finishes.
- Exterior wall panels have minor surface damage.
- Insulation along foundation is damaged, missing in places.
- Windows are in good condition.
- Served by packaged AHU at grade. AHU is in good condition.

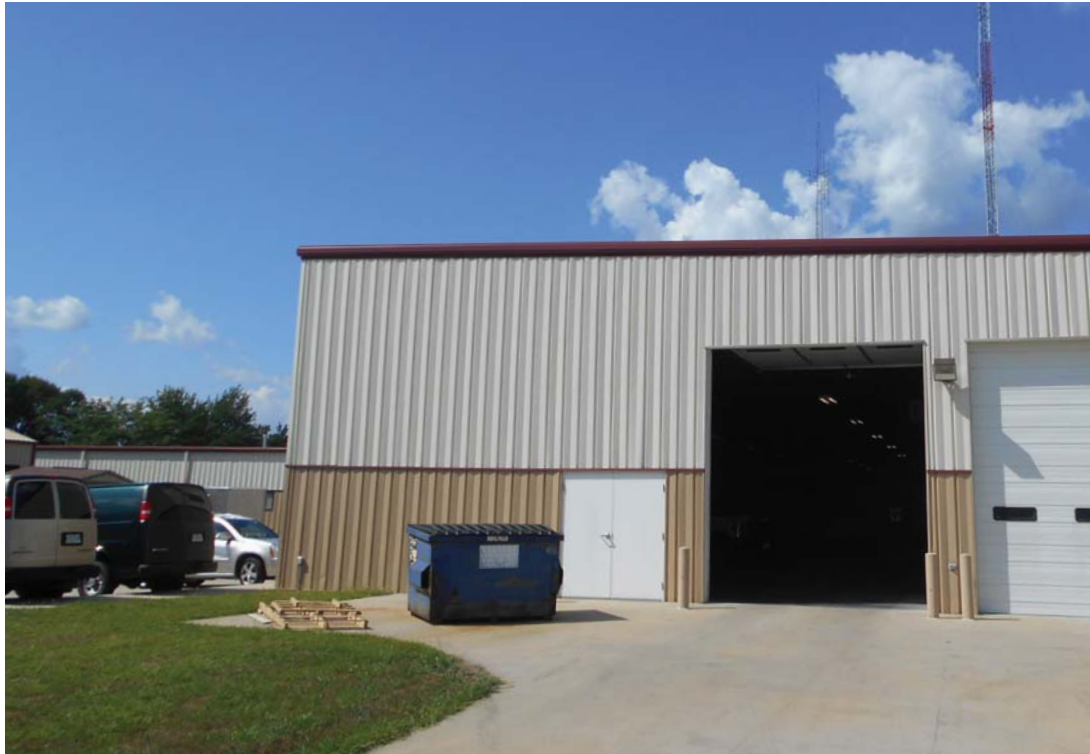
Observation Highlights:

- Building is overall in good condition.
- Metal wall panels on exterior in generally good condition, minor damage.
- Interior sealed concrete flooring stained and worn.
- VCT flooring heavily scratched and worn, stained in some areas.
- Minor drywall damage, some impact damage and scratches.
- Insulation behind exposed structure stained in places on ceiling and walls.
- Insulation along foundation damaged and missing in places.
- Heavy water damage to landscaping at downspouts.
- Sealant failure along edge between metal panels and concrete.
- Ventilation provided by roof mounted exhaust fan in good condition.
- Heating provided by three gas fired unit heaters in good condition.

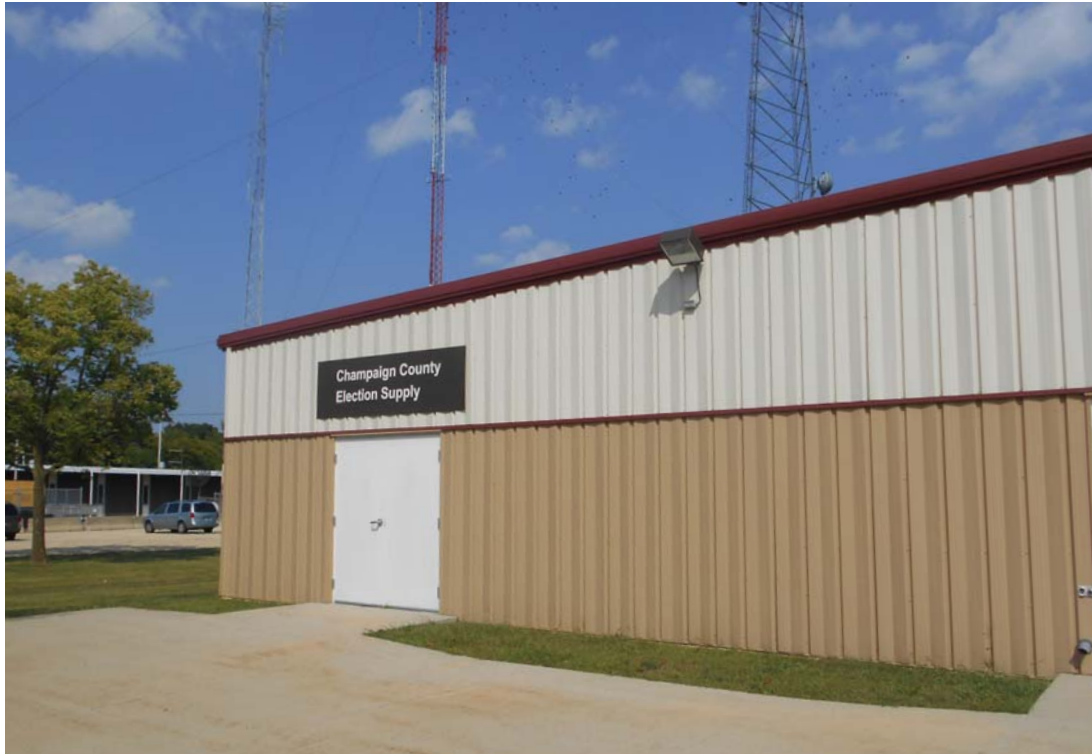
Election Supply

Observation Highlights:

- This building is in good condition.
- Minor dents and cosmetic damage to exterior metal panels.
- Windows are in good condition.
- Foundation insulation is damaged and missing in places.
- Interior sealed concrete flooring is stained and worn.
- Ceiling tiles are in good condition, few missing or stained.
- Rubber wall base missing in places.
- VCT in bathroom worn and stained.
- Carpet tiles in good condition.
- Interior drywall and finishes in good condition.
- HVAC provided by unit mounted on grade

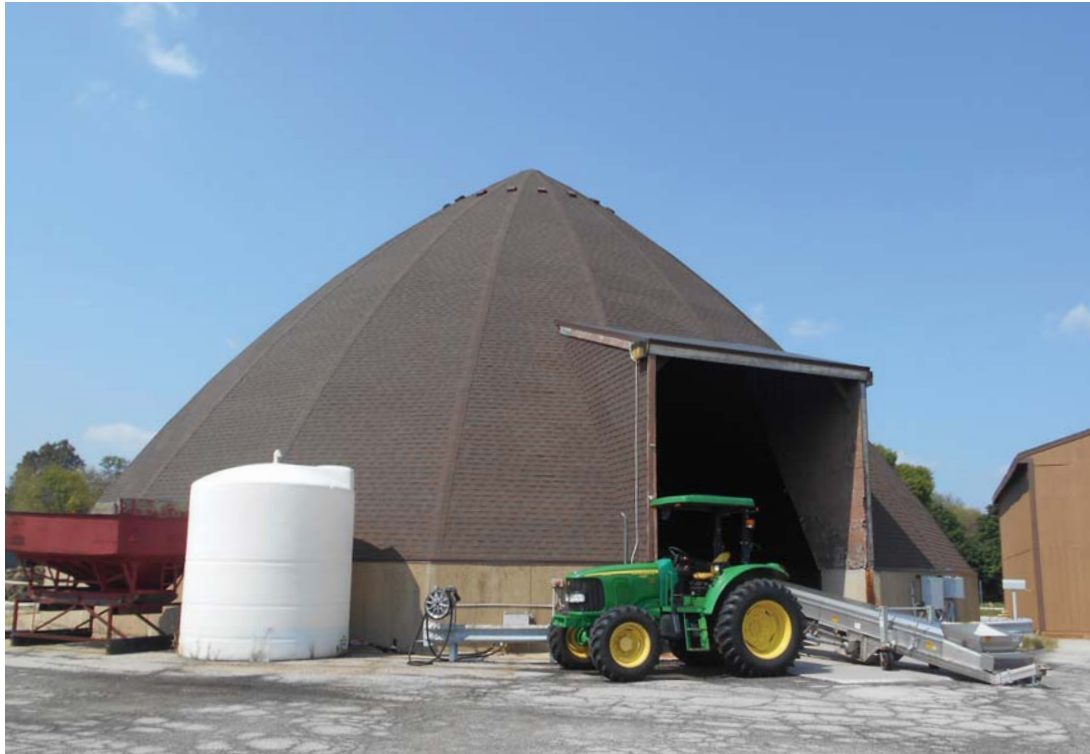
Observation Highlights:

- Overall the building is in fair condition.
- All metal in the building is deteriorated, some has completely deteriorated.
- Rusty metal is staining surrounding concrete surfaces.
- Most concrete surfaces, mainly by the entrance, are pitted and have exposed aggregate.
- Exposed wood at entrance is deteriorated.
- Asphalt shingles are in generally good condition.
- Interior wood dome structure is in good condition.
- Concrete seals around exterior are worn and deteriorated.
- Standing water around foundations.

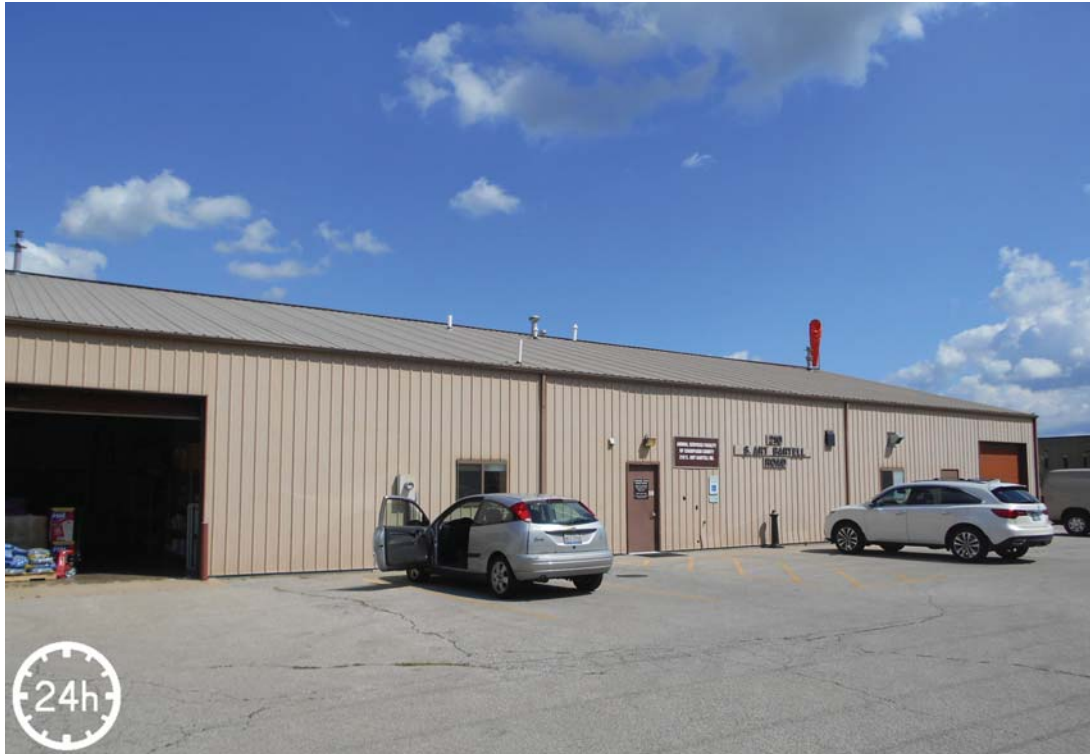
Observation Highlights:

- This building has no back-up generator.
- Exterior metal wall panels have impact damage in multiple locations.
- Downspouts are in good condition, minor damage.
- Exterior wood door trim is deteriorated, paint peeling.
- Threshold sealants are failed.
- Metal doors are scratched and worn.
- Ceiling tiles are in fair condition, some large stains in places.
- Sealed concrete flooring is stained and worn.
- Overhead doors have impact damage on the exterior.
- Windows are in fair condition, some deterioration around edges of window frames.
- HVAC provided by two packaged AHU's on grade and are in good condition.

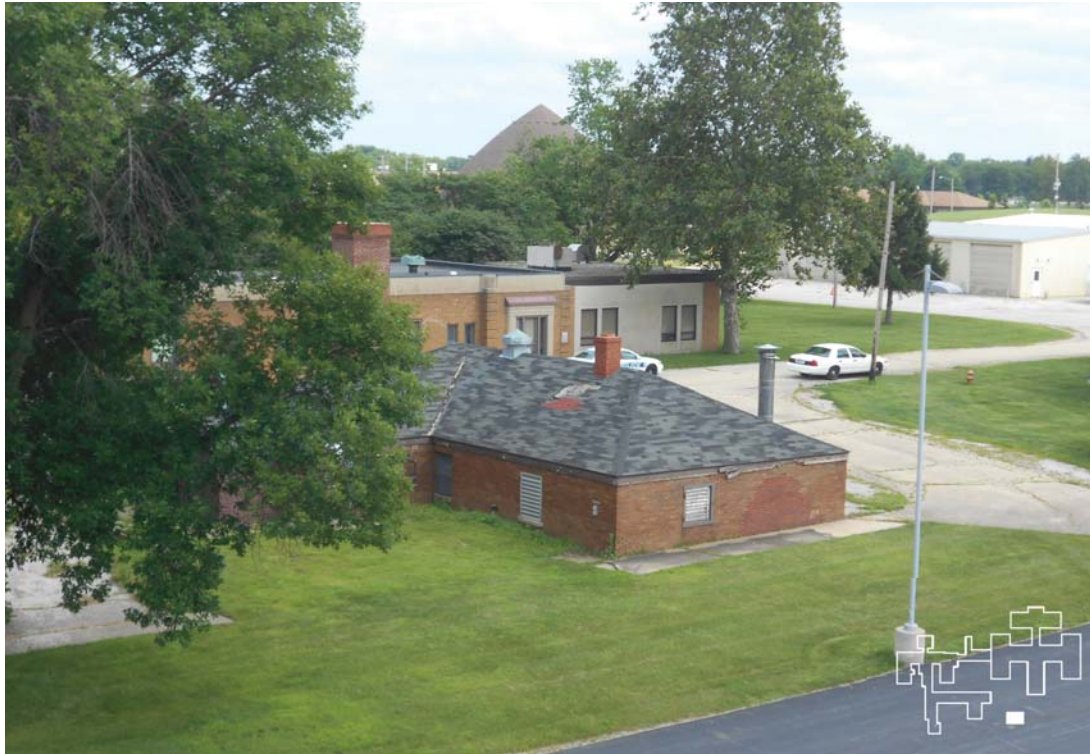
ILEAS Boiler House

Observation Highlights:

- The building envelope is severely deteriorated and requires reconstruction.
- Landscaping is overgrown and encroaching on the building.
- There is water infiltration and efflorescence on exterior brick.
- Gutters contain organic material.
- With the exception of one boiler, the mechanical systems should be completely replaced.
- Adjacent concrete and paving is cracked and deteriorated.
- Brick joints are deteriorated or missing; bricks are loose in places.
- Wood trim is heavily damaged and deteriorated.
- Asphalt shingles are damaged and missing.
- Roofing and roof structure require replacement.

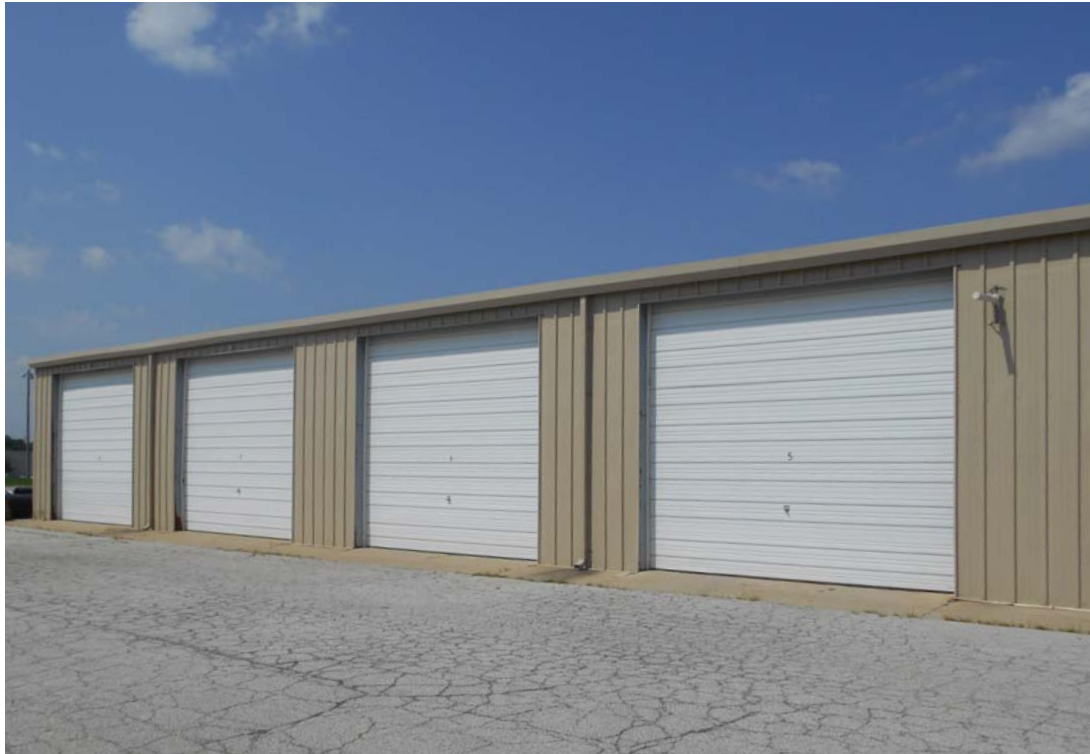
Observation Highlights:

- Exterior door finishes deteriorated at base of doors.
- Exterior wall panels in fair condition, minor damage and deterioration.
- Downspouts damaged, finish worn and integrity compromised.
- Soffits and gutters rusted, paint deteriorated.
- Perimeter sealant/patch at concrete joints failed.
- Weatherstripping at overhead doors failed. Trim broken and missing.
- Windows are in good condition.
- Gaps in metal panels at penetration locations, require sealant.
- Interior insulation panels worn, some impact damage.
- Concrete flooring heavily worn and pitted.

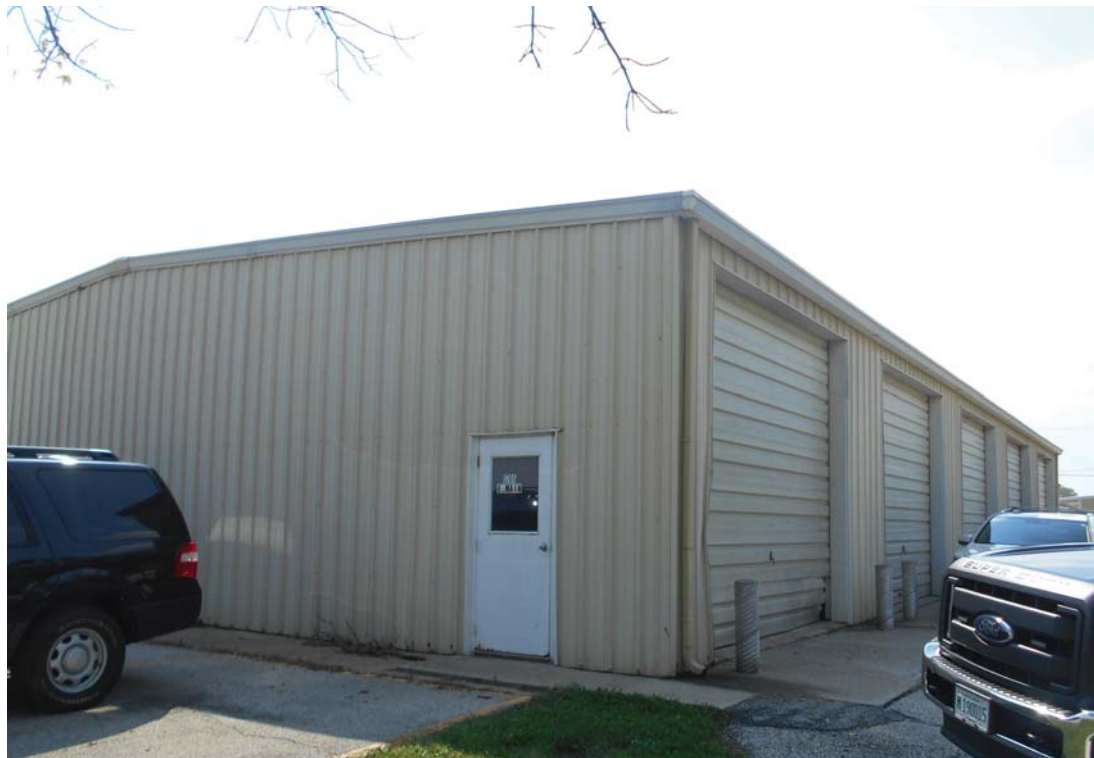
Observation Highlights:

- The garage overall is in fair condition.
- Concrete flooring stained and worn, minor cracks.
- Exterior door finishes and frames are deteriorated and rusted at base.
- Fiberglass overhead doors are damaged, panels cracked and kicked-in at base of frame.
- Overhead door jambs are dented and warped.
- Moisture damage and rust at base of metal wall panels.
- Metal wall panel seams dented and peeling apart.
- Several large tears in metal wall panels.
- Sealant at base of metal wall panels along concrete deteriorated.
- Bollards damaged from impact.
- No ventilation or heating present. No oil interceptor at trench drains.

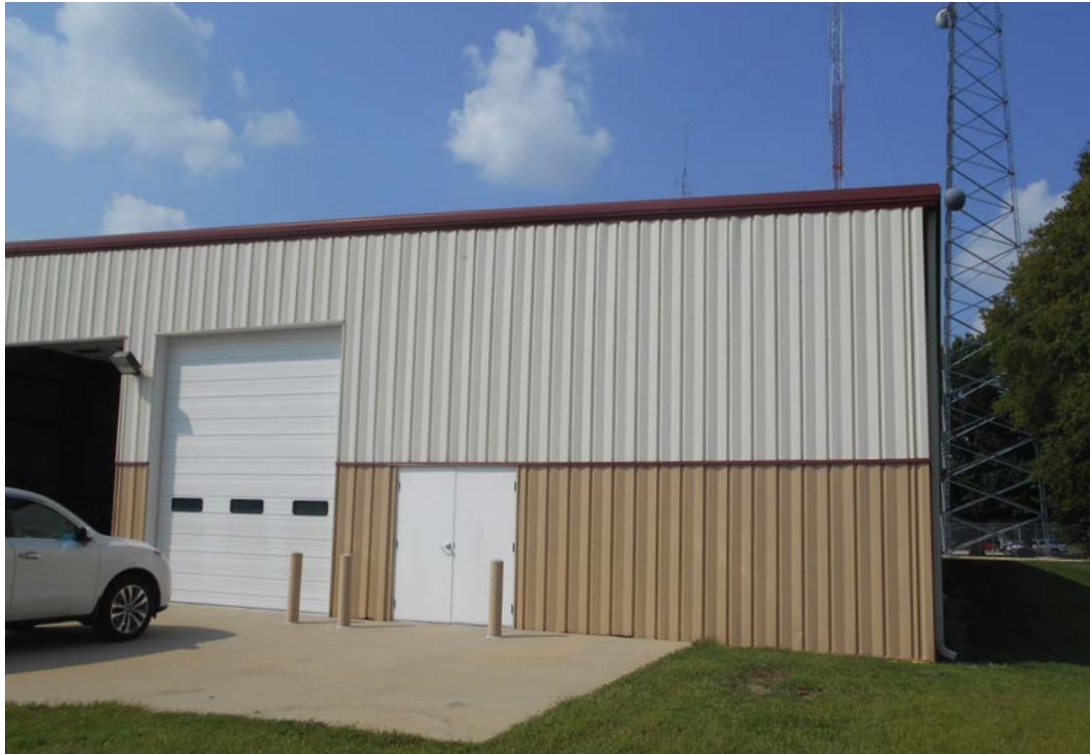
Nursing Home Storage

Observation Highlights:

- Building is in overall good condition.
- Sealant failure at base of metal wall panels along concrete.
- Insulation along foundation broken, damaged and missing in places.
- Metal panels dented at corner.
- Interior drywall in fair condition, minor scratches; one puncture found.
- Sealed concrete flooring in good condition, minor wear.
- Interior cage in good condition.
- No rubber base at bottom of drywall.
- Exterior door in good condition.
- Exposed structure and insulation in good condition.
- No ventilation. Heat provided by ceiling mounted gas fired unit heater.

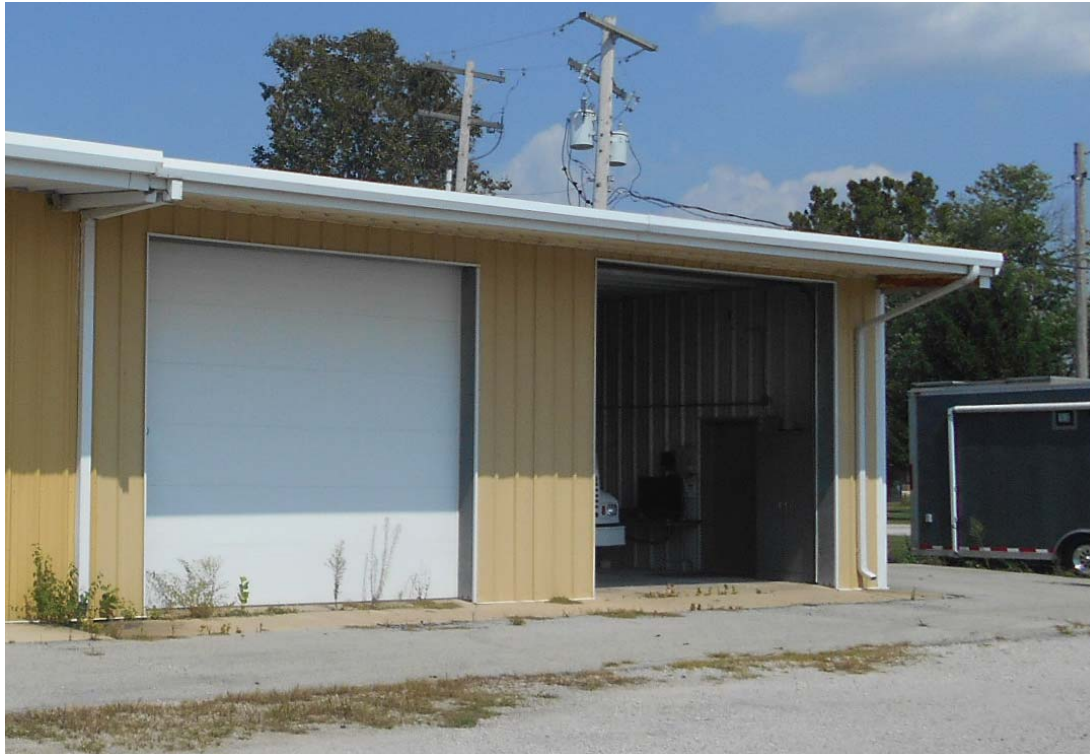
Observation Highlights:

- Concrete flooring is in fair condition, some stains and wear from use.
- A few large cracks in concrete flooring.
- Interior and exterior deterioration on metal panel.
- Metal downspouts deteriorated, leaks found at joints.
- Exterior trim bent and damaged at door openings.
- Exterior doors deteriorated and damaged at base.
- Interior steel structure worn and deteriorated.
- Punctures, bent and damaged metal panels along base of exterior.
- Oil interceptor at trench drains and exhaust fan installed.
- No ventilation. Ceiling mounted gas fired unit heater nearing end of useful life

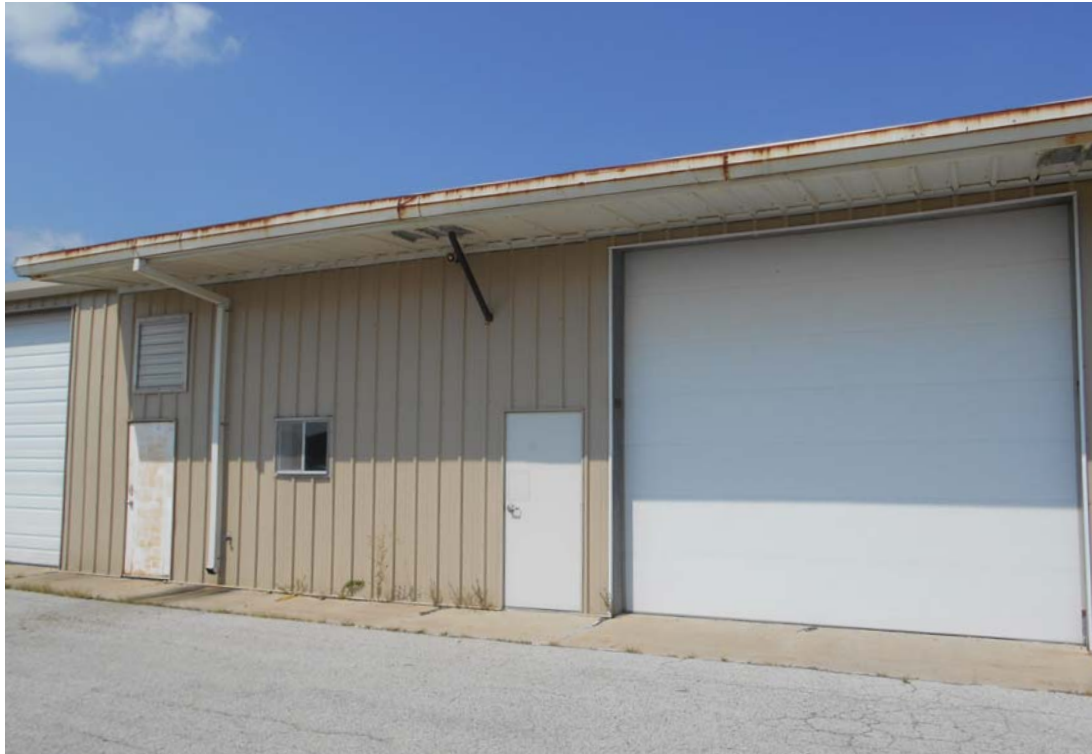
Observation Highlights:

- ILEAS Garage 2 is connected to Sheriff's Garage.
- The building is in overall fair condition.
- Sealed concrete flooring is scratched and worn in places.
- Doors are worn with some deterioration.
- Finish on interior exposed structure is worn and deteriorated.
- Metal wall panels are in fair condition.
- Gutters and downspouts are deteriorated.
- Roof overhang is deteriorated and has impact damage.
- Organic plant growth in cracks along exterior concrete and base of building.
- Sealant deterioration in places along concrete.
- No ventilation. Heat provided by ceiling mounted gas fired unit heater.

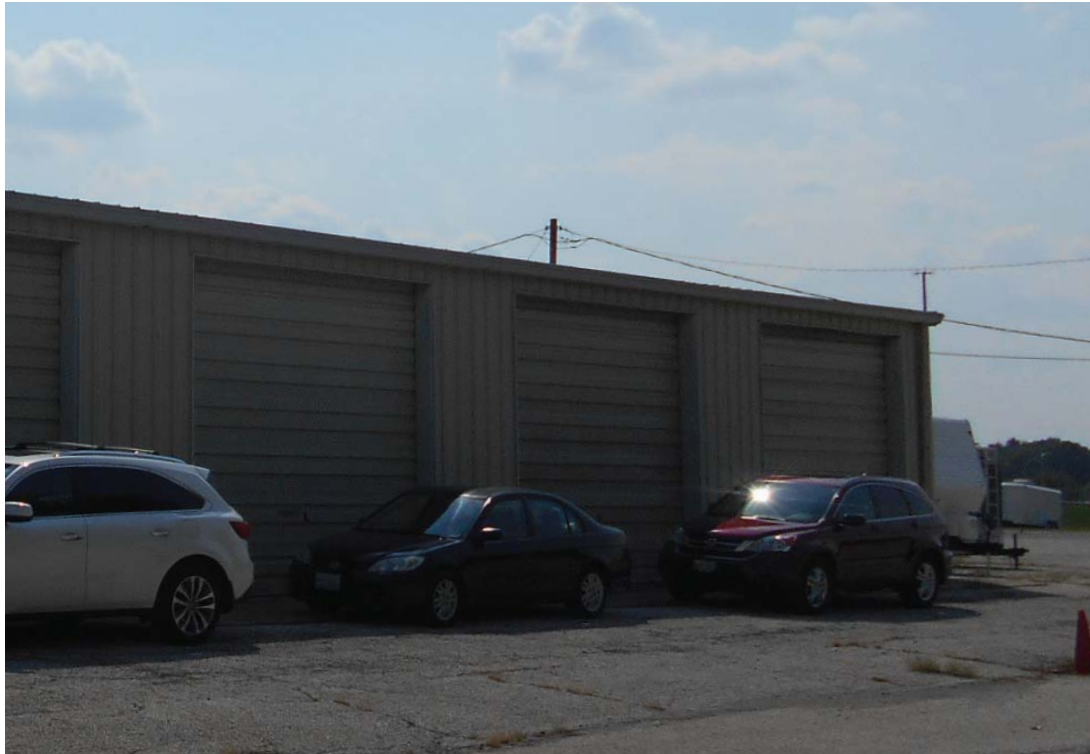
Observation Highlights:

- ILEAS Garage 3 is connected to County Highway Garage.
- The building is in overall fair condition.
- Sealed concrete flooring is scratched and worn in places.
- Finish on interior exposed structure is worn and deteriorated.
- Metal wall panels are in fair condition.
- Doors have some deterioration and are in fair condition.
- Interior structure is in good condition, some deterioration.
- Overhead door is in fair condition, minor impact damage.
- Organic plant growth in cracks along exterior concrete.
- Sealant deterioration in places along concrete.
- No ventilation. Heat provided by ceiling mounted gas fired unit heater.

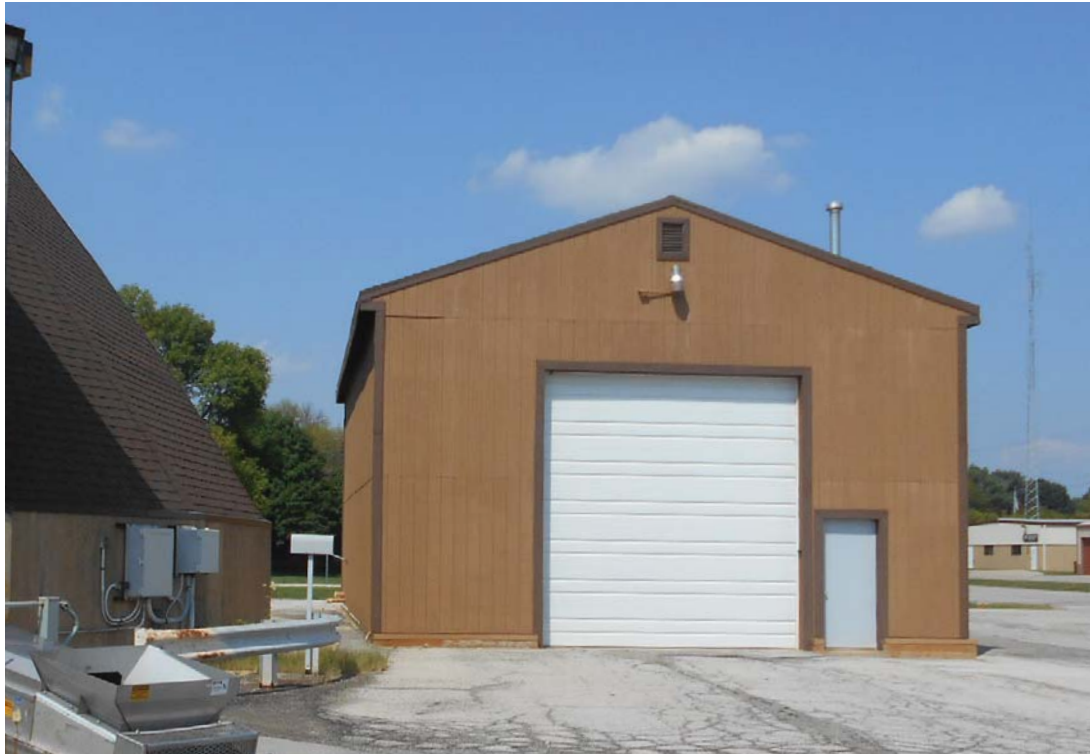
Observation Highlights:

- The building overall is in fair condition.
- Soffits are not protected, raw wood exposed to elements.
- Asphalt shingles are in fair condition.
- Worn and deteriorated paint at roof edge trim.
- Paint overall is in fair condition.
- Overhead door is in good condition, minor impact damage.
- Some cracks in concrete surfaces.
- Interior concrete flooring is heavily worn.
- No ventilation. Heat provided by ceiling mounted gas fired unit heater in good condition.
