Facilities Assessment Report

November 19, 2015

County of Champaign, Illinois

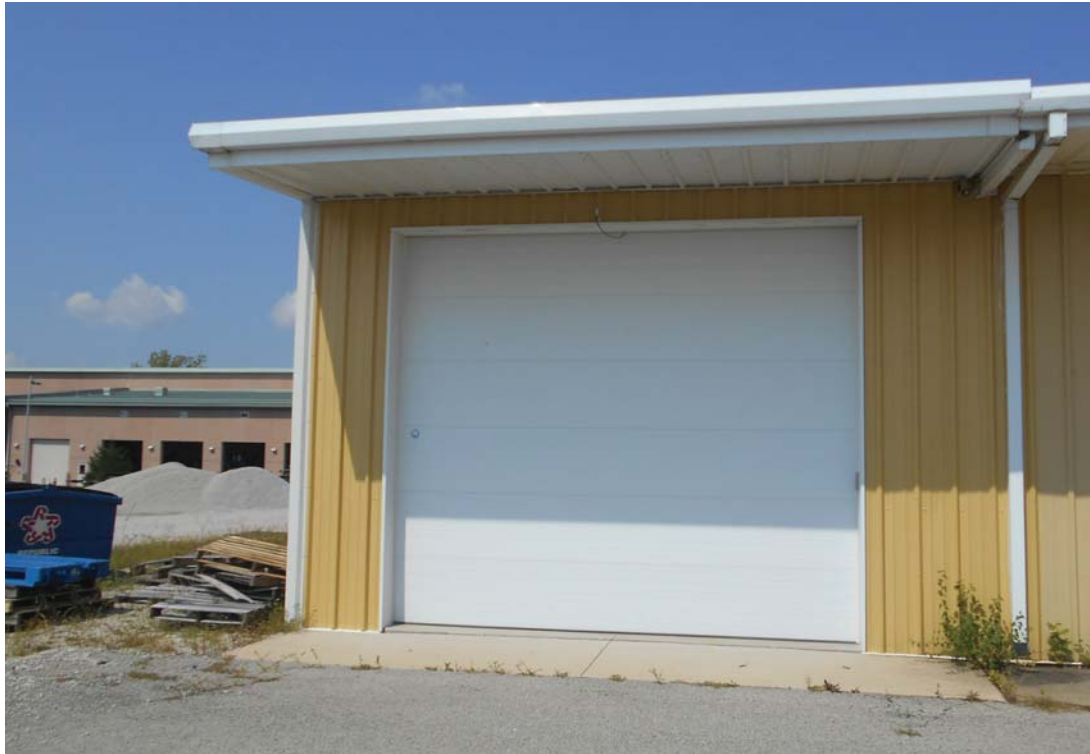
Observation Highlights:

- ILEAS Garage 1 is connected to EMA Garage.
- The building is in overall good condition.
- Sealed concrete flooring is scratched and worn in places.
- Finish on interior exposed structure is worn and deteriorated.
- Overhead door and frame is in fair condition.
- Metal wall panels are in good condition.
- Roof system is in good condition.
- Gutters and downspouts are in good condition.
- Some plant growth in cracks along exterior concrete and pavement.
- Sealant deterioration in places along concrete.
- No ventilation. Heat provided by ceiling mounted gas fired unit heater.
