CASE 967-S-19

SUPPLEMENTAL MEMORANDUM #4
August 21, 2020

Request: Authorize a Contractor's Facility with Outdoor Storage and Outdoor Operations as a Special Use in the AG-1 Agriculture Zoning District.

**Bureau of Land – Field Operations Section
Evaluation Report**

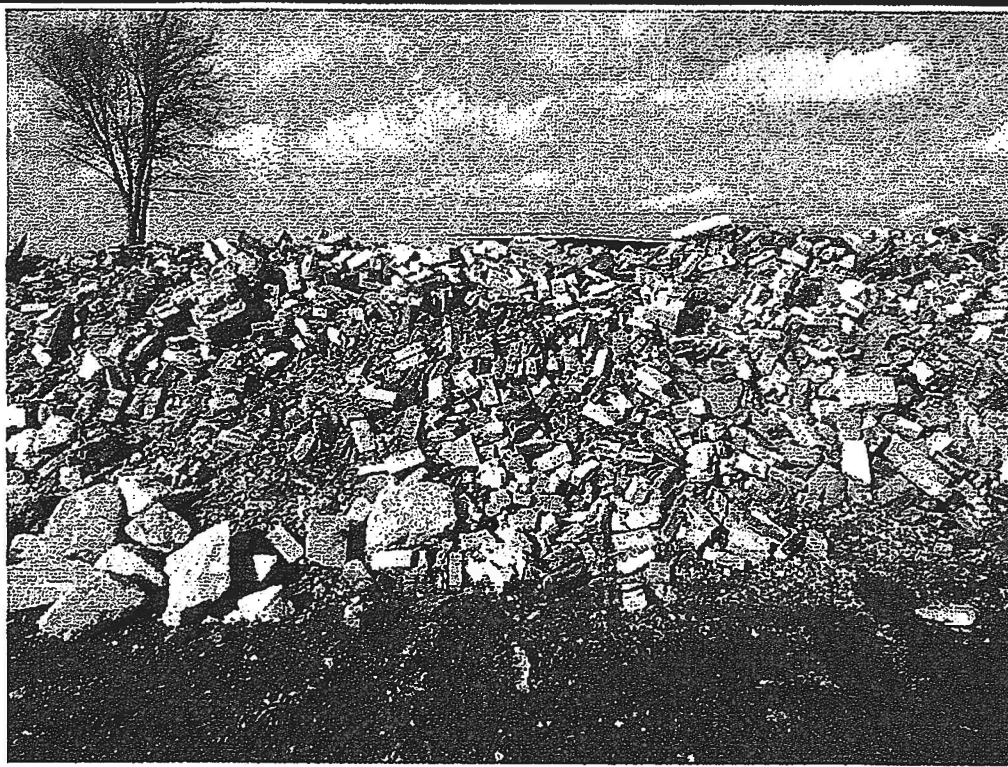
Photo ID: 1
Photo Date: 2/11/2020
Photo Time: 14:07:11
Direction: N
Taken By: Jennifer O'Hearn

I drove into the site, parked and began the inspection. I observed a new pile of bricks and concrete with some painted bricks that according to Mr. Block are from the demolition of Kam's bar in Champaign, Illinois (photo 1). I then viewed piles of crushed concrete, some broken chunks of concrete, and further back large mound of milled, reclaimed asphalt pavement. There appeared to be more crushed concrete than in the previous inspection (photo 2). Next, I observed a pile of bricks and concrete with some painted bricks from a distance, where in the previous inspection there was mainly concrete (photo 3). Then, I observed piles of crushed brick and crushed concrete (photos 4 & 11). I then observed piles of concrete that have been at the site since August 11, 2015 and some brick and brick pieces (photos 5, 6, 7 & 17). Next, I observed an approximately thirty-cubic yard crushed brick pile, where in the previous inspection a thirty-cubic yard pile of uncrushed bricks was located (photo 8). I then viewed a loader being used at the site and newer mixed concrete and brick piles, concrete piles, and crushed brick piles. I also observed the previous locations of a 20-cubic yard pile of brick and concrete, now removed and a thirty-cubic yard pile of soil, brick and concrete, now removed (photo 9). Then, I observed a new pile of mostly crushed concrete with some bits of crushed brick mixed in (photo 10). I next viewed the previous location of a pile with brick, concrete, and one piece of dimensional lumber now with crushed brick, crushed concrete, splintered wood, etc. in a pile (photo 12). Next, I observed a pile of concrete, brick, soil, reclaimed asphalt pavement, painted concrete, dimensional lumber, etc. with some concrete removed and some apparent asphalt removed as compared to the previous inspection (photo 13). Then, I viewed new concrete, brick, painted concrete and soil in a pile (photo 14). Subsequently, I observed a new pile of soil, concrete, brick and dimensional lumber. Further back, I observed apparent metal as observed in the previous inspection. I also observed dimensional lumber and plastic had been removed from the area since the last inspection (photo 15). Then, I observed new concrete, brick, clay field tile, etc. in a pile (photo 16). I next observed new landscape waste, dimensional lumber and metal (photo 17). Next, I viewed a large-scale crusher and piles of newly crushed asphalt (photos 18 & 19). I observed an apparent new pile of crushed concrete and apparent crushed concrete pile as observed previously (photo 19). I viewed piles of broken concrete, some broken reclaimed asphalt, as observed in previous inspection (photo 20). Then, I observed piles of concrete as observed previously (photo 21). Finally, I observed a skid steer with a jack-hammer-like extension being used to break up pieces of concrete in the piles of concrete (photo 22).

View of pile of bricks and
concrete with some painted
bricks.

Note: Any painted concrete or brick should be tested by TCLP or SPLP extraction to confirm the paint does not exceed the Class I groundwater quality standards at 35 Illinois Administrative Code 620.410 for arsenic, cadmium, chromium (total), lead, mercury and zinc before recycling the material. Material contaminated with paint containing heavy metals should be disposed at a permitted landfill.

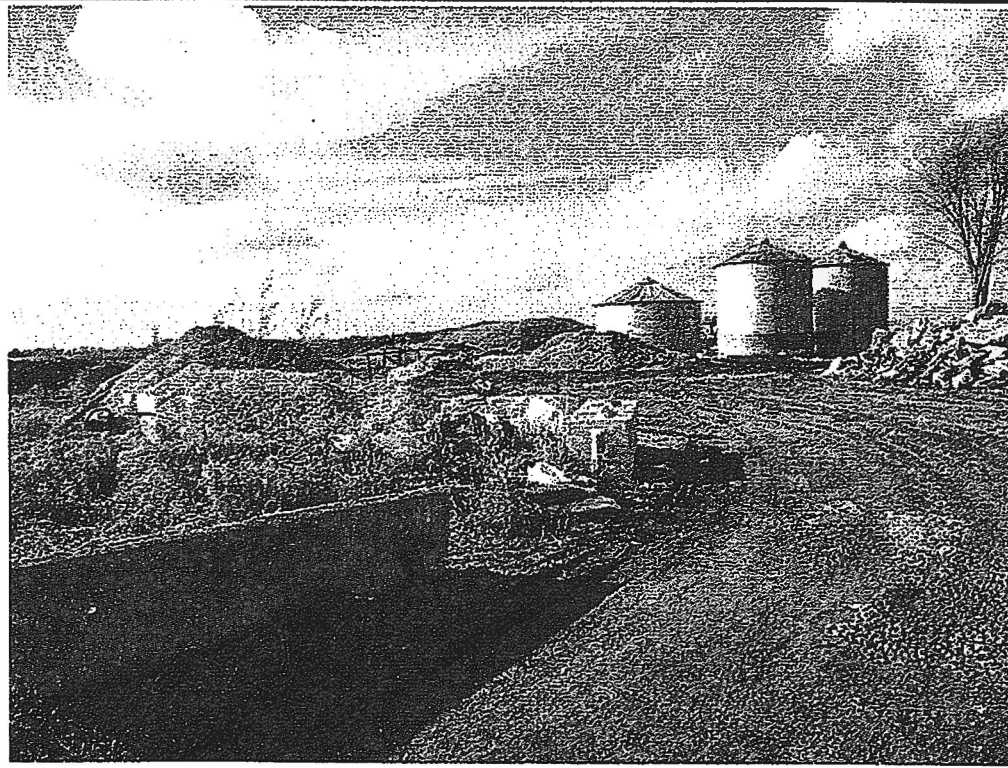
Photo ID: 2
Photo Date: 2/11/2020
Photo Time: 14:08:12
Direction: NW
Taken By: Jennifer O'Hearn

However, north and east of the barn show no signs of improvement with around 120 cubic yards of concrete that have been at the site since August 11, 2015. To the west of the grain bins a couple hundred cubic yards of ground asphalt (photo 2) that were observed previously have not left the site.

View of piles of crushed
concrete, some broken chunks
of concrete, and further back
large mound of milled,
reclaimed asphalt pavement.

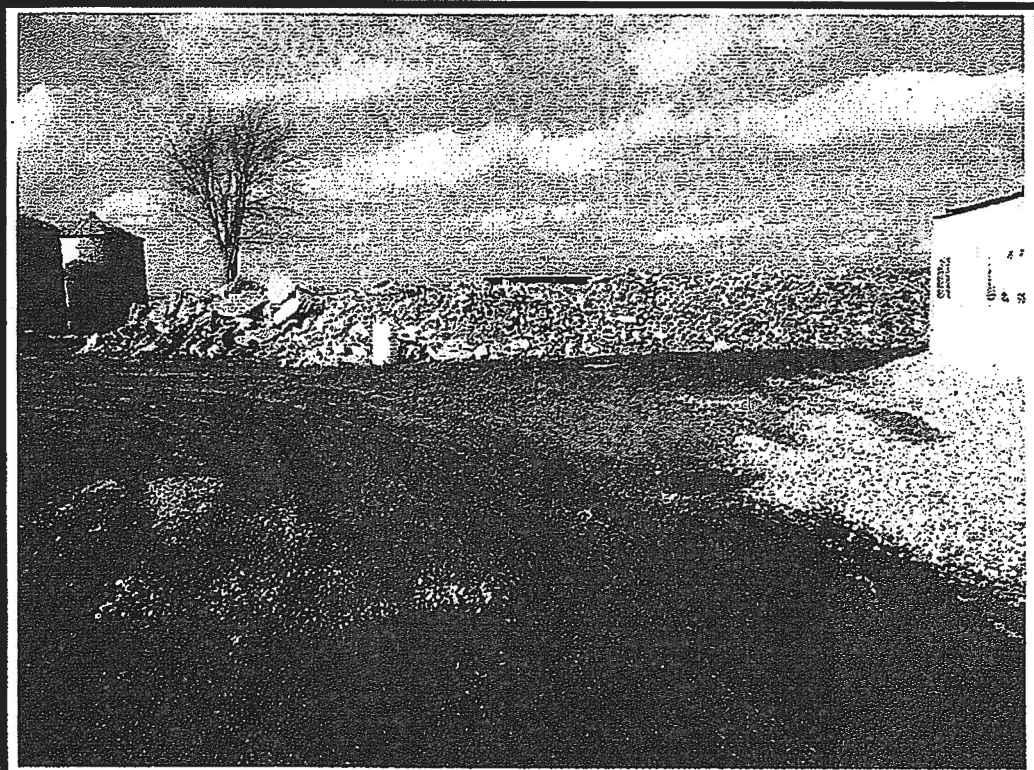
Photo ID: 3
Photo Date: 2/11/2020
Photo Time: 14:08:19
Direction: N
Taken By: Jennifer O'Hearn

View of pile of bricks and
concrete with some painted
bricks from a distance.

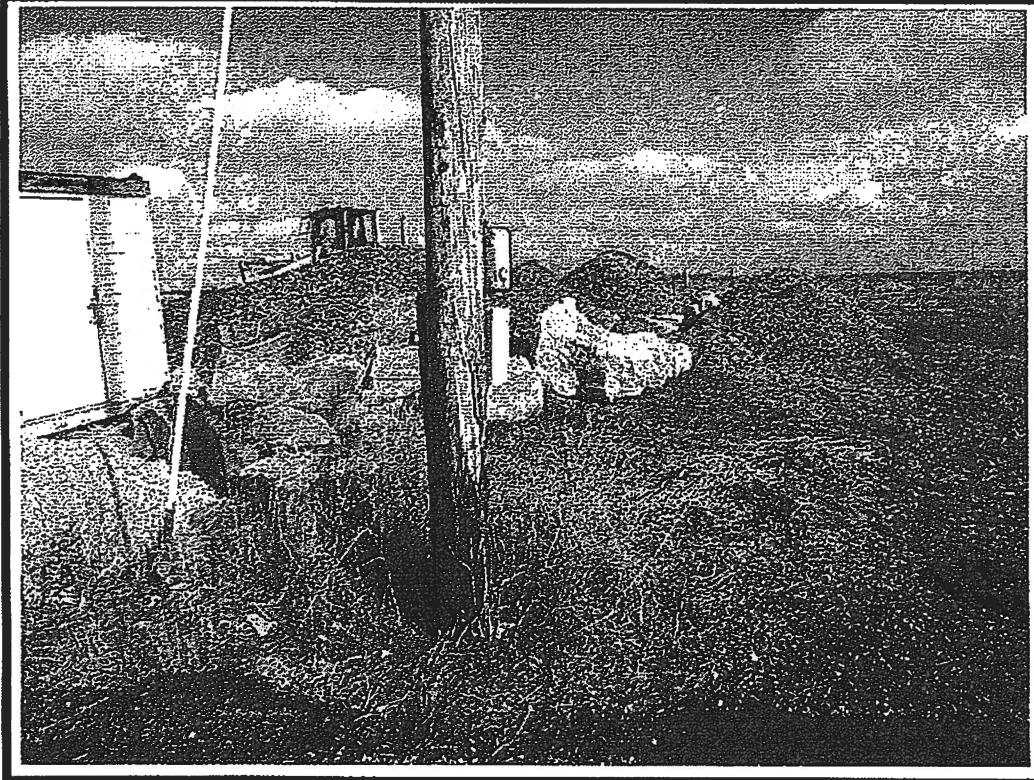
Photo ID: 4
Photo Date: 2/11/2020
Photo Time: 14:08:29
Direction: NE
Taken By: Jennifer O'Hearn

View of piles of crushed brick.

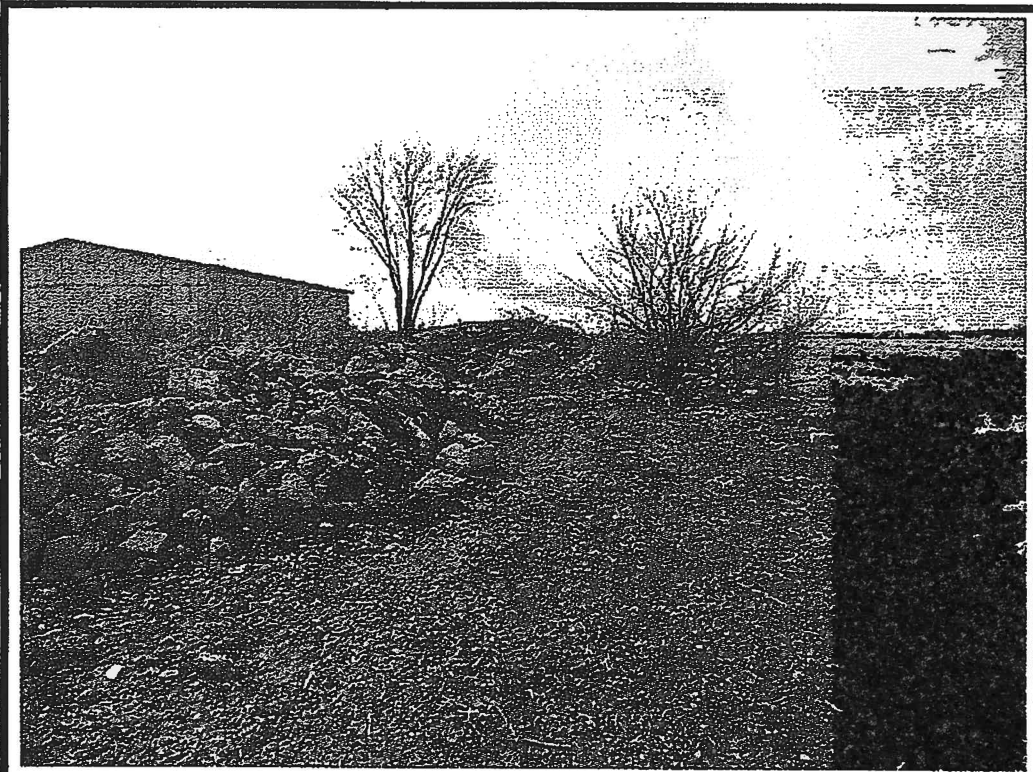
Photo ID: 5
Photo Date: 2/11/2020
Photo Time: 14:28:14
Direction: W
Taken By: Jennifer O'Hearn

View of broken concrete piles
from which vegetation is
growing as previously
observed.

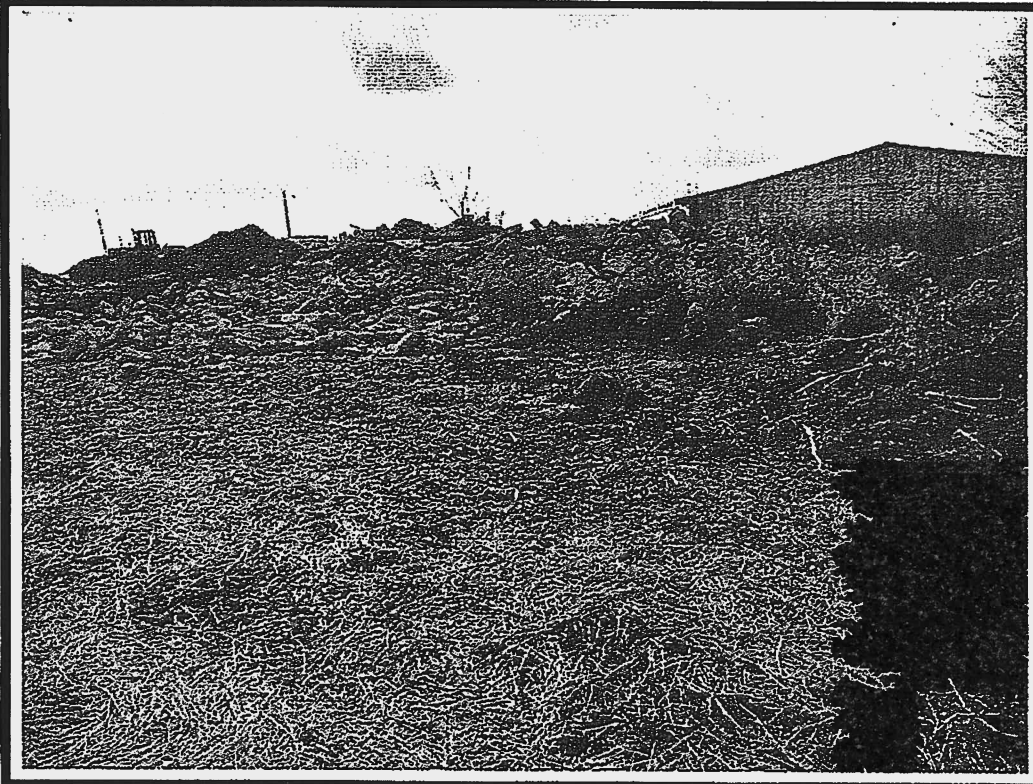
Photo ID: 6
Photo Date: 2/11/2020
Photo Time: 14:28:42
Direction: SW
Taken By: Jennifer O'Hearn

View of broken concrete piles
from which vegetation is
growing as previously
observed.

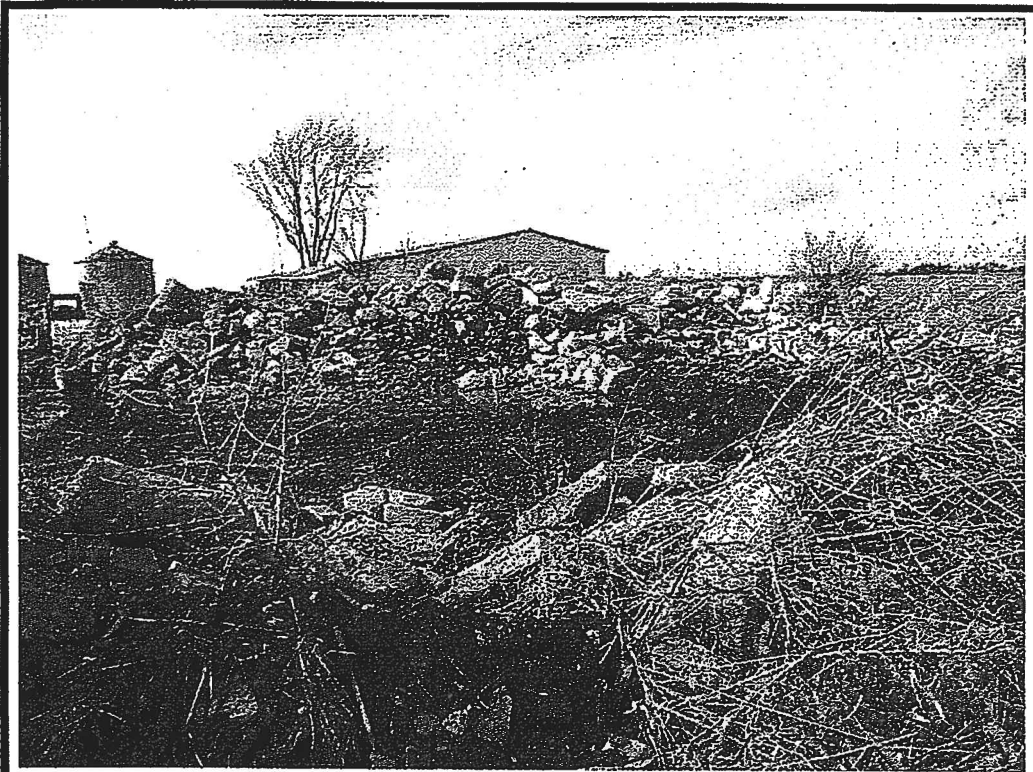
Photo ID: 7
Photo Date: 2/11/2020
Photo Time: 14:29:54
Direction: NW
Taken By: Jennifer O'Hearn

View of some brick and broken concrete piles from which vegetation is growing as previously observed.

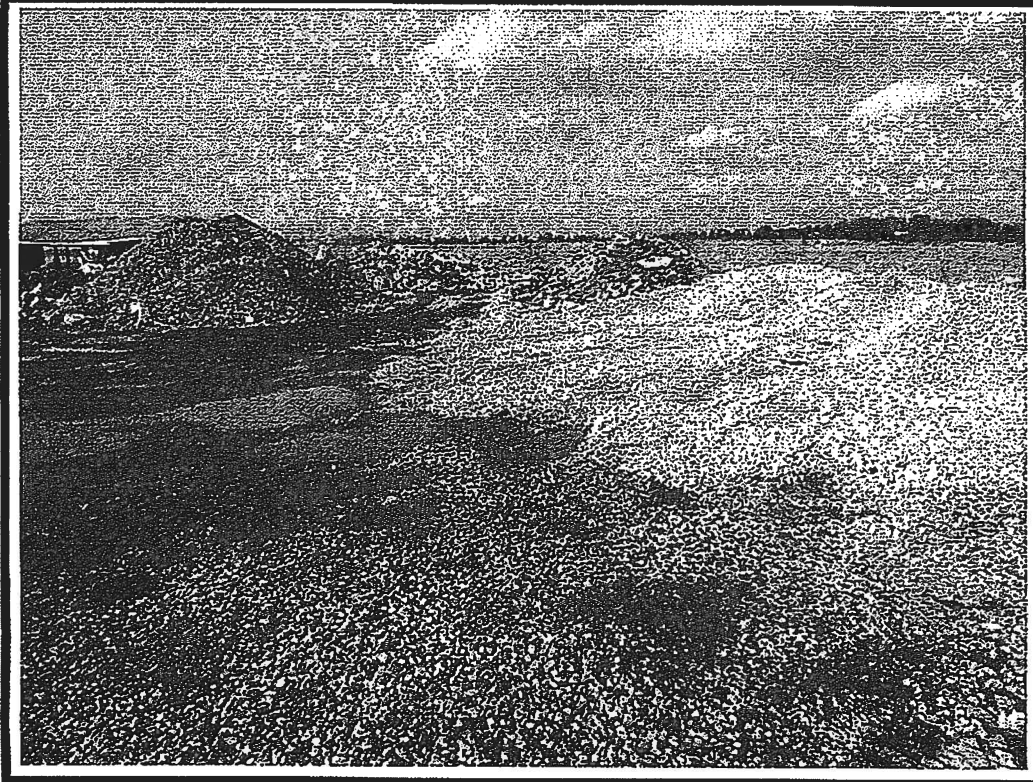
Photo ID: 8
Photo Date: 2/11/2020
Photo Time: 14:33:08
Direction: N
Taken By: Jennifer O'Hearn

In summary, much activity has occurred at the site. Around 30 cubic yards of brick was crushed from a former pile of brick (photos 8 & 9). Around 40 cubic yards of asphalt was crushed (photos 18 & 19). Around 30 cubic yards of concrete was apparently newly crushed (photo 2). Around 5 cubic yards of lumber and plastic were removed (photo 15). Around 10 cubic yards of concrete and asphalt were

View of crushed brick pile, crushed concrete pile, mixed concrete and brick pile and concrete piles. A previously observed 30-cubic yard uncrushed brick pile apparently had been crushed.

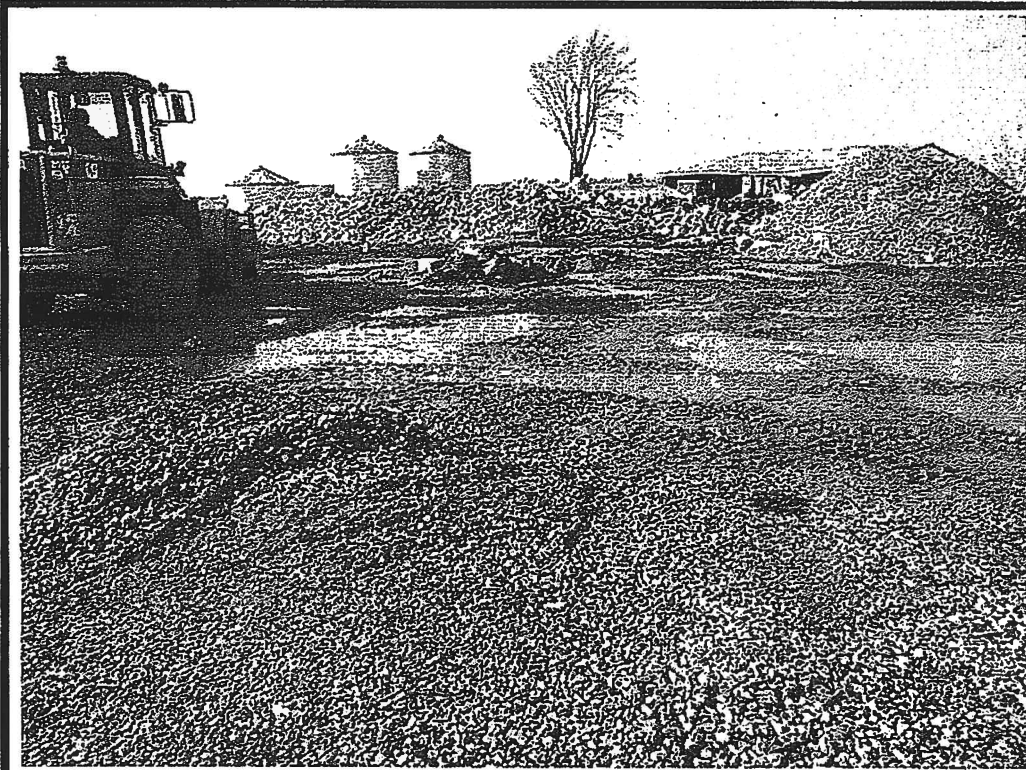
Photo ID: 9
Photo Date: 2/11/2020
Photo Time: 14:33:13
Direction: NW
Taken By: Jennifer O'Hearn

removed (photo 13). Around 20 cubic yards of brick and concrete and 30 cubic yards of soil, brick and concrete were removed (photos 8 & 9). A total of 125 cubic yards is estimated to have either been crushed or removed at the site.

View of loader being used at the site and of newer mixed concrete and brick piles, concrete piles, and crushed brick piles. View of previous location of 20-cubic yard pile of brick and concrete now removed.

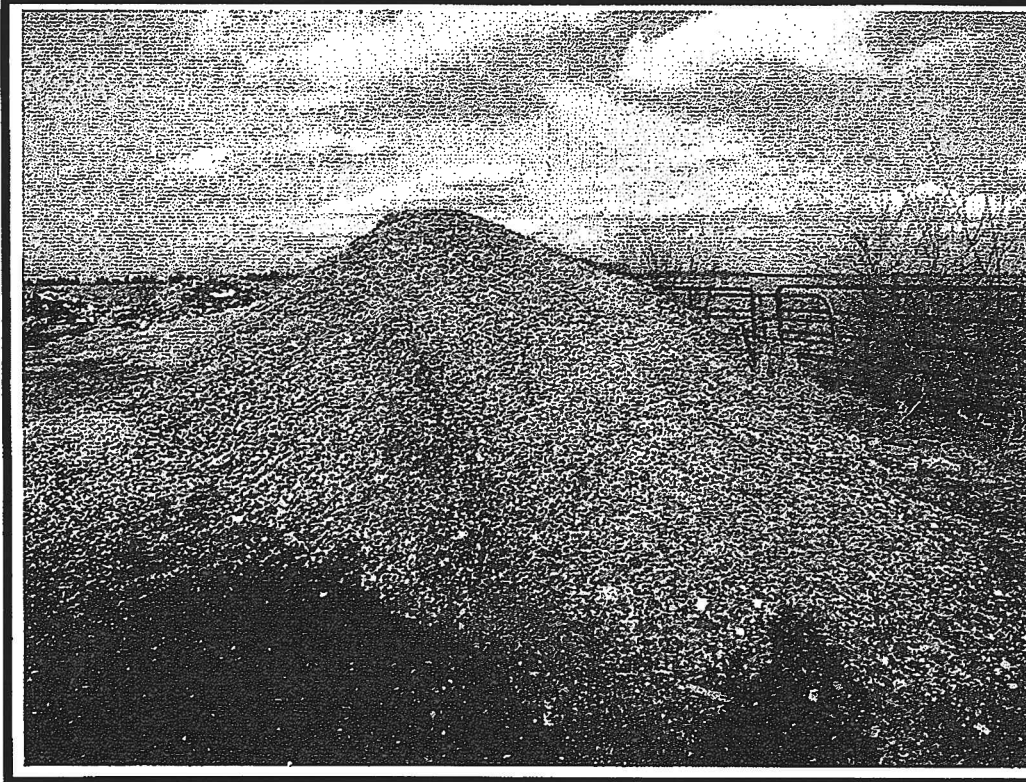
Photo ID: 10
Photo Date: 2/11/2020
Photo Time: 14:36:48
Direction: NE
Taken By: Jennifer O'Hearn

View of pile of mostly crushed concrete with some bits of crushed brick mixed in.

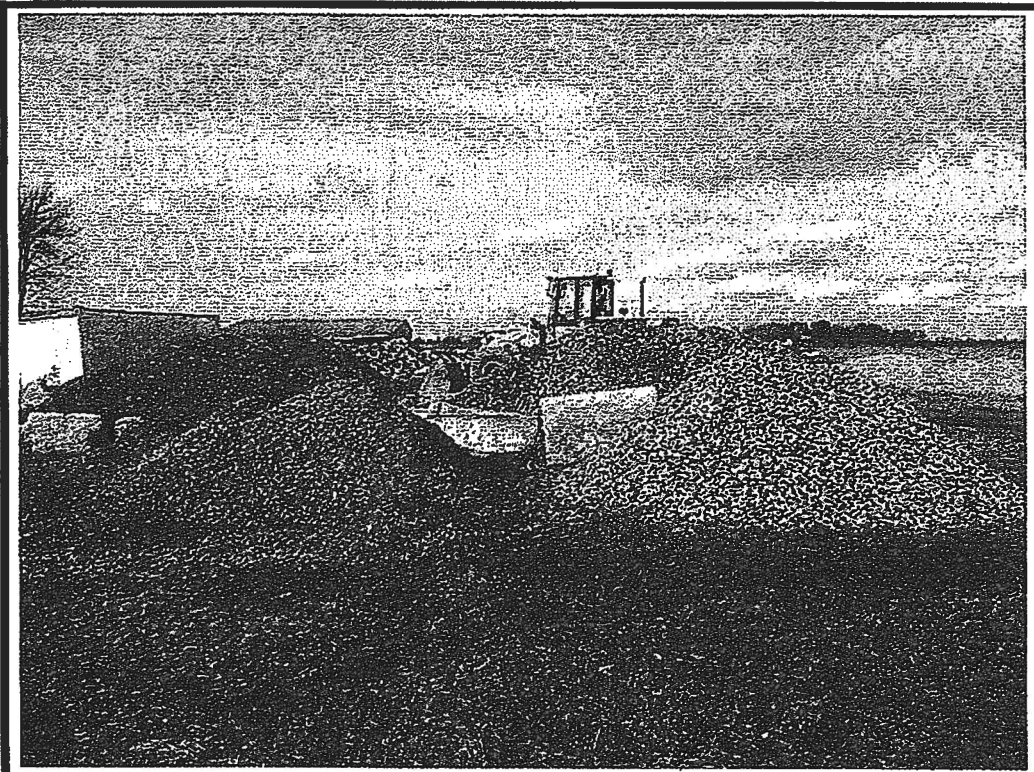
Photo ID: 11
Photo Date: 2/11/2020
Photo Time: 14:38:14
Direction: N
Taken By: Jennifer O'Hearn

View of piles of varying amounts of crushed brick and crushed concrete.

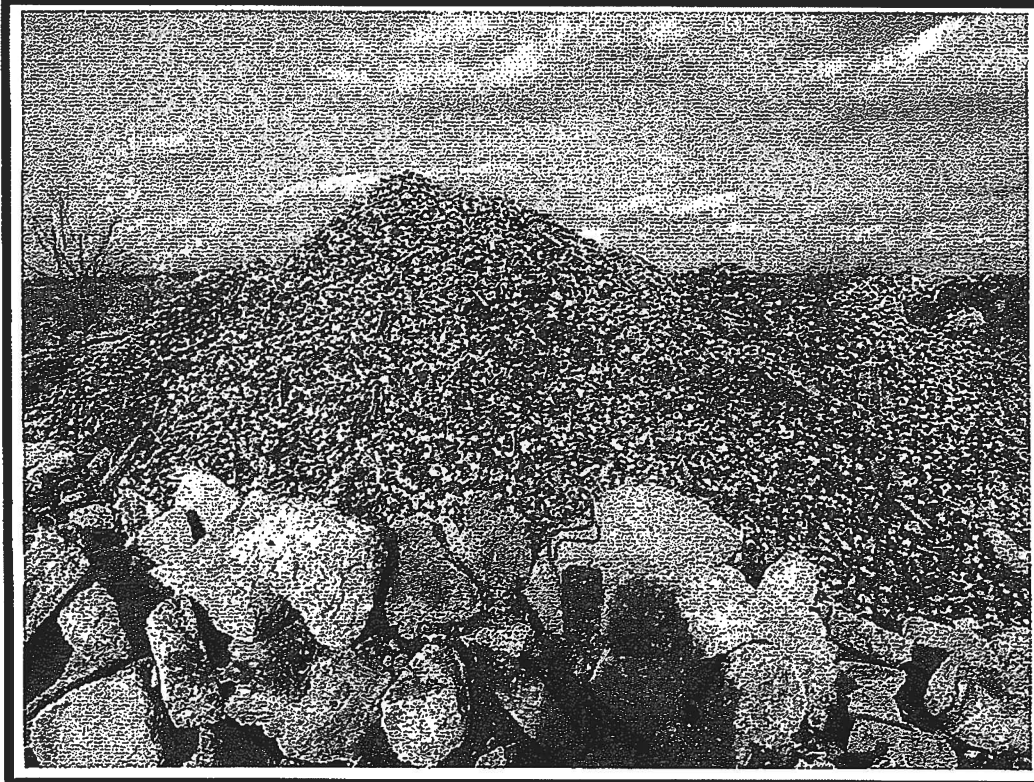
Photo ID: 12
Photo Date: 2/11/2020
Photo Time: 14:40:13
Direction: E
Taken By: Jennifer O'Hearn

View of crushed brick, crushed concrete, splintered wood, etc. in pile.

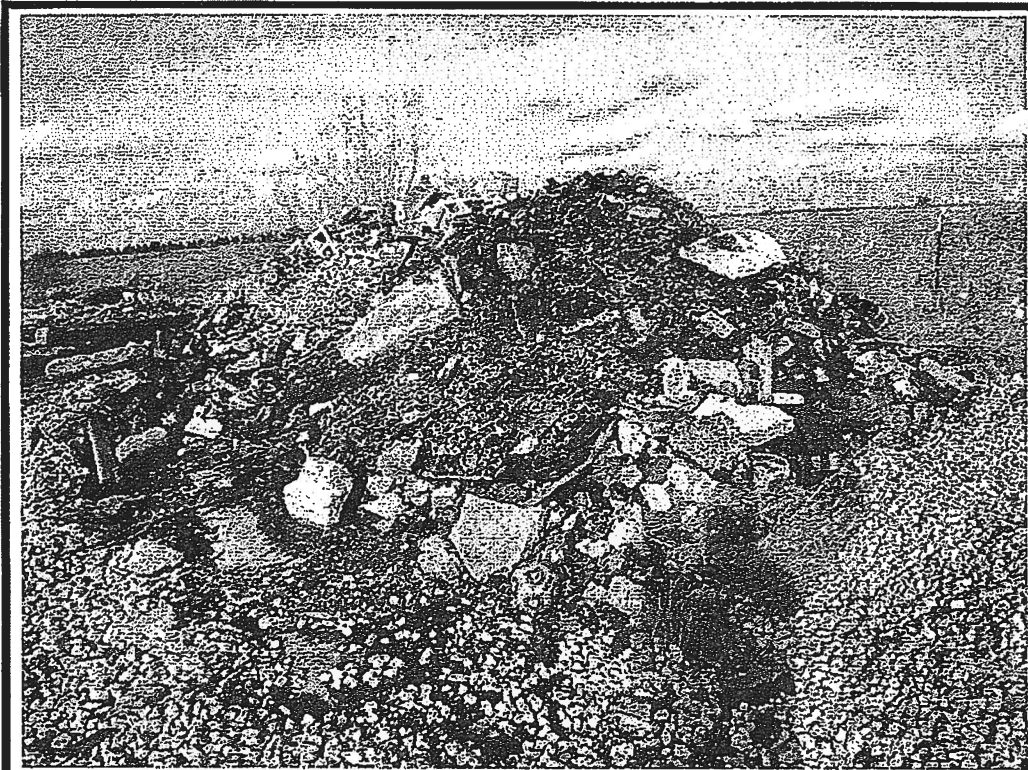
Photo ID: 13
Photo Date: 2/11/2020
Photo Time: 14:51:07
Direction: NE
Taken By: Jennifer O'Hearn

View of pile of concrete, brick, soil, reclaimed asphalt pavement, painted concrete, dimensional lumber, etc. with some concrete removed and some apparent asphalt removed as compared to the previous inspection.

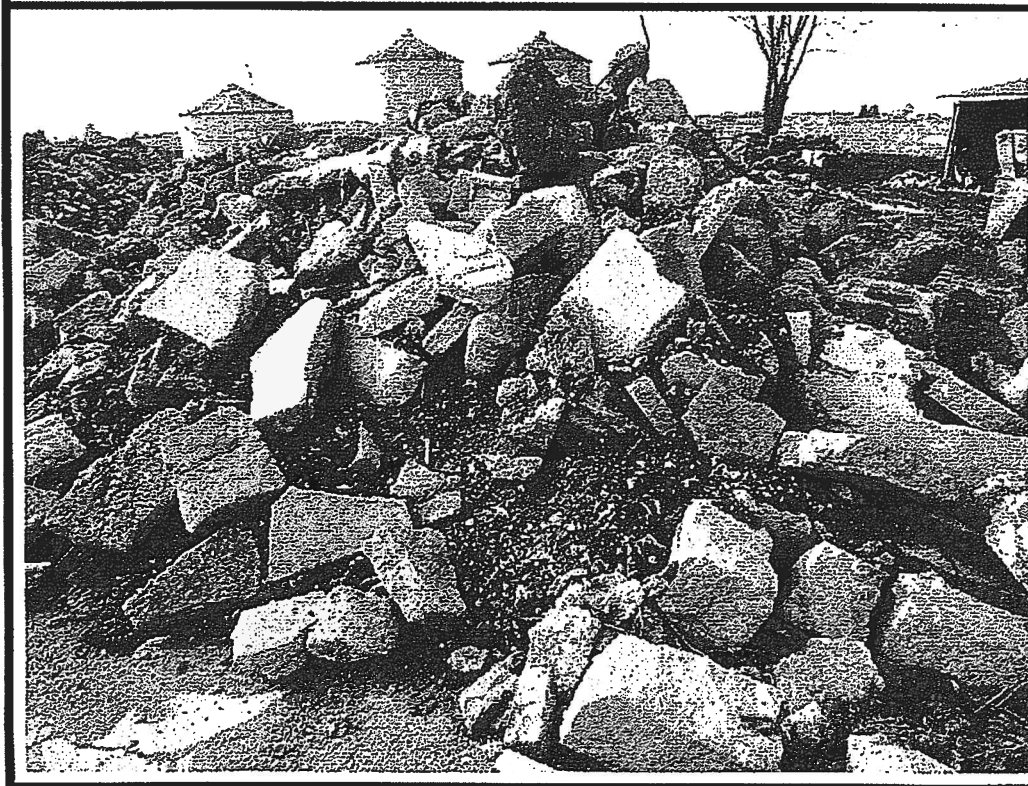
Photo ID: 14
Photo Date: 2/11/2020
Photo Time: 14:53:53
Direction: NW
Taken By: Jennifer O'Hearn

Much new material was observed including about 15 cubic yards of new painted concrete, unpainted concrete and soil (photo 14), 40 cubic yards new bricks (photo 16) and 30 cubic yards of new bricks, some with paint (photo 1). A total estimated 85 cubic yards of new material came into the site.

View of new concrete, brick, painted concrete and soil in a pile.

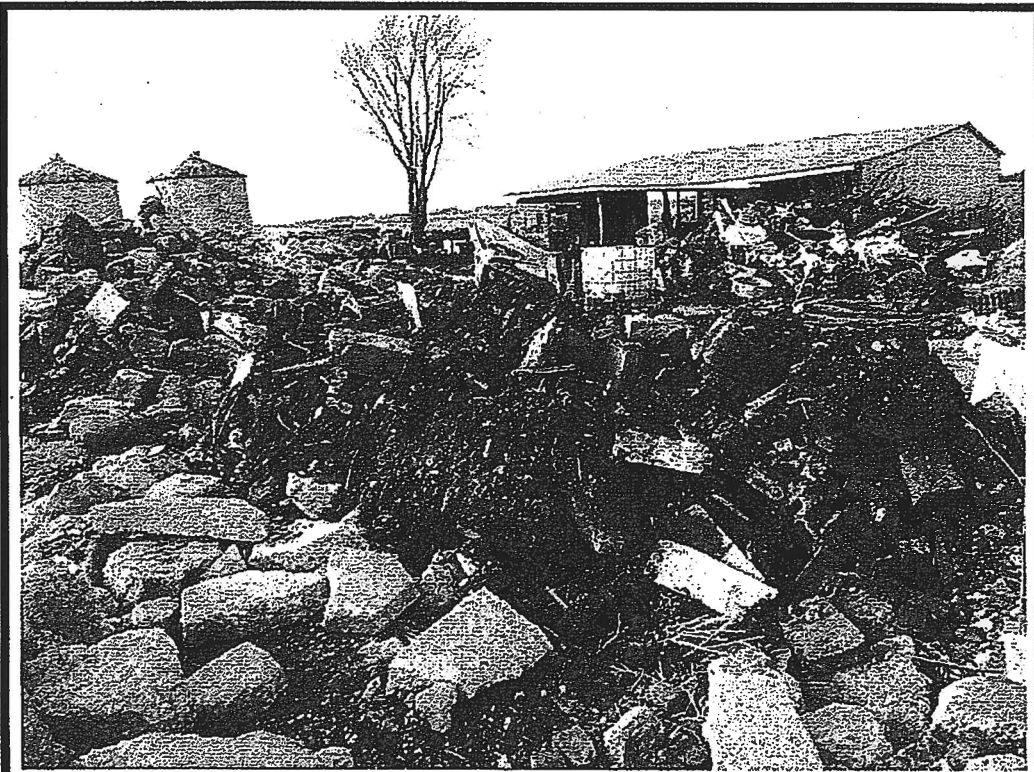
Photo ID: 15
Photo Date: 2/11/2020
Photo Time: 14:58:09
Direction: NW
Taken By: Jennifer O'Hearn

View of a new pile of soil, concrete, brick and dimensional lumber; further back, apparent metal as observed in the previous inspection; dimensional lumber and plastic removed from the area since the last inspection.

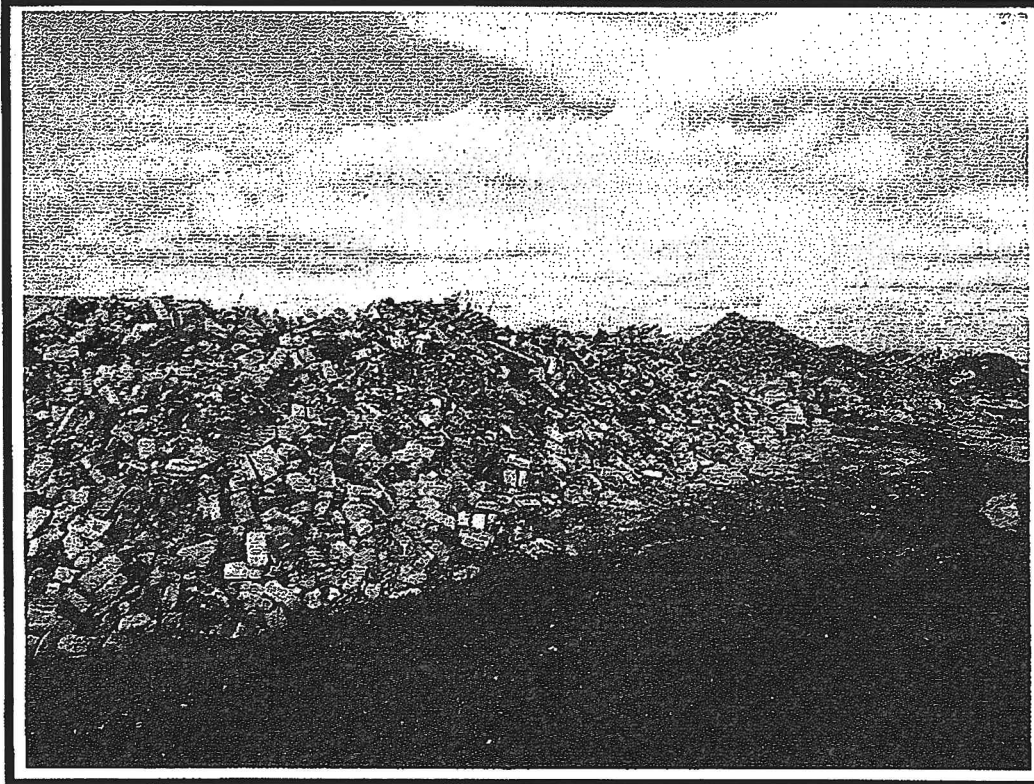
Photo ID: 16
Photo Date: 2/11/2020
Photo Time: 15:02:03
Direction: NE
Taken By: Jennifer O'Hearn

View of new concrete, brick, clay field tile, etc. in a pile.

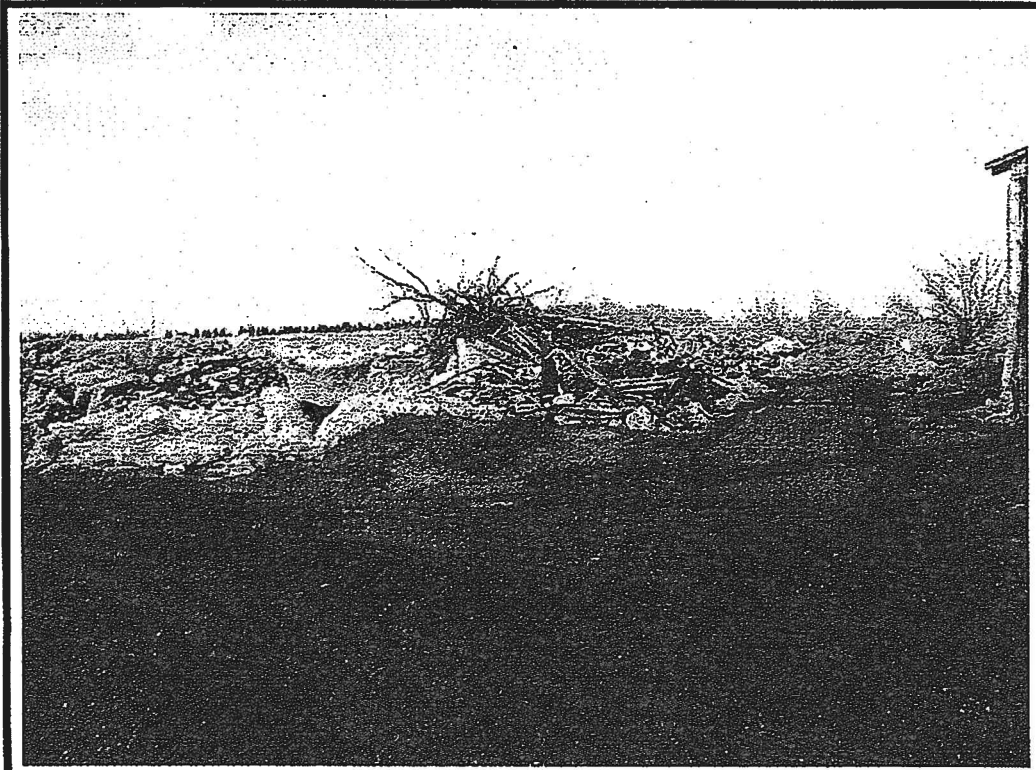
Photo ID: 17
Photo Date: 2/11/2020
Photo Time: 15:03:30
Direction: NE
Taken By: Jennifer O'Hearn

View of piles of concrete as before and new landscape waste, dimensional lumber and metal.

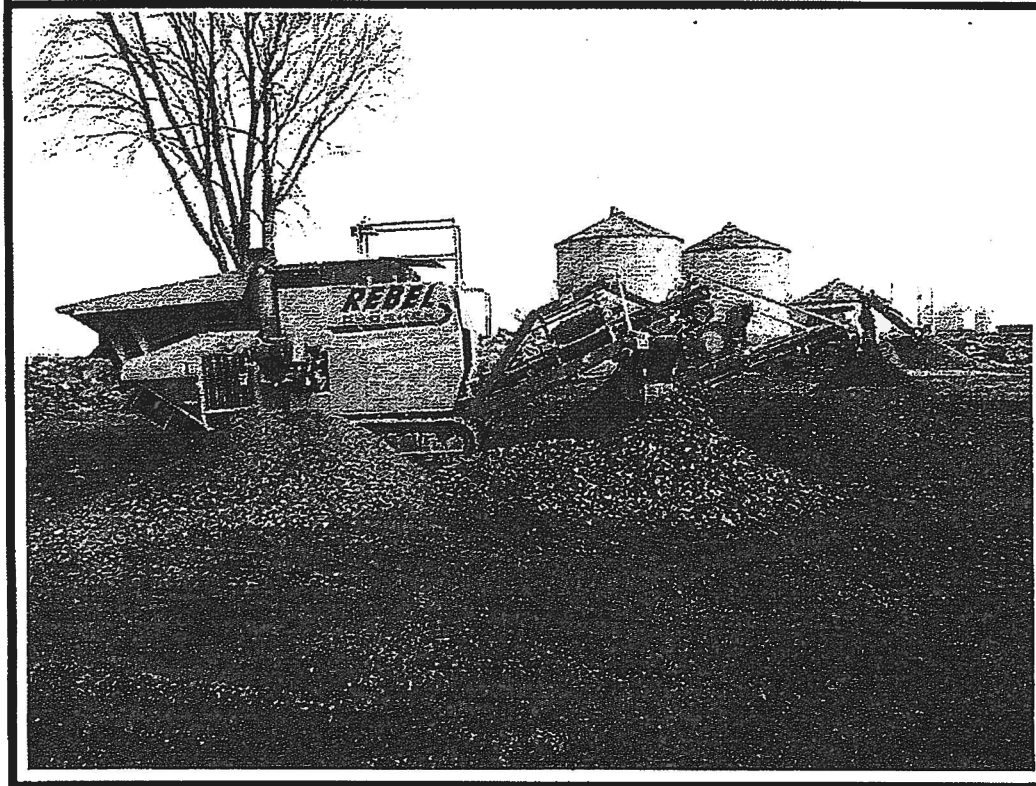
Photo ID: 18
Photo Date: 2/11/2020
Photo Time: 15:05:40
Direction: SE
Taken By: Jennifer O'Hearn

View of large-scale crusher and piles of newly crushed asphalt.

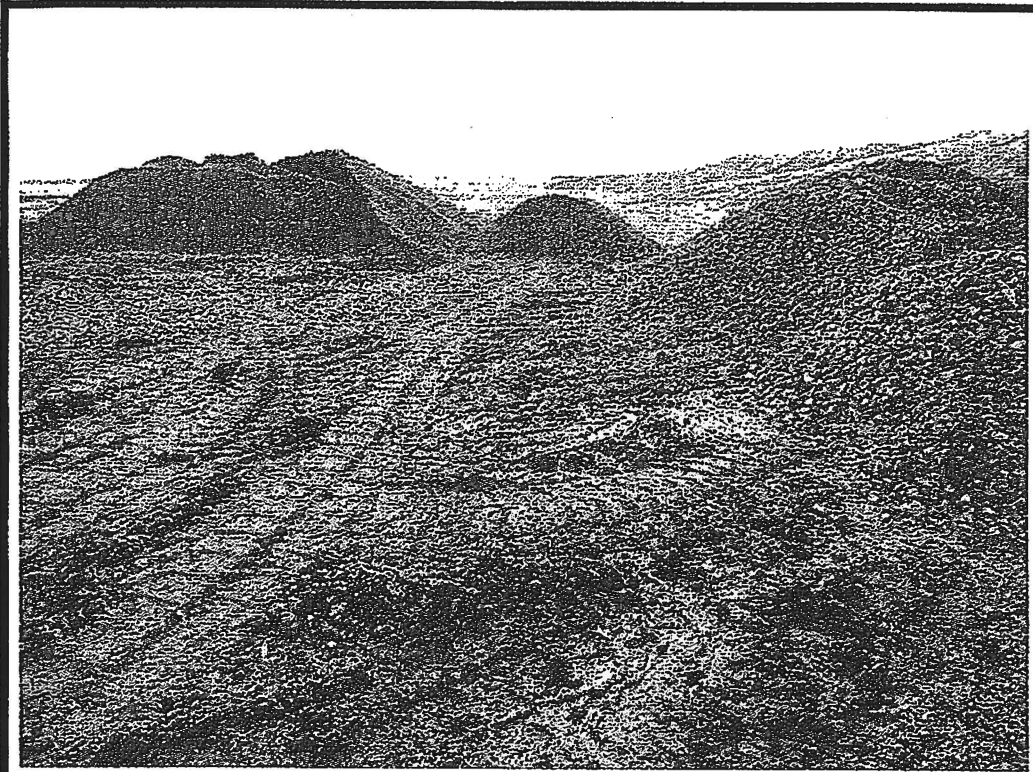
Photo ID: 19
Photo Date: 2/11/2020
Photo Time: 15:06:22
Direction: SW
Taken By: Jennifer O'Hearn

View of piles of apparent
crushed and milled asphalt.

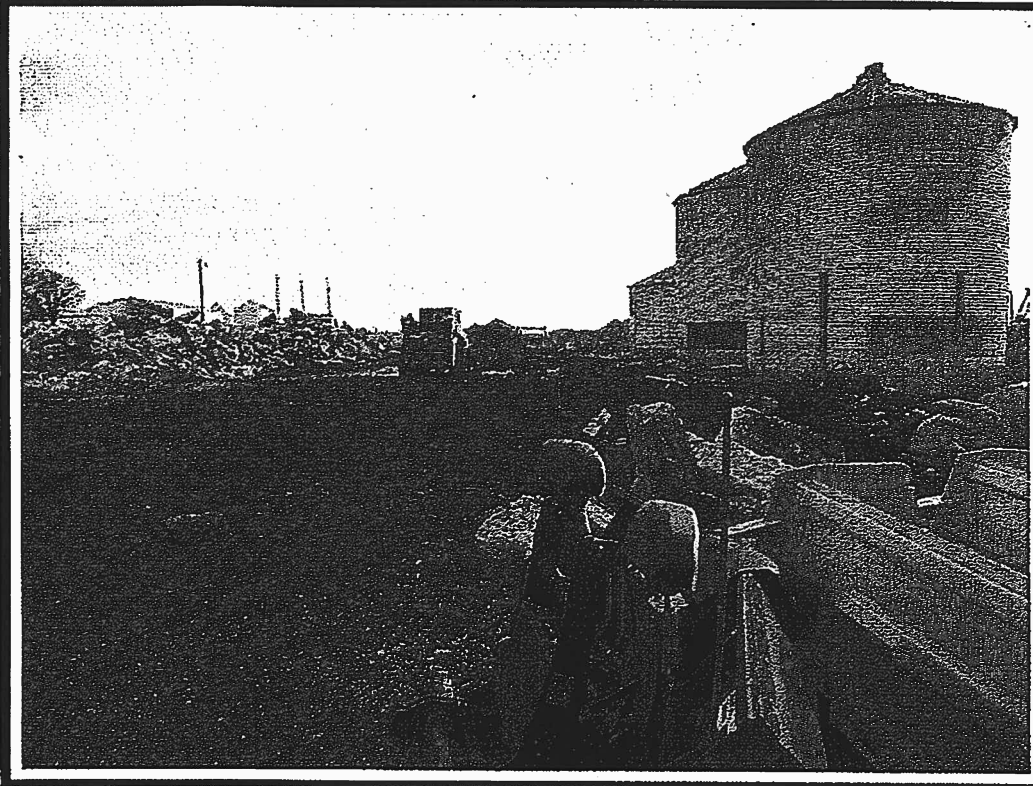
Photo ID: 20
Photo Date: 2/11/2020
Photo Time: 15:08:07
Direction: S
Taken By: Jennifer O'Hearn

View of piles of broken
concrete, some broken
reclaimed asphalt, as observed
in previous inspection.

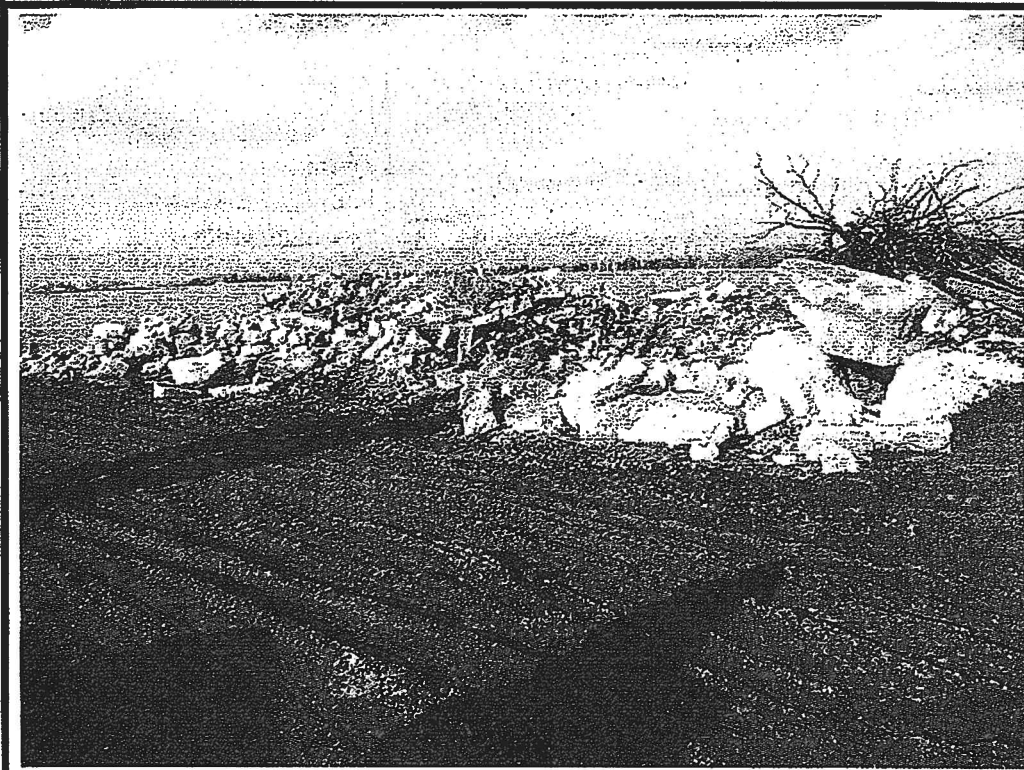
Photo ID: 21
Photo Date: 2/11/2020
Photo Time: 15:10:12
Direction: NE
Taken By: Jennifer O'Hearn

View of piles of concrete as
observed previously.

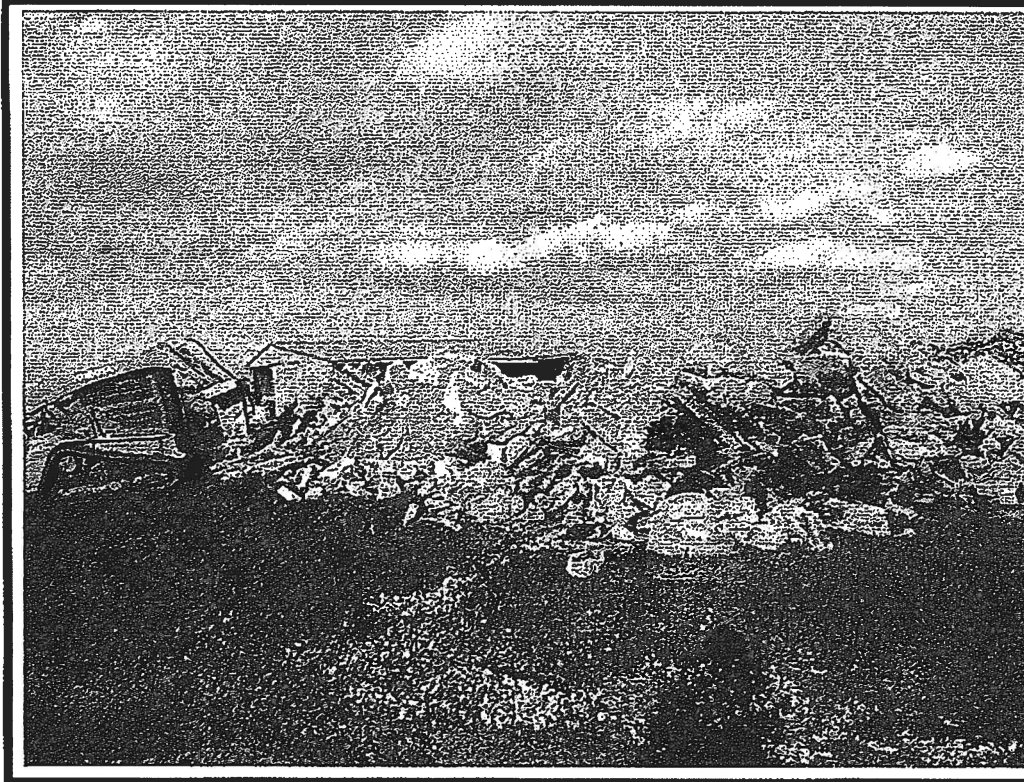
Photo ID: 22
Photo Date: 2/11/2020
Photo Time: 15:18:11
Direction: NE
Taken By: Jennifer O'Hearn

View of a skid steer with a jack-
hammer-like extension being
used to break up pieces of
concrete in the piles of
concrete.
