To: Chair Alan Kurtz and the Members of the Champaign County Board  
From: Van A. Anderson, Deputy County Administrator of Finance  
Subject: Update: Satellite Jail Concrete Wall Panel Cracking Investigation  
Date: August 21, 2014

Re: Satellite Jail Exterior Wall Cracking  
WJE No. 2014.4772

At the request of Dana Brenner, Champaign County Facility Director, we conducted a brief evaluation of exterior wall cracking at the Champaign County Satellite Jail (Jail), located in Urbana, Illinois. The scope of this evaluation included a review of various construction documents and photographs provided by Mr. Brenner, and a roughly 2 hour site visit. This letter summarizes our findings and opinions.

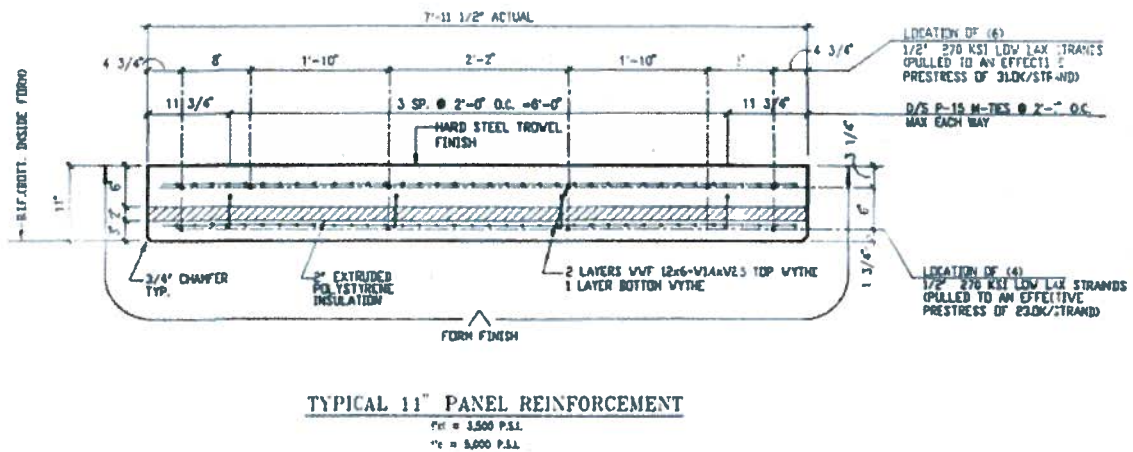
Figure 2 - Typical exterior wall section (PDM Shop Drawing E12)

A cross-section of a typical exterior wall panel is shown in Figure 2. Figure 3 shows the typical condition at the wall panel/foundation interface. A section through the top of the east wall of the outdoor recreation area is shown in Figure 4.

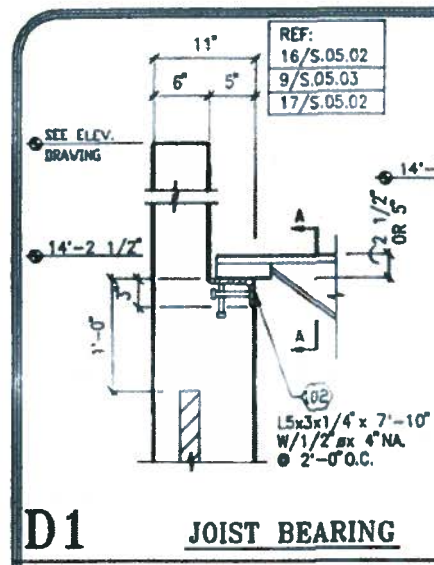
Figure 4 - Top of east wall of outdoor recreation area (PDM Shop Drawing E10)

Several exterior wall panels were visually examined from inside the building. In each case, the panel was free of noticeable cracking, even panels that had clear exterior cracks. The only panels that exhibited significant cracks in the thicker wythes were panels that formed the east wall of the exterior recreation area. Both faces of these panels are really exterior faces, and the tops of these panels were not covered with any form of membrane or coping. Figure 7 shows a portion of the top of one such panel. Also visible in Figure 7 is a portion of the steel framing supported by these panels. This framing supports a steel mesh and fabric net covering over the outdoor recreation area. As shown in Figure 4, this framing rests on a continuous steel angle that is connected to the panel with rows of steel studs.
