Facilities Assessment Report

November 19, 2015

County of Champaign, Illinois

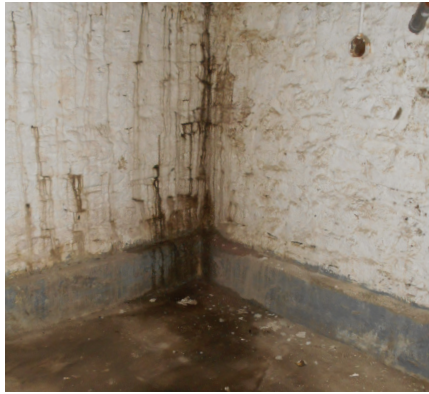
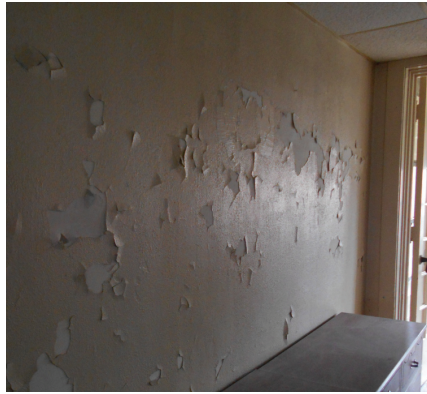
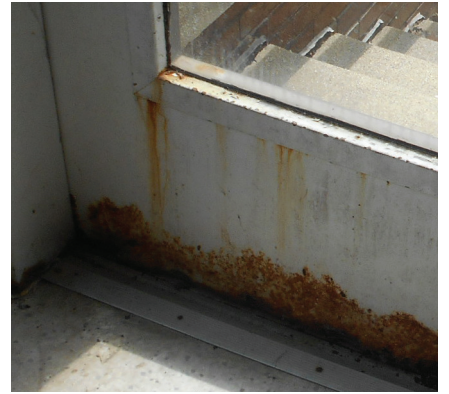
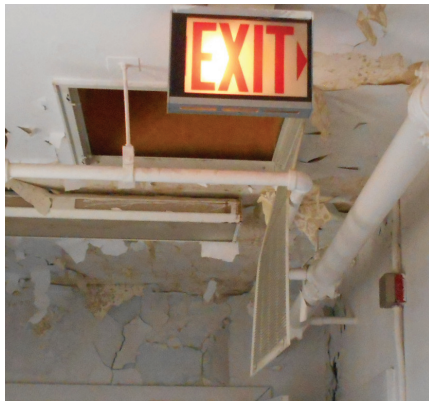
ILEAS Original Building

- This building has a back-up generator.
- Exterior brick planters are cracked.
- Some exterior walkways are cracked and pose tripping hazards.
- Two wings require interior finish upgrade.
- Grout in tile flooring is stained, some tile broken on walls.
- galvanized piping nearing the end of its useful life.
- VCT is stained and damaged at tactical areas.
- Exterior stone sealant is deteriorated, signs of water penetration.
- Exterior window storefront panels, mullion end caps missing and glass is cracked.
- Organic material found inside facility.
- Spaces served by 4 pipe fan coil units that are nearing end of useful life.

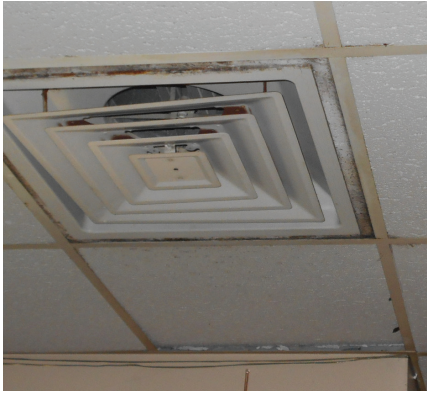
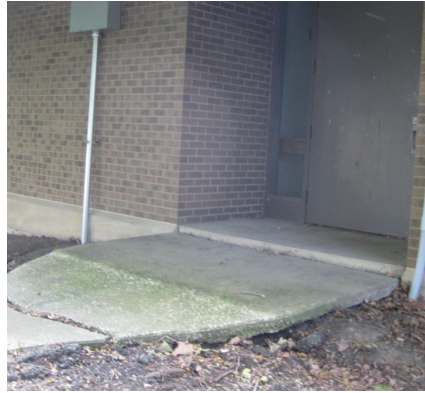
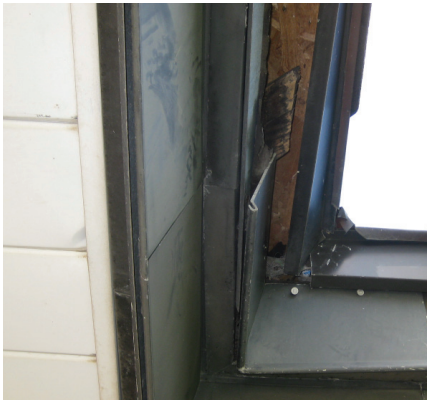
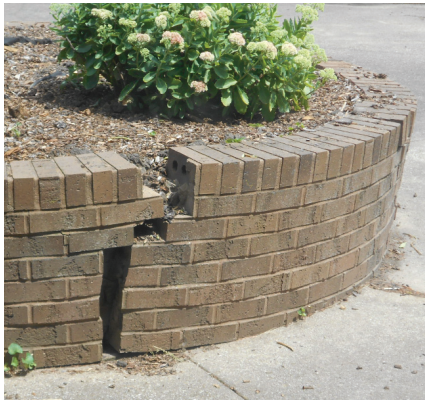
ILEAS Training Center

- This building has a back-up generator.
- Roof and soffit replacement needed at portion of facility.
- Downspouts are in need of repair, many are dented or loose.
- Parking lot recently resurfaced and is in good condition.
- Minor brick repair and sealant replacement required.
- Sidewalks cracked and damaged in places.
- Interior wall finishes in generally good condition.
- Exterior insulation is heavily damaged or missing.
- Roofing membrane in fair condition, Pod 100 and 200 need to be replaced.
- Served by small DX cool, gas heat RTUs nearing end of useful life.

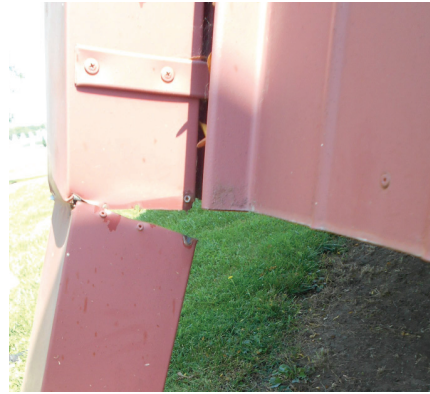
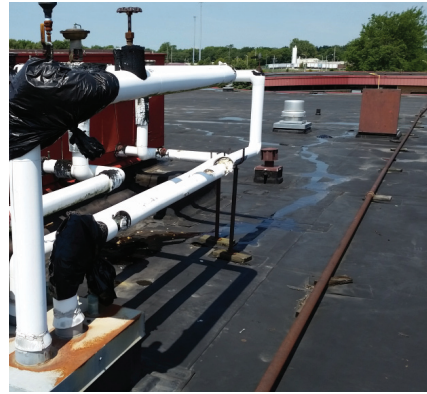
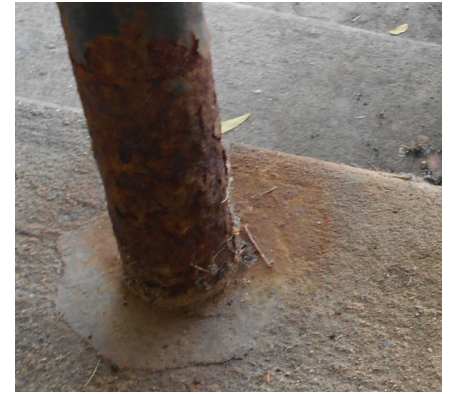
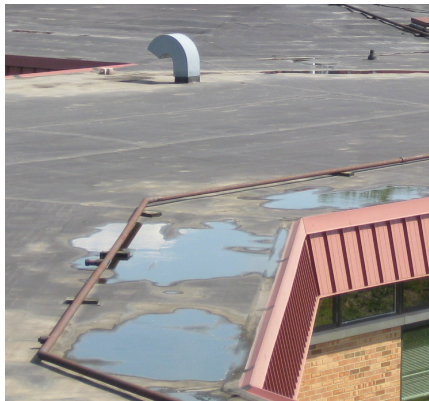
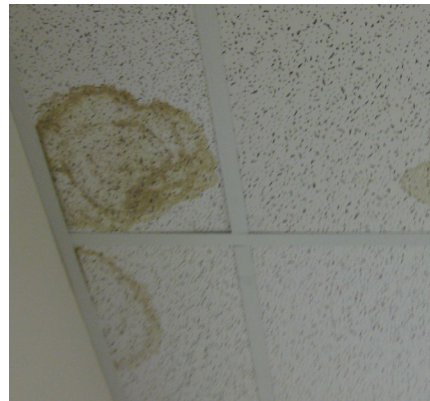
Brookens Administrative Center

- This building has a back-up generator.
- Stair treads worn and damaged.
- Carpet in generally good condition, stained and worn in select locations.
- Decorative marble chair rail stained and shows signs of deteriorated grout.
- Drywall finishes in good condition, some damage at corners and window jambs.
- Asphalt shingles in good condition.
- Wood steps and platform on roof heavily deteriorated and need to be replaced.
- Roof ballast missing and uneven in locations.
- Exterior brick and stone in generally good condition, some cracks and damaged stone.
- EPDM roof requires replacement.
- HVAC provided by air handling units, boilers, and chillers. Shared with addition.

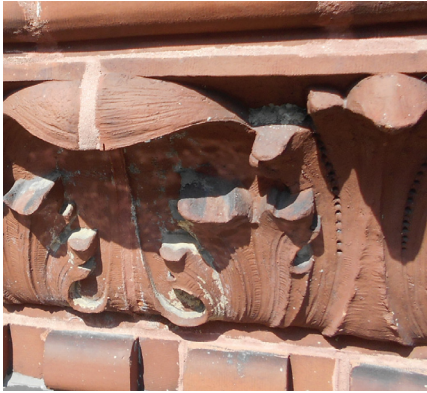
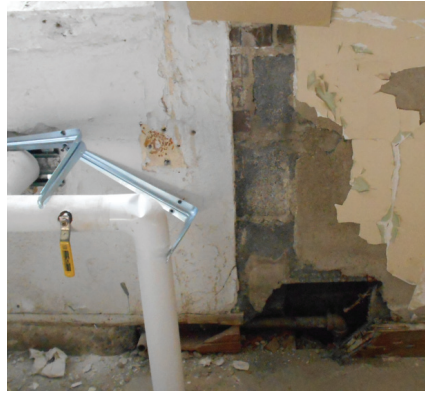
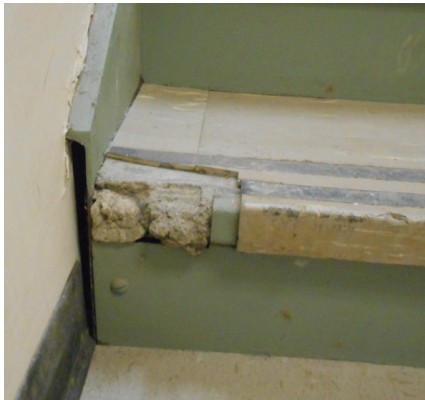
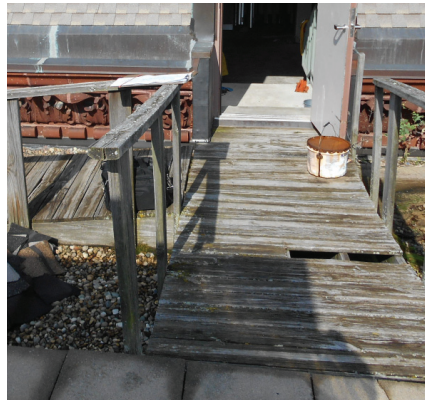
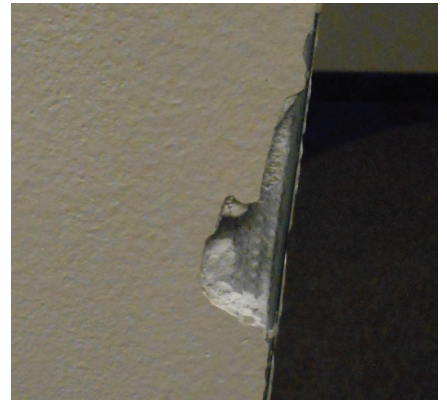
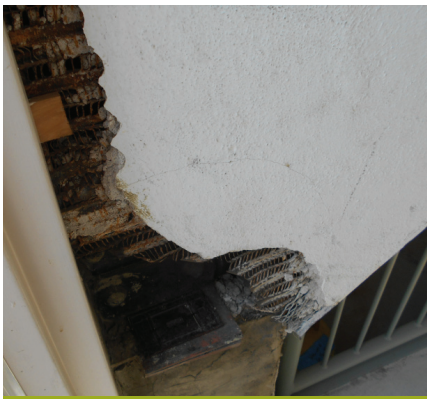
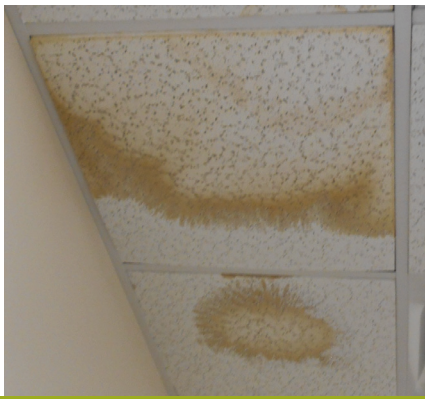
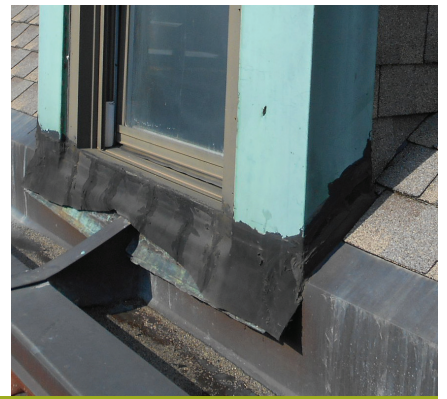
Courthouse

- This building has a back-up generator.
- Overall the building is in fair condition.
- Interior sealed concrete is heavily worn with some large cracks.
- Metal doors are scratched and dented.
- Cell doors show signs of deterioration and impact damage.
- Floor drains are heavily rusted and filled with debris.
- Sally port doors are oversized and prone to failure.
- Security system is outdated and needs to be replaced.
- Paint finishes are worn and deteriorating.
- Carpeting and millwork is heavily worn with some staining.
- Served by four mechanical units installed in two rooftop penthouses.

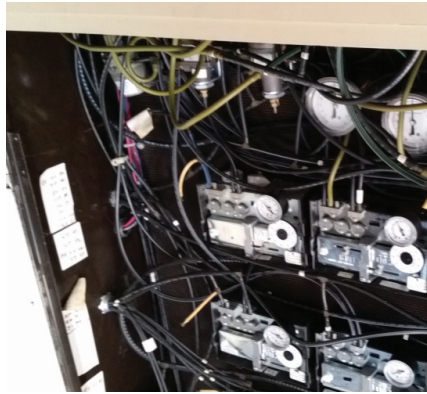
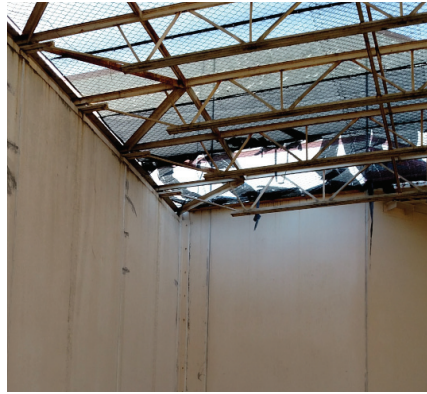
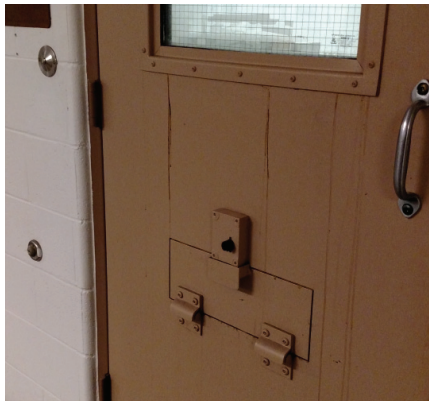
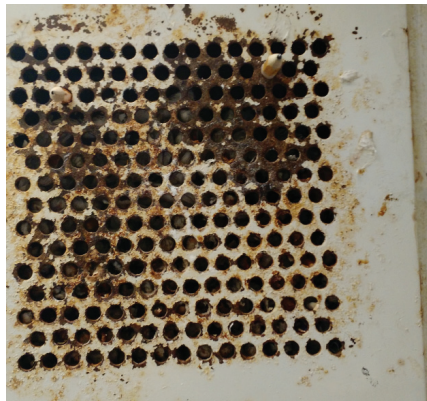
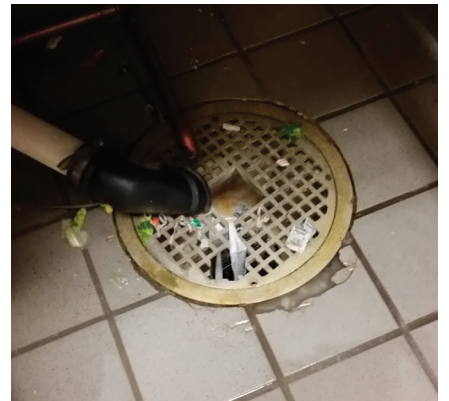
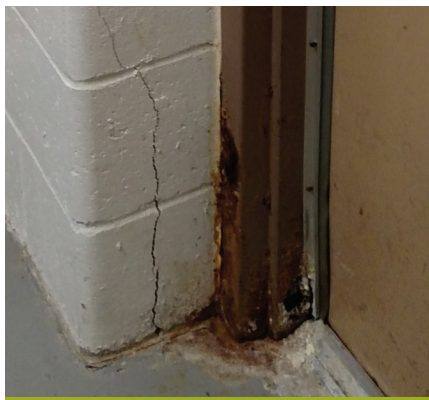
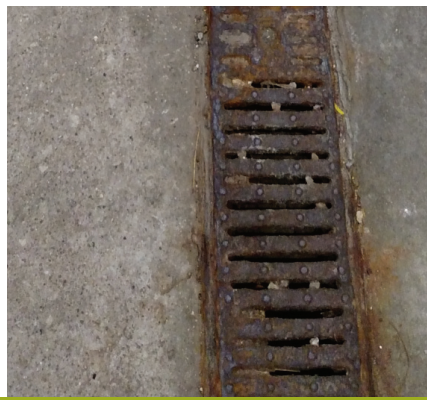
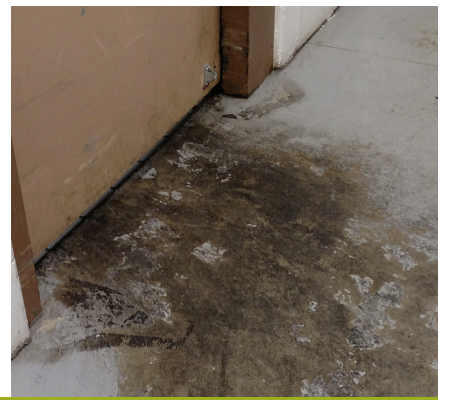
Adult Detention Facility

Observation Highlights:

- This building has a back-up generator.
- Original mechanical equipment requires replacement.
- Masonry joint deterioration, minor cracking, and plant growth.
- Major brick efflorescence on walls around building and screen walls.
- Stone parapet stained, possible moisture penetration.
- Exterior metal doors have deteriorated.
- Sun screen at ceiling enclosure in recreation area is heavily damaged.
- VCT adhesive failed and tiles are missing.
- Interior CMU cracked in multiple locations.
- Served by two boilers and a chiller original to building.
- Cooling tower leaks and is not used.

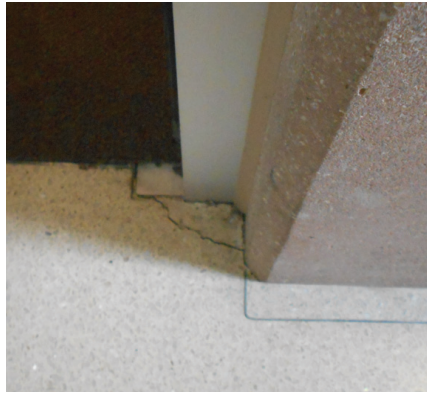
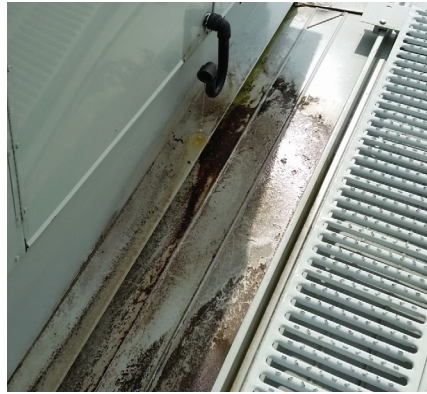
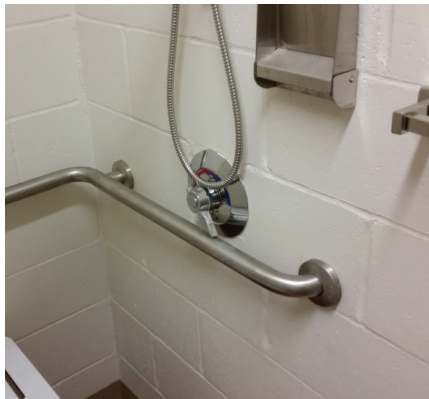
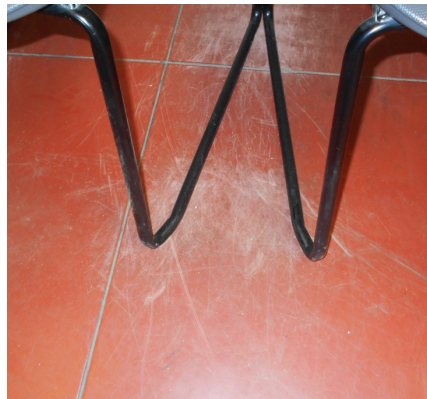
Highway Fleet Maintenance

- This building has a back-up generator.
- Interior carpet in generally good condition, minor wear and stains from normal use.
- Paint peeling and flaking off interior window sills and jambs.
- Ceiling tiles stained around HVAC vents.
- Heavy wear and staining to VCT in bathrooms.
- Interior metal doors show signs of wear and rust. Trim and frame paint peeling in areas.
- Sealed concrete flooring stained in some places, mostly along walls.
- Vinyl wall base heavily damaged and worn.
- Main entrance threshold worn, VCT chipped.
- Exterior is in generally good condition, some water stains and minor cracks.
- Served by several small rooftop units and are in good condition.

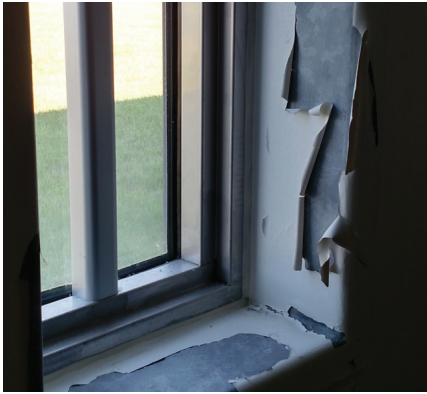
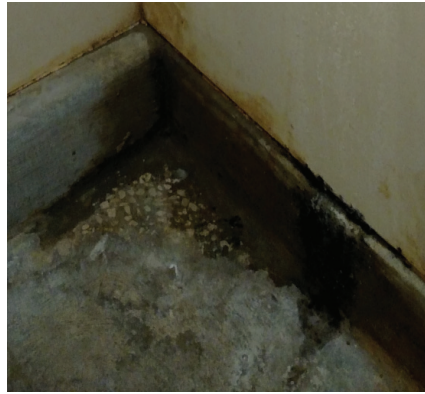
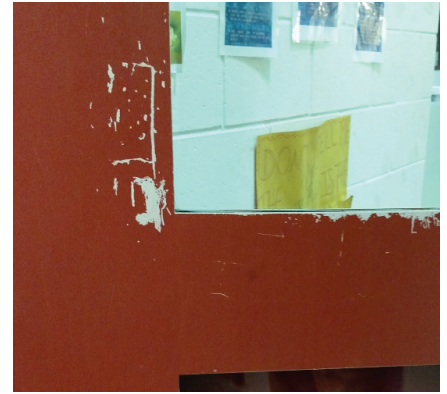
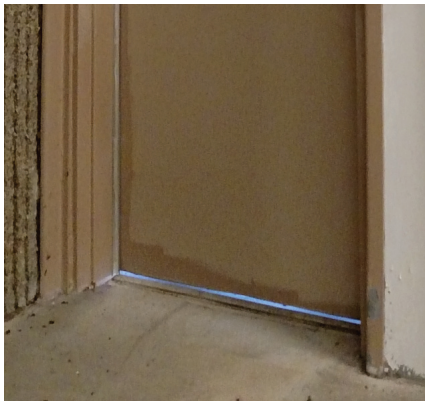
Juvenile Detention Facility

- This building has a back-up generator.
- AHU near the end of its useful life.
- Overall, the building is in good condition.
- The interior wall finishes are in generally good condition, normal use wear.
- Carpet and VCT surfaces are in good condition.
- Exterior brick is worn, some sealant damage at windows.
- Railings along accessible ramp are deteriorating.
- Minor cracks on ramp and walk.
- Gutters in good condition, some paint peeling.
- Roof will need replacement.
- Served by AHU's and condensing units, AHU's nearing end of useful life.

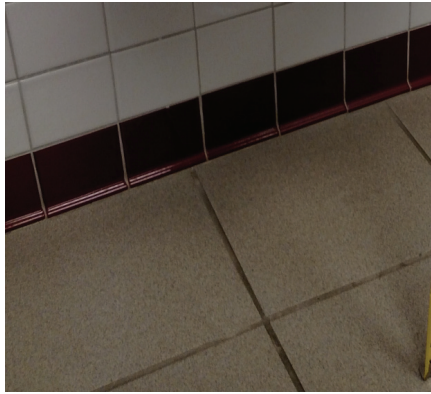
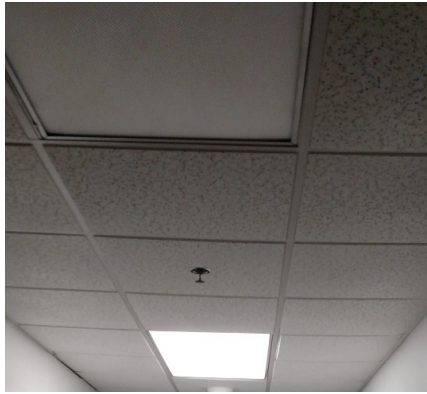
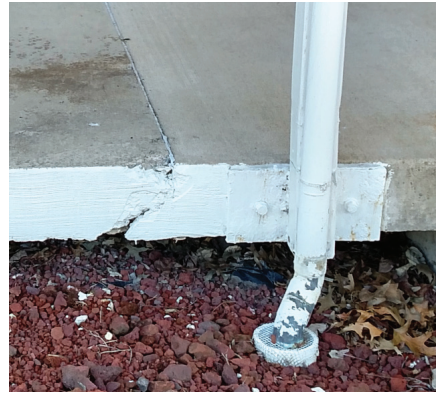
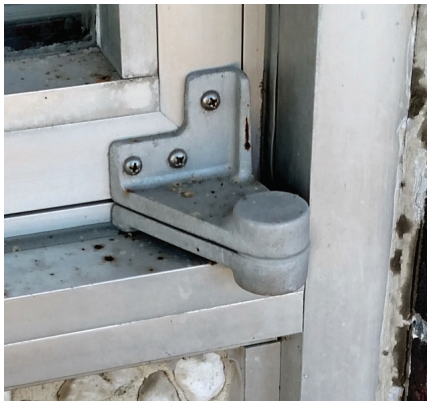
Emergency Operation Center (METCAD)

- This building has no back-up generator.
- The building is in generally good condition.
- Ceiling tiles show signs of minor water damage.
- VCT flooring is worn and scratched in places of heavy use. Some joints are separated.
- Drywall is in good condition, minor scratches and cosmetic damage.
- Interior doors show signs of wear and some damage to finishes.
- Exterior wall panels have minor surface damage.
- Insulation along foundation is damaged, missing in places.
- Windows are in good condition.
- Served by packaged AHU at grade. AHU is in good condition.

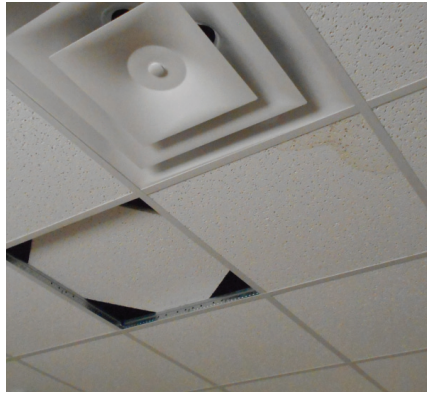
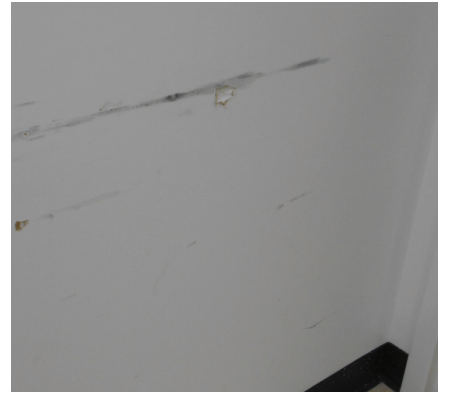
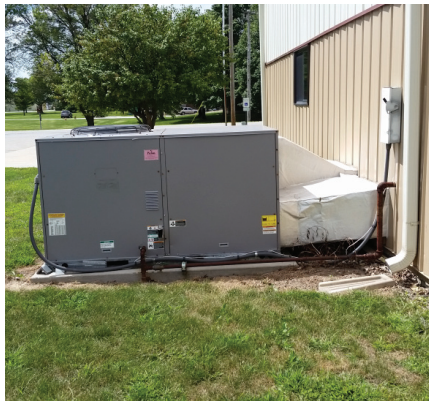
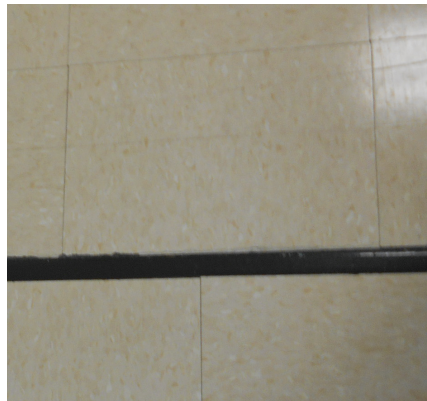
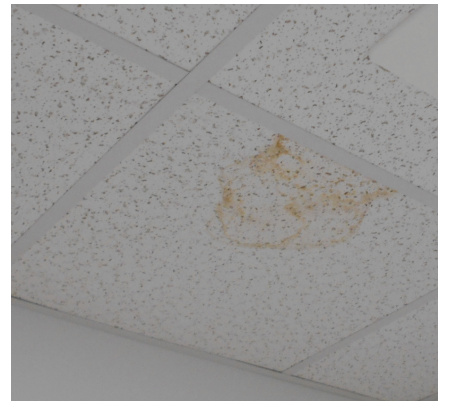
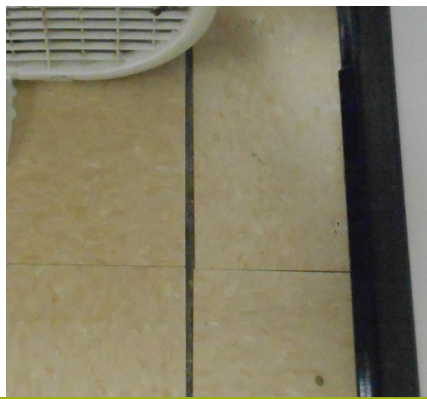
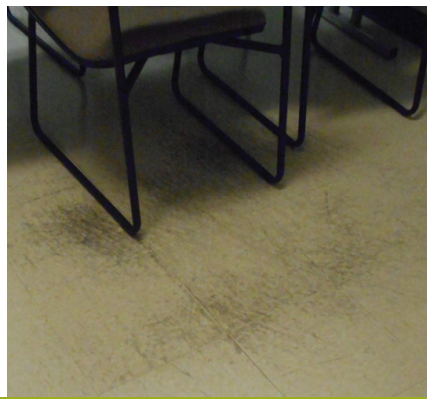
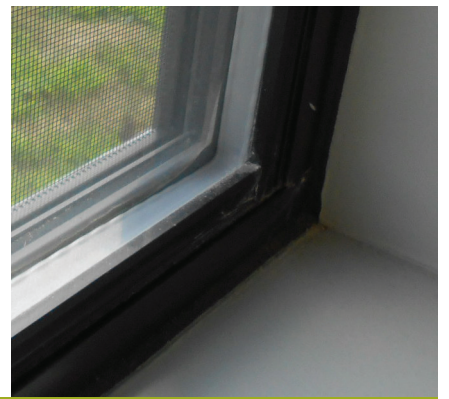
Coroner's Office

- Building is overall in good condition.
- Metal wall panels on exterior in generally good condition, minor damage.
- Interior sealed concrete flooring stained and worn.
- VCT flooring heavily scratched and worn, stained in some areas.
- Minor drywall damage, some impact damage and scratches.
- Insulation behind exposed structure stained in places on ceiling and walls.
- Insulation along foundation damaged and missing in places.
- Heavy water damage to landscaping at downspouts.
- Sealant failure along edge between metal panels and concrete.
- Ventilation provided by roof mounted exhaust fan in good condition.
- Heating provided by three gas fired unit heaters in good condition.

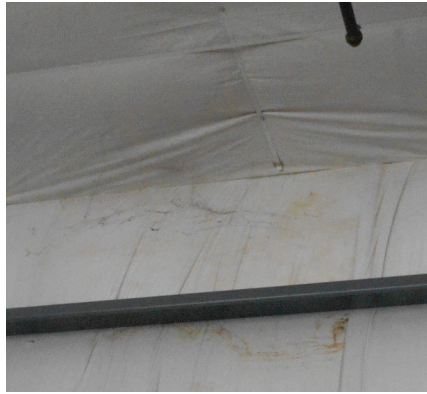
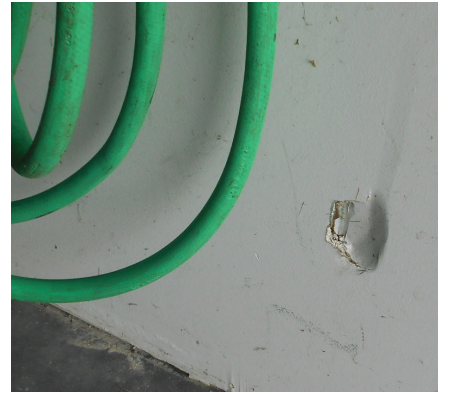
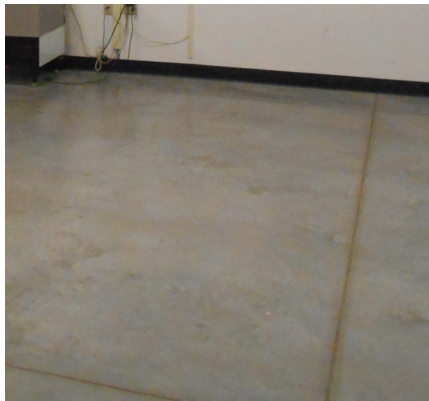
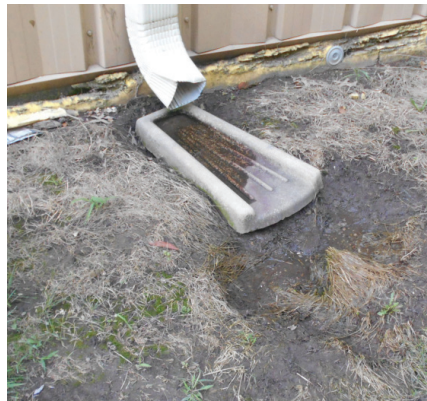
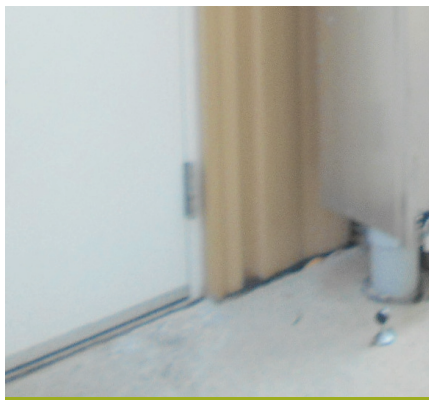
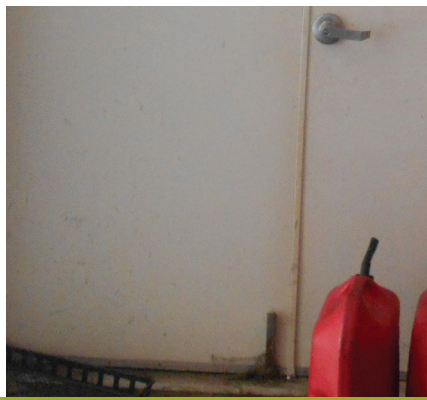
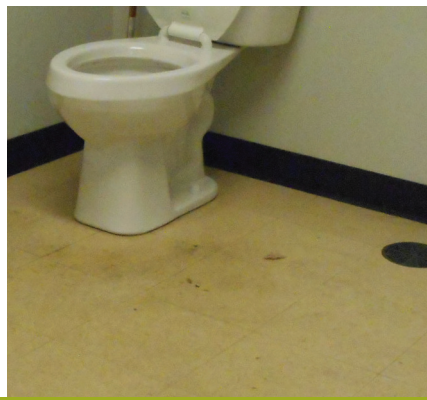
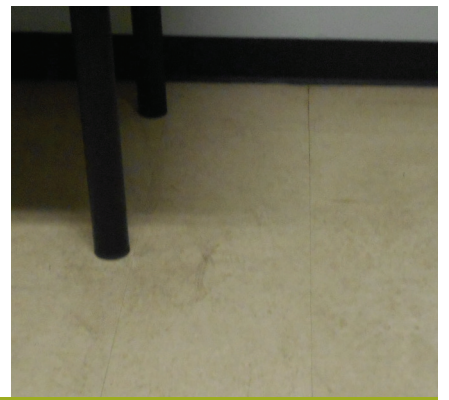
Physical Plant Shop

- This building is in good condition.
- Minor dents and cosmetic damage to exterior metal panels.
- Windows are in good condition.
- Foundation insulation is damaged and missing in places.
- Interior sealed concrete flooring is stained and worn.
- Ceiling tiles are in good condition, few missing or stained.
- Rubber wall base missing in places.
- VCT in bathroom worn and stained.
- Carpet tiles in good condition.
- Interior drywall and finishes in good condition.
- HVAC provided by unit mounted on grade

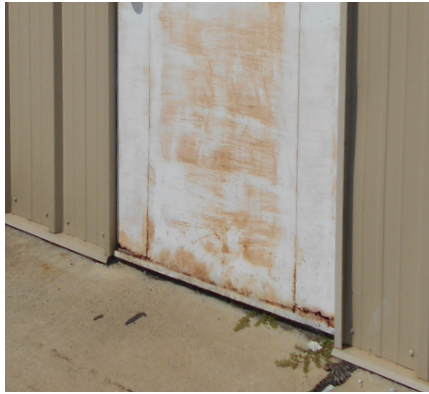
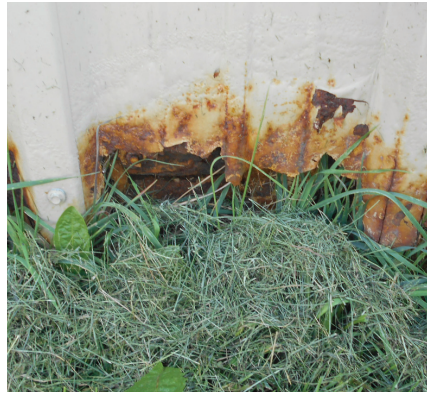
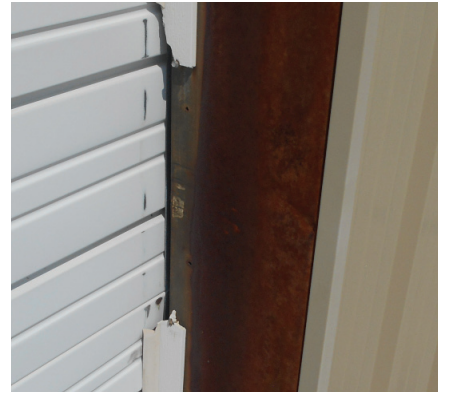
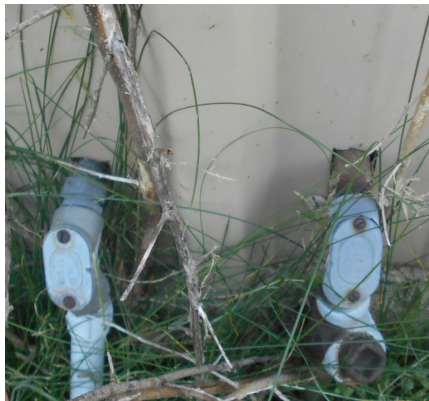
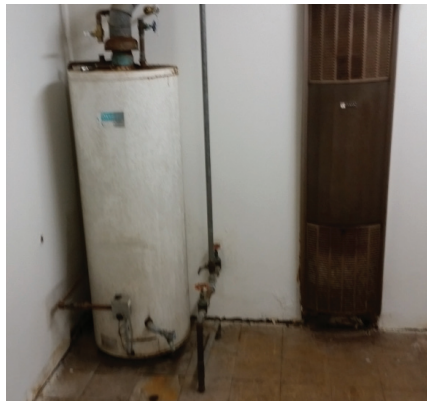
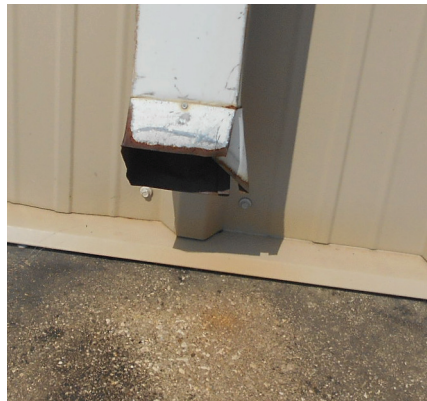
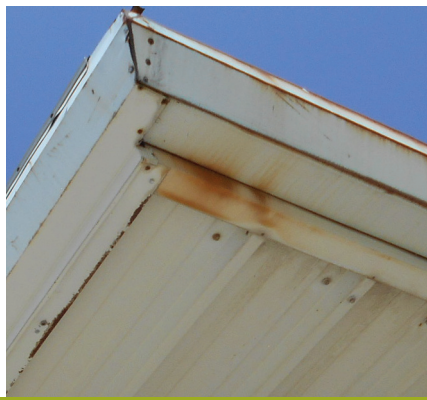
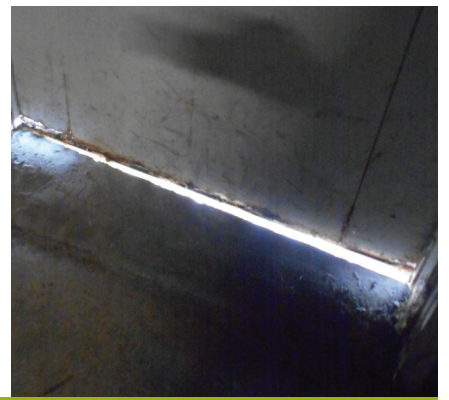
Sheriff Garage

- The garage overall is in fair condition.
- Concrete flooring stained and worn, minor cracks.
- Exterior door finishes and frames are deteriorated and rusted at base.
- Fiberglass overhead doors are damaged, panels cracked and kicked-in at base of frame.
- Overhead door jambs are dented and warped.
- Moisture damage and rust at base of metal wall panels.
- Metal wall panel seams dented and peeling apart.
- Several large tears in metal wall panels.
- Sealant at base of metal wall panels along concrete deteriorated.
- Bollards damaged from impact.
- No ventilation or heating present. No oil interceptor at trench drains.

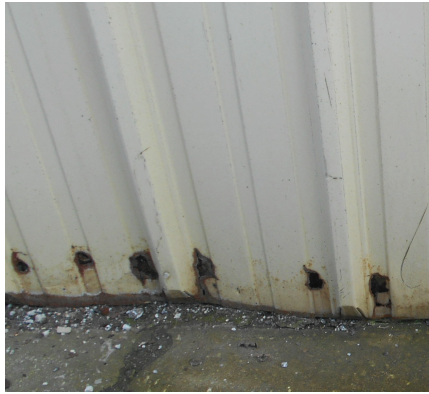
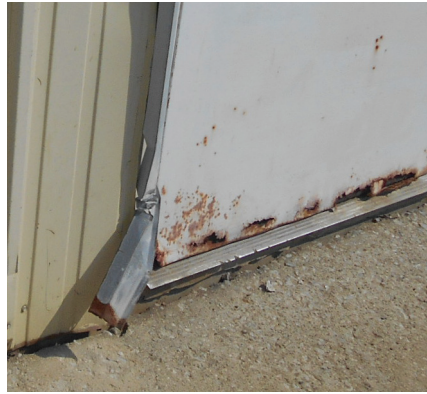
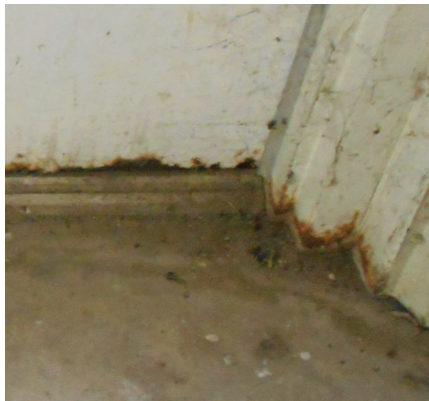
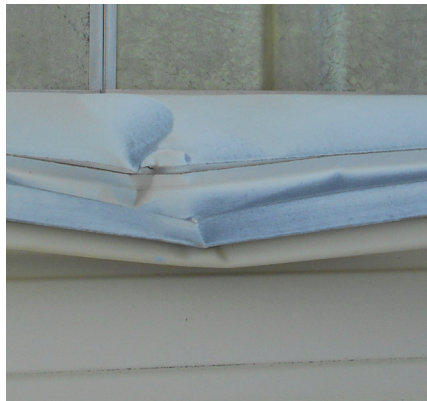
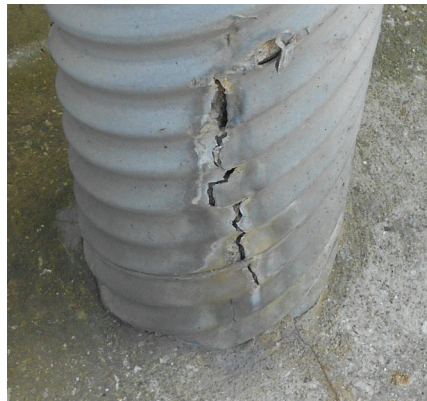
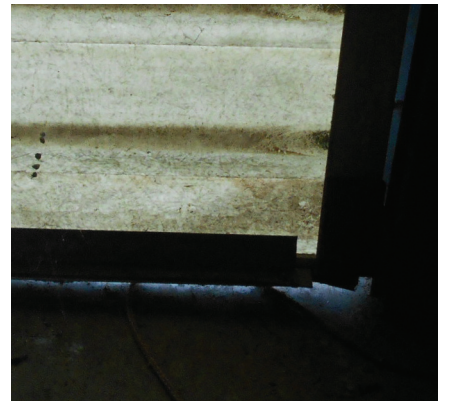
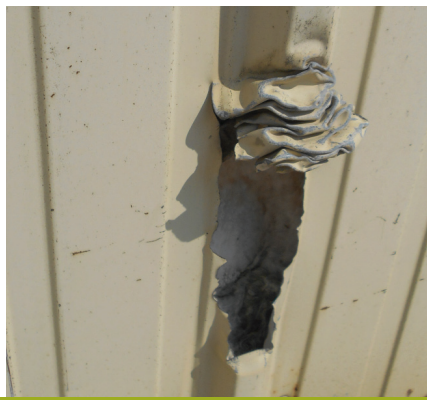
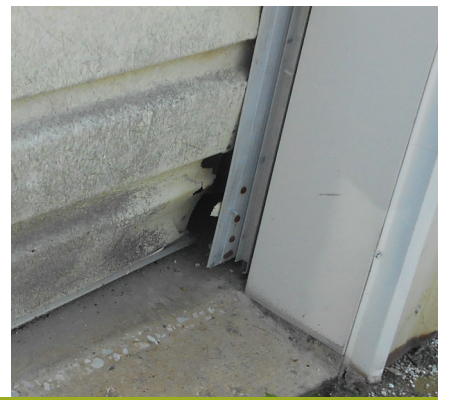
County Highway Garage

- Building is in overall good condition.
- Sealant failure at base of metal wall panels along concrete.
- Insulation along foundation broken, damaged and missing in places.
- Metal panels dented at corner.
- Interior drywall in fair condition, minor scratches; one puncture found.
- Sealed concrete flooring in good condition, minor wear.
- Interior cage in good condition.
- No rubber base at bottom of drywall.
- Exterior door in good condition.
- Exposed structure and insulation in good condition.
- No ventilation. Heat provided by ceiling mounted gas fired unit heater.

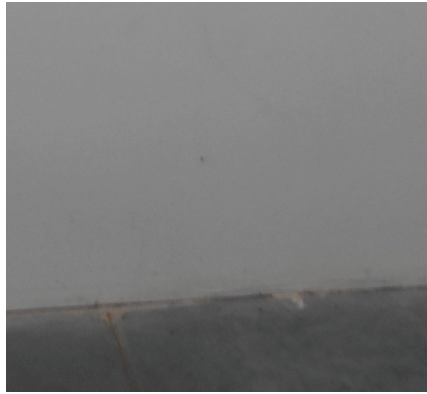
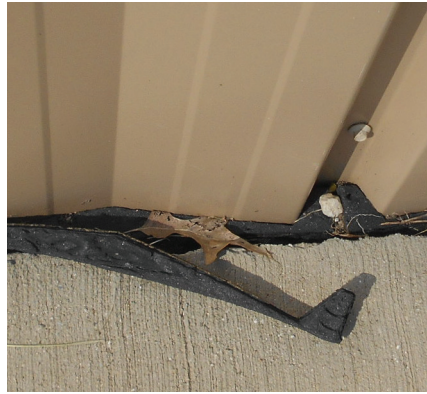
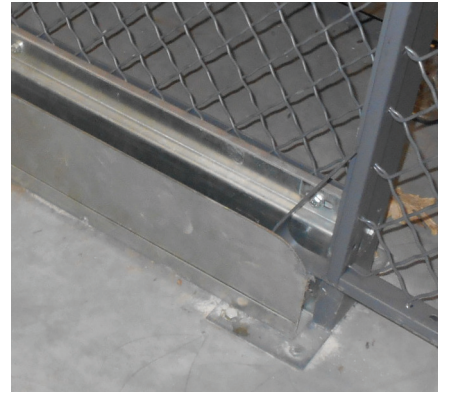
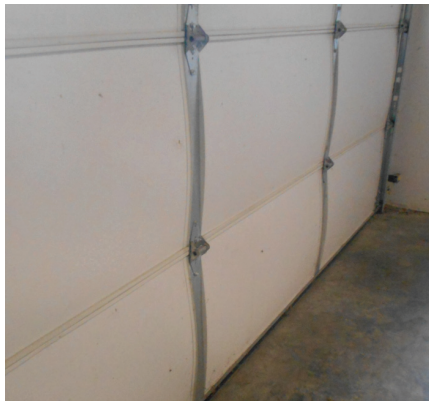
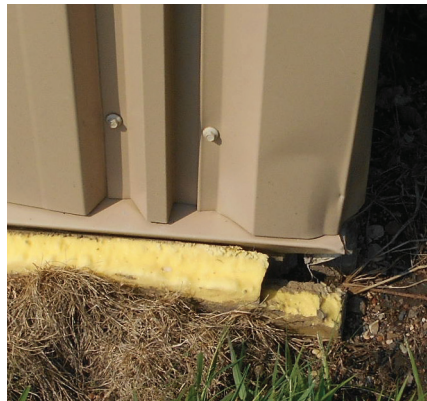
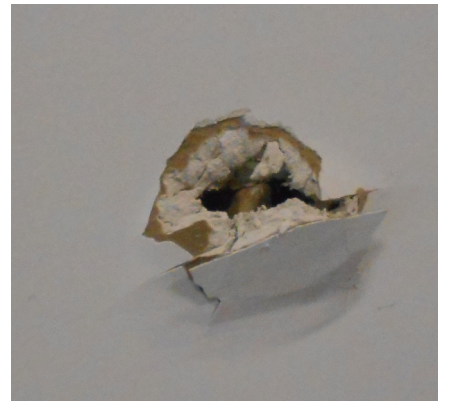
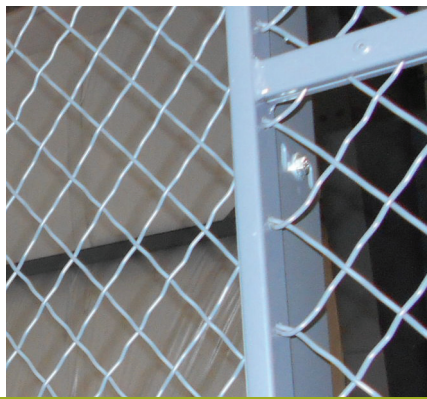
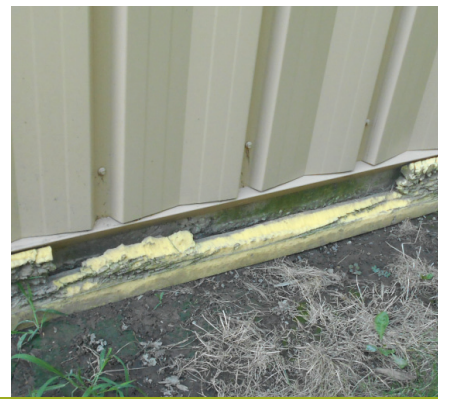
Nursing Home Storage

- Concrete flooring is in fair condition, some stains and wear from use.
- A few large cracks in concrete flooring.
- Interior and exterior deterioration on metal panel.
- Metal downspouts deteriorated, leaks found at joints.
- Exterior trim bent and damaged at door openings.
- Exterior doors deteriorated and damaged at base.
- Interior steel structure worn and deteriorated.
- Punctures, bent and damaged metal panels along base of exterior.
- Oil interceptor at trench drains and exhaust fan installed.
- No ventilation. Ceiling mounted gas fired unit heater nearing end of useful life

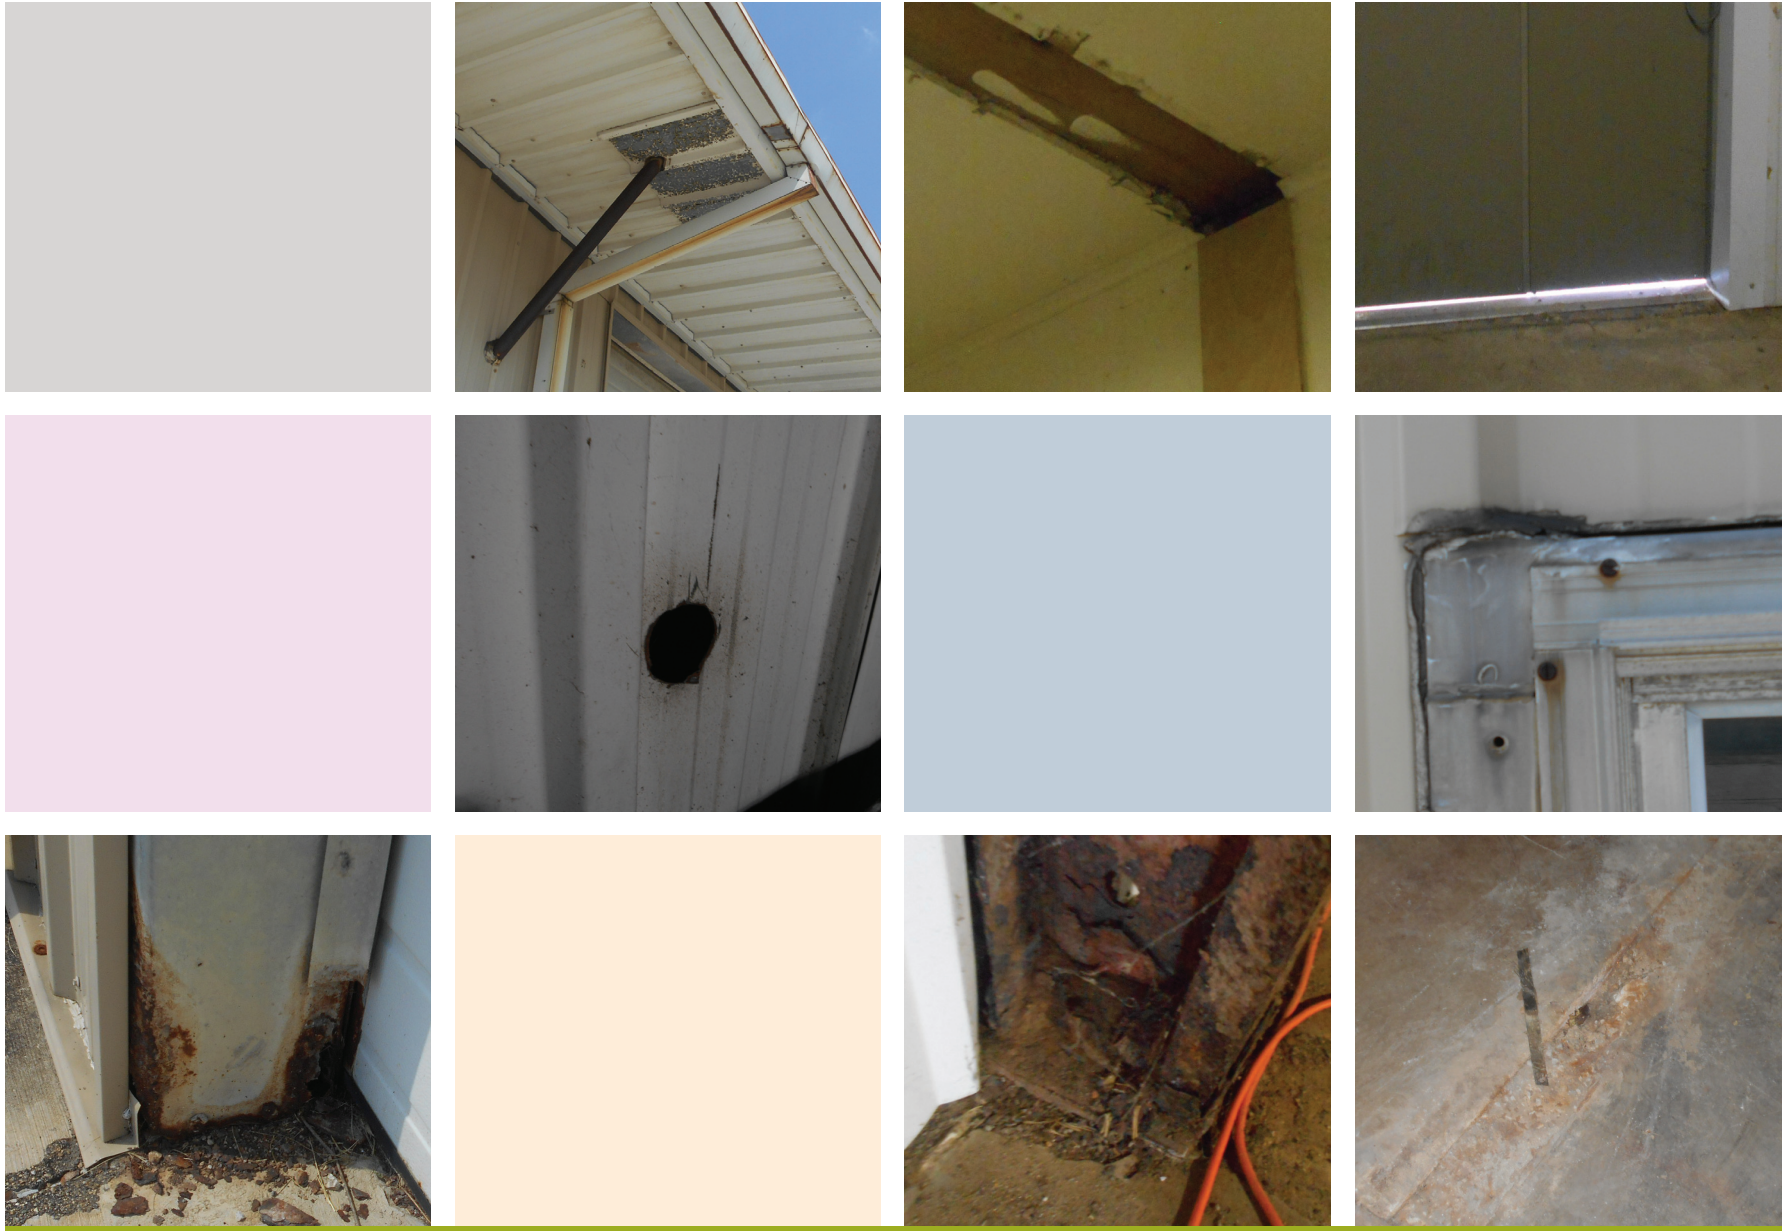
- ILEAS Garage 2 is connected to Sheriff's Garage.
- The building is in overall fair condition.
- Sealed concrete flooring is scratched and worn in places.
- Doors are worn with some deterioration.
- Finish on interior exposed structure is worn and deteriorated.
- Metal wall panels are in fair condition.
- Gutters and downspouts are deteriorated.
- Roof overhang is deteriorated and has impact damage.
- Organic plant growth in cracks along exterior concrete and base of building.
- Sealant deterioration in places along concrete.
- No ventilation. Heat provided by ceiling mounted gas fired unit heater.

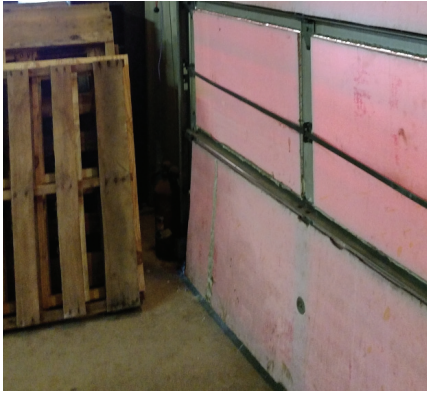
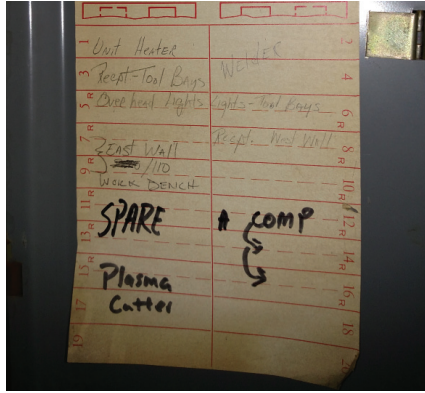
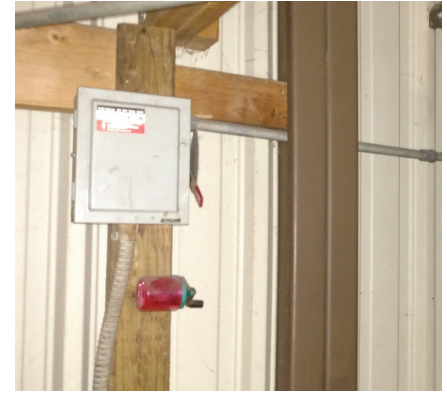
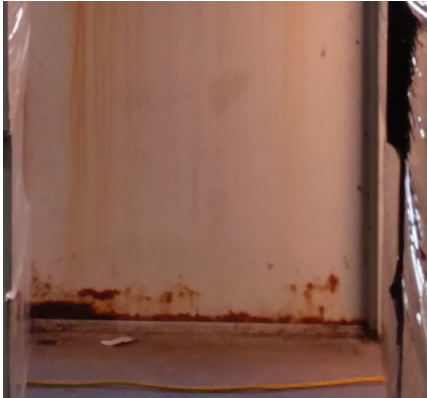
- ILEAS Garage 3 is connected to County Highway Garage.
- The building is in overall fair condition.
- Sealed concrete flooring is scratched and worn in places.
- Finish on interior exposed structure is worn and deteriorated.
- Metal wall panels are in fair condition.
- Doors have some deterioration and are in fair condition.
- Interior structure is in good condition, some deterioration.
- Overhead door is in fair condition, minor impact damage.
- Organic plant growth in cracks along exterior concrete.
- Sealant deterioration in places along concrete.
- No ventilation. Heat provided by ceiling mounted gas fired unit heater.

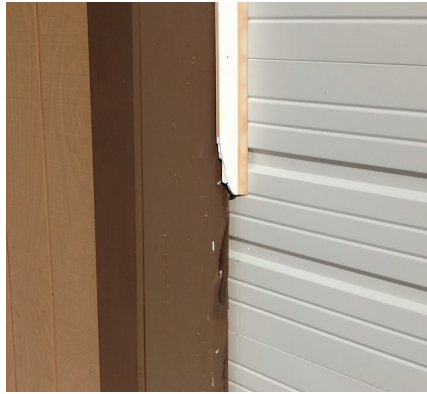
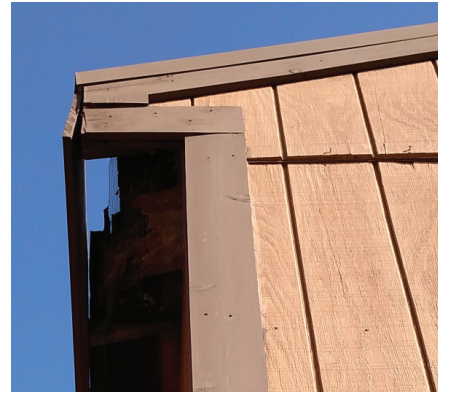
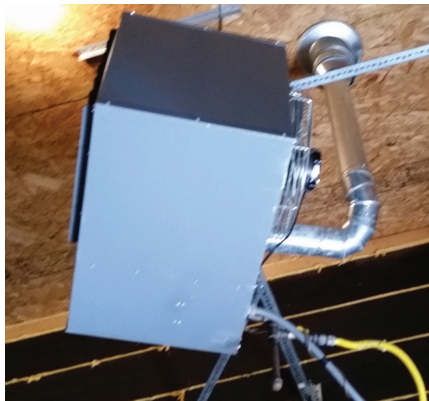
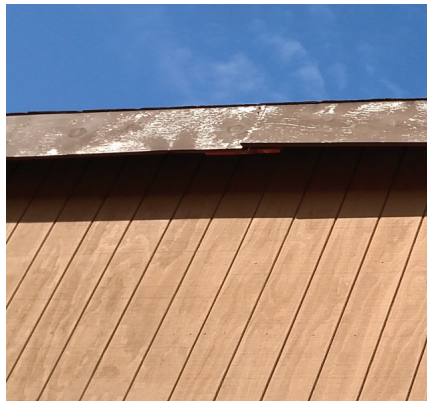
Salt Dome Garage

- The building overall is in fair condition.
- Soffits are not protected, raw wood exposed to elements.
- Asphalt shingles are in fair condition.
- Worn and deteriorated paint at roof edge trim.
- Paint overall is in fair condition.
- Overhead door is in good condition, minor impact damage.
- Some cracks in concrete surfaces.
- Interior concrete flooring is heavily worn.
- No ventilation. Heat provided by ceiling mounted gas fired unit heater in good condition.

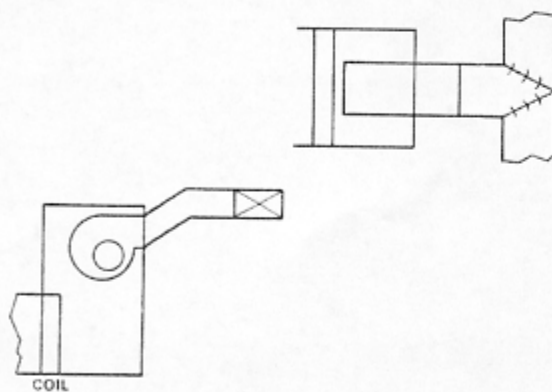
Figure 72—Improper Installation

For example, in the situation illustrated in Figure 72 high losses would occur.

There are two things wrong with this illustration:

Duct turns immediately out of the fan (should have 1½ diameters as minimum).

The turn in the duct is counter to the rotation of the wheel (should have bottom horizontal discharge). The
