EXISTING AGRICULTURAL DRAIN TILE INVESTIGATION PLAN

Champaign 1 and 2 Solar

Section no. 34, Pesotum Twp., Champaign Co., IL.

EXISTING SUBSURFACE AGRICULTURAL DRAIN TILE INVESTIGATION REPORT

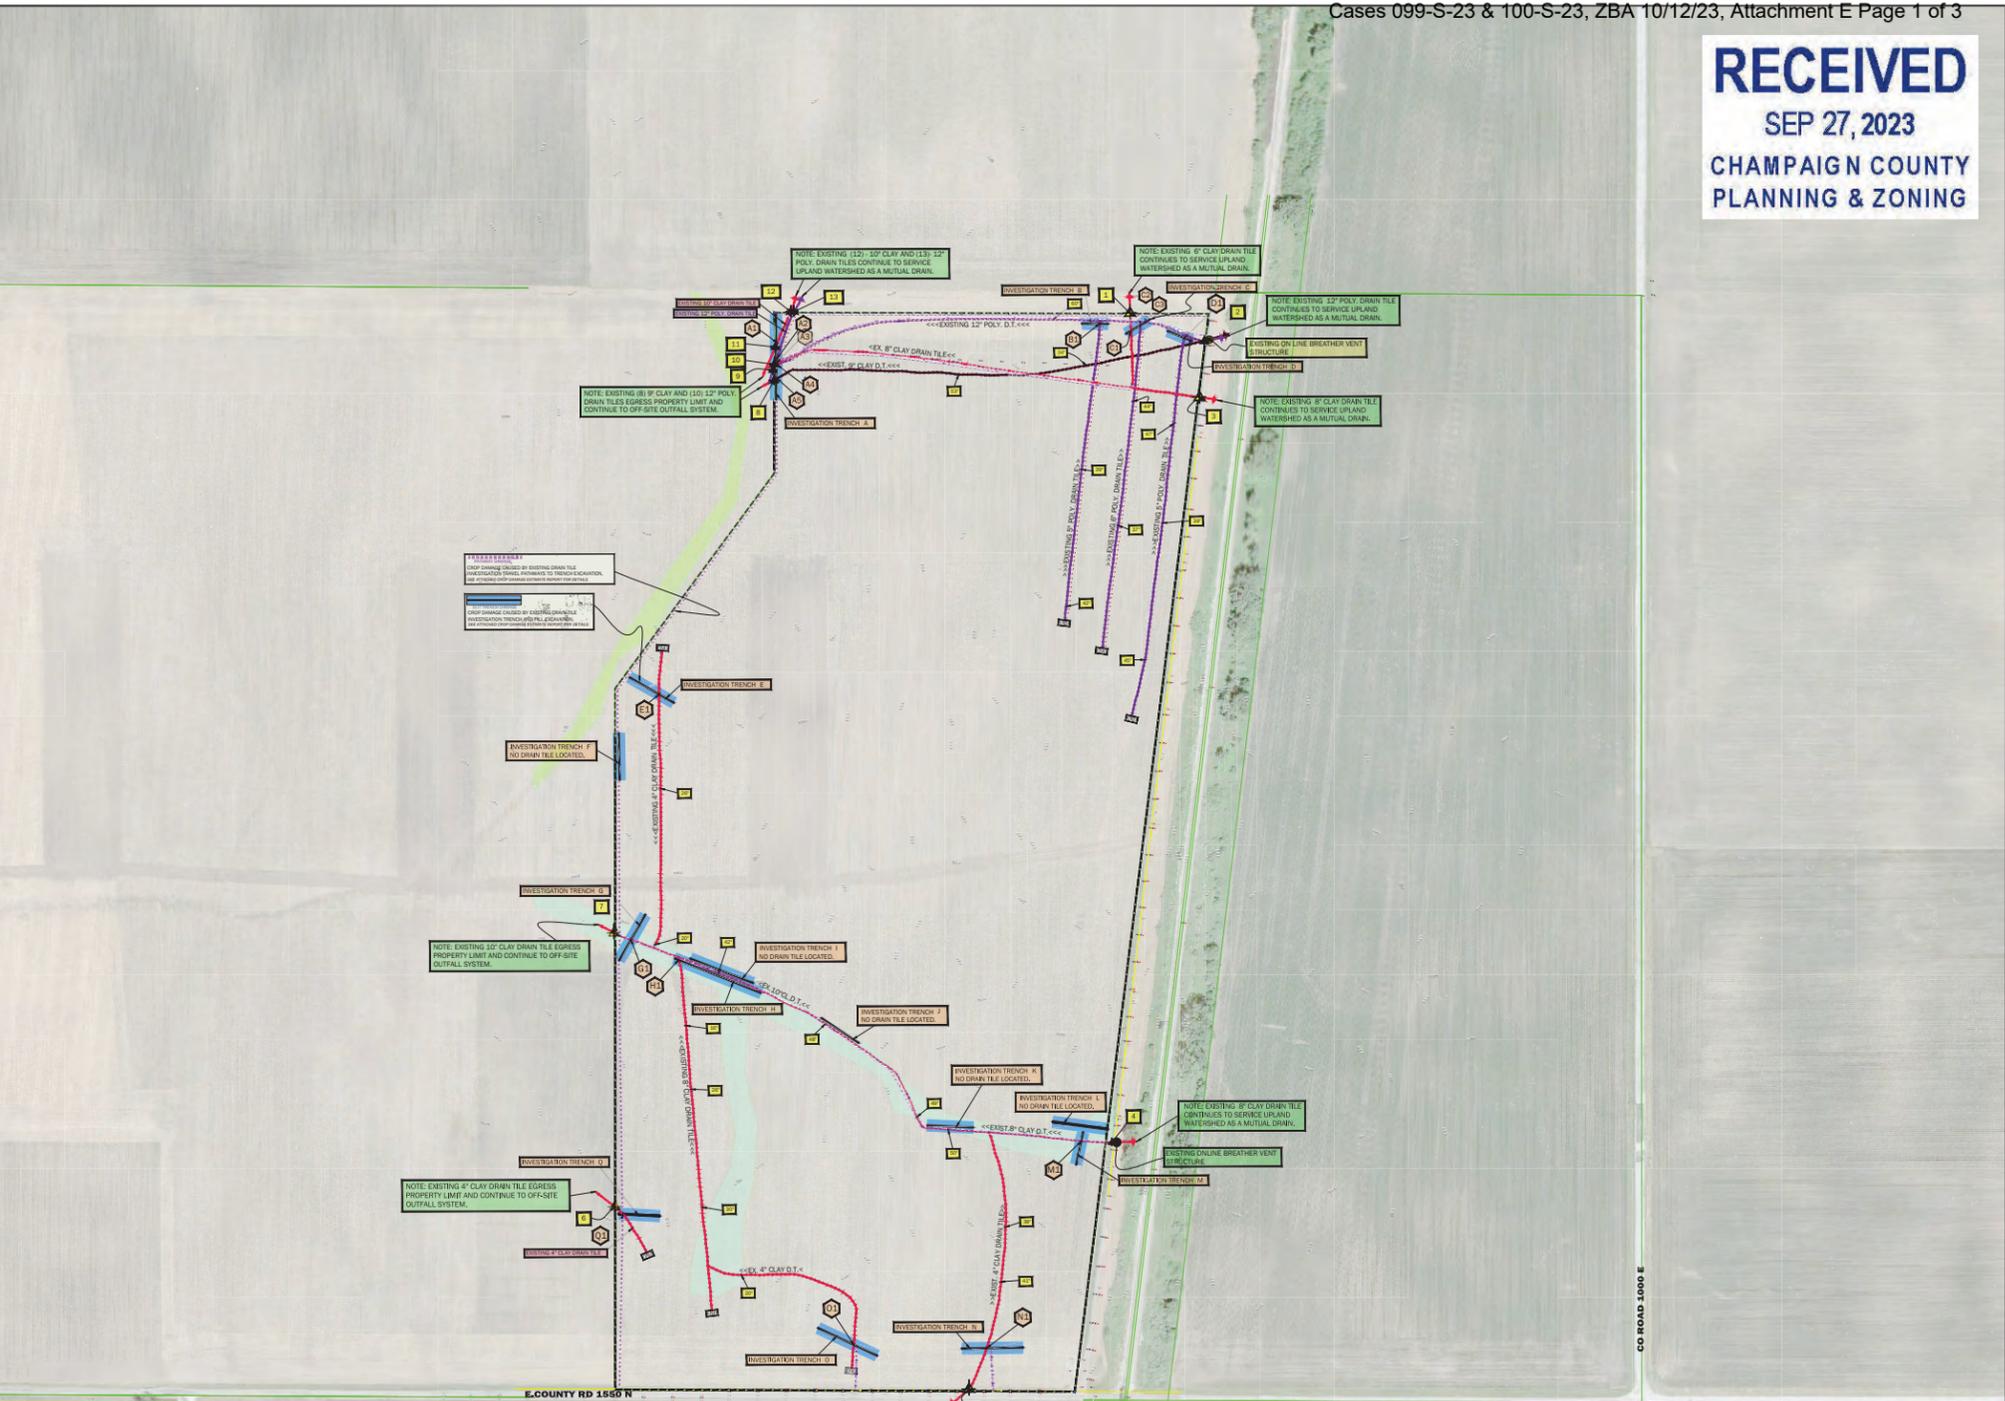
DESCRIPTION CHART NO. 1A:

ID NO.	SZ.	TYPE / QUALITY	FLOW %	SILT %	DEPTH	FIELD NOTES
A1	10"	CLAY / POOR	NO	50%	33"	POOR PIPE QUALITY, FAILING SYSTEM
A2	12"	PLASTIC / GOOD	10%	CLEAN	33"	ACTIVE FLOW RATE AND CAPACITY
A3	8"	CLAY / POOR	NO	100%	23"	SILT RESTRICTED / NO CAPACITY
A4	12"	PLASTIC / GOOD	10%	CLEAN	33"	ACTIVE FLOW RATE AND CAPACITY
A5	10"	CLAY / GOOD	20%	25%	33"	ACTIVE FLOW RATE AND CAPACITY
B1	8"	PLASTIC / GOOD	10%	CLEAN	33"	ACTIVE FLOW RATE AND CAPACITY
B2	10"	CLAY / GOOD	NO	25%	33"	ACTIVE FLOW RATE AND CAPACITY
B3	8"	PLASTIC / GOOD	TRACE	CLEAN	33"	ACTIVE FLOW RATE AND CAPACITY
B4	10"	PLASTIC / GOOD	10%	CLEAN	33"	ACTIVE FLOW RATE AND CAPACITY
B5	8"	PLASTIC / GOOD	5%	CLEAN	33"	ACTIVE FLOW RATE AND CAPACITY
B6	8"	CLAY / GOOD	NO	25%	33"	ACTIVE FLOW RATE AND CAPACITY
B7	10"	CLAY / POOR	15%	CLEAN	33"	NO DRAIN TILE LOCATED
B8	8"	N 1/2" / GOOD	NO	CLEAN	33"	ACTIVE FLOW RATE AND CAPACITY
C1	10"	CLAY / GOOD	NO	25%	33"	NO DRAIN TILE LOCATED

C2	10"	CLAY / GOOD	NO	25%	33"	NO DRAIN TILE LOCATED
C3	10"	CLAY / GOOD	NO	25%	33"	NO DRAIN TILE LOCATED
C4	10"	CLAY / GOOD	NO	25%	33"	NO DRAIN TILE LOCATED
C5	10"	CLAY / GOOD	NO	25%	33"	NO DRAIN TILE LOCATED
C6	10"	CLAY / GOOD	NO	25%	33"	NO DRAIN TILE LOCATED
C7	10"	CLAY / GOOD	NO	25%	33"	NO DRAIN TILE LOCATED
C8	10"	CLAY / GOOD	NO	25%	33"	NO DRAIN TILE LOCATED
C9	10"	CLAY / GOOD	NO	25%	33"	NO DRAIN TILE LOCATED
C10	10"	CLAY / GOOD	NO	25%	33"	NO DRAIN TILE LOCATED

DESCRIPTION CHART NO. 1B:

DATA POINT	SZ.	TYPE / QUALITY	FLOW %	SILT %	DEPTH	FIELD NOTES
1	8"	CLAY / GOOD	NO	20%	23"	LATERAL AT PROPERTY EGRESS
2	8"	CLAY / GOOD	10%	10%	23"	MAINLINE AT PROPERTY EGRESS
3	8"	CLAY / GOOD	NO	10%	23"	LATERAL AT PROPERTY EGRESS
4	8"	CLAY / GOOD	10%	10%	23"	MAINLINE AT PROPERTY EGRESS
5	8"	CLAY / GOOD	NO	10%	23"	LATERAL AT PROPERTY EGRESS
6	8"	CLAY / GOOD	NO	10%	23"	LATERAL AT PROPERTY EGRESS
7	8"	CLAY / GOOD	NO	10%	23"	LATERAL AT PROPERTY EGRESS
8	8"	CLAY / GOOD	NO	10%	23"	LATERAL AT PROPERTY EGRESS
9	8"	CLAY / GOOD	NO	10%	23"	LATERAL AT PROPERTY EGRESS
10	8"	CLAY / GOOD	NO	10%	23"	LATERAL AT PROPERTY EGRESS
11	8"	CLAY / GOOD	NO	10%	23"	LATERAL AT PROPERTY EGRESS
12	8"	CLAY / GOOD	NO	10%	23"	LATERAL AT PROPERTY EGRESS
13	8"	CLAY / GOOD	NO	10%	23"	LATERAL AT PROPERTY EGRESS
14	8"	CLAY / GOOD	NO	10%	23"	LATERAL AT PROPERTY EGRESS
15	8"	CLAY / GOOD	NO	10%	23"	LATERAL AT PROPERTY EGRESS

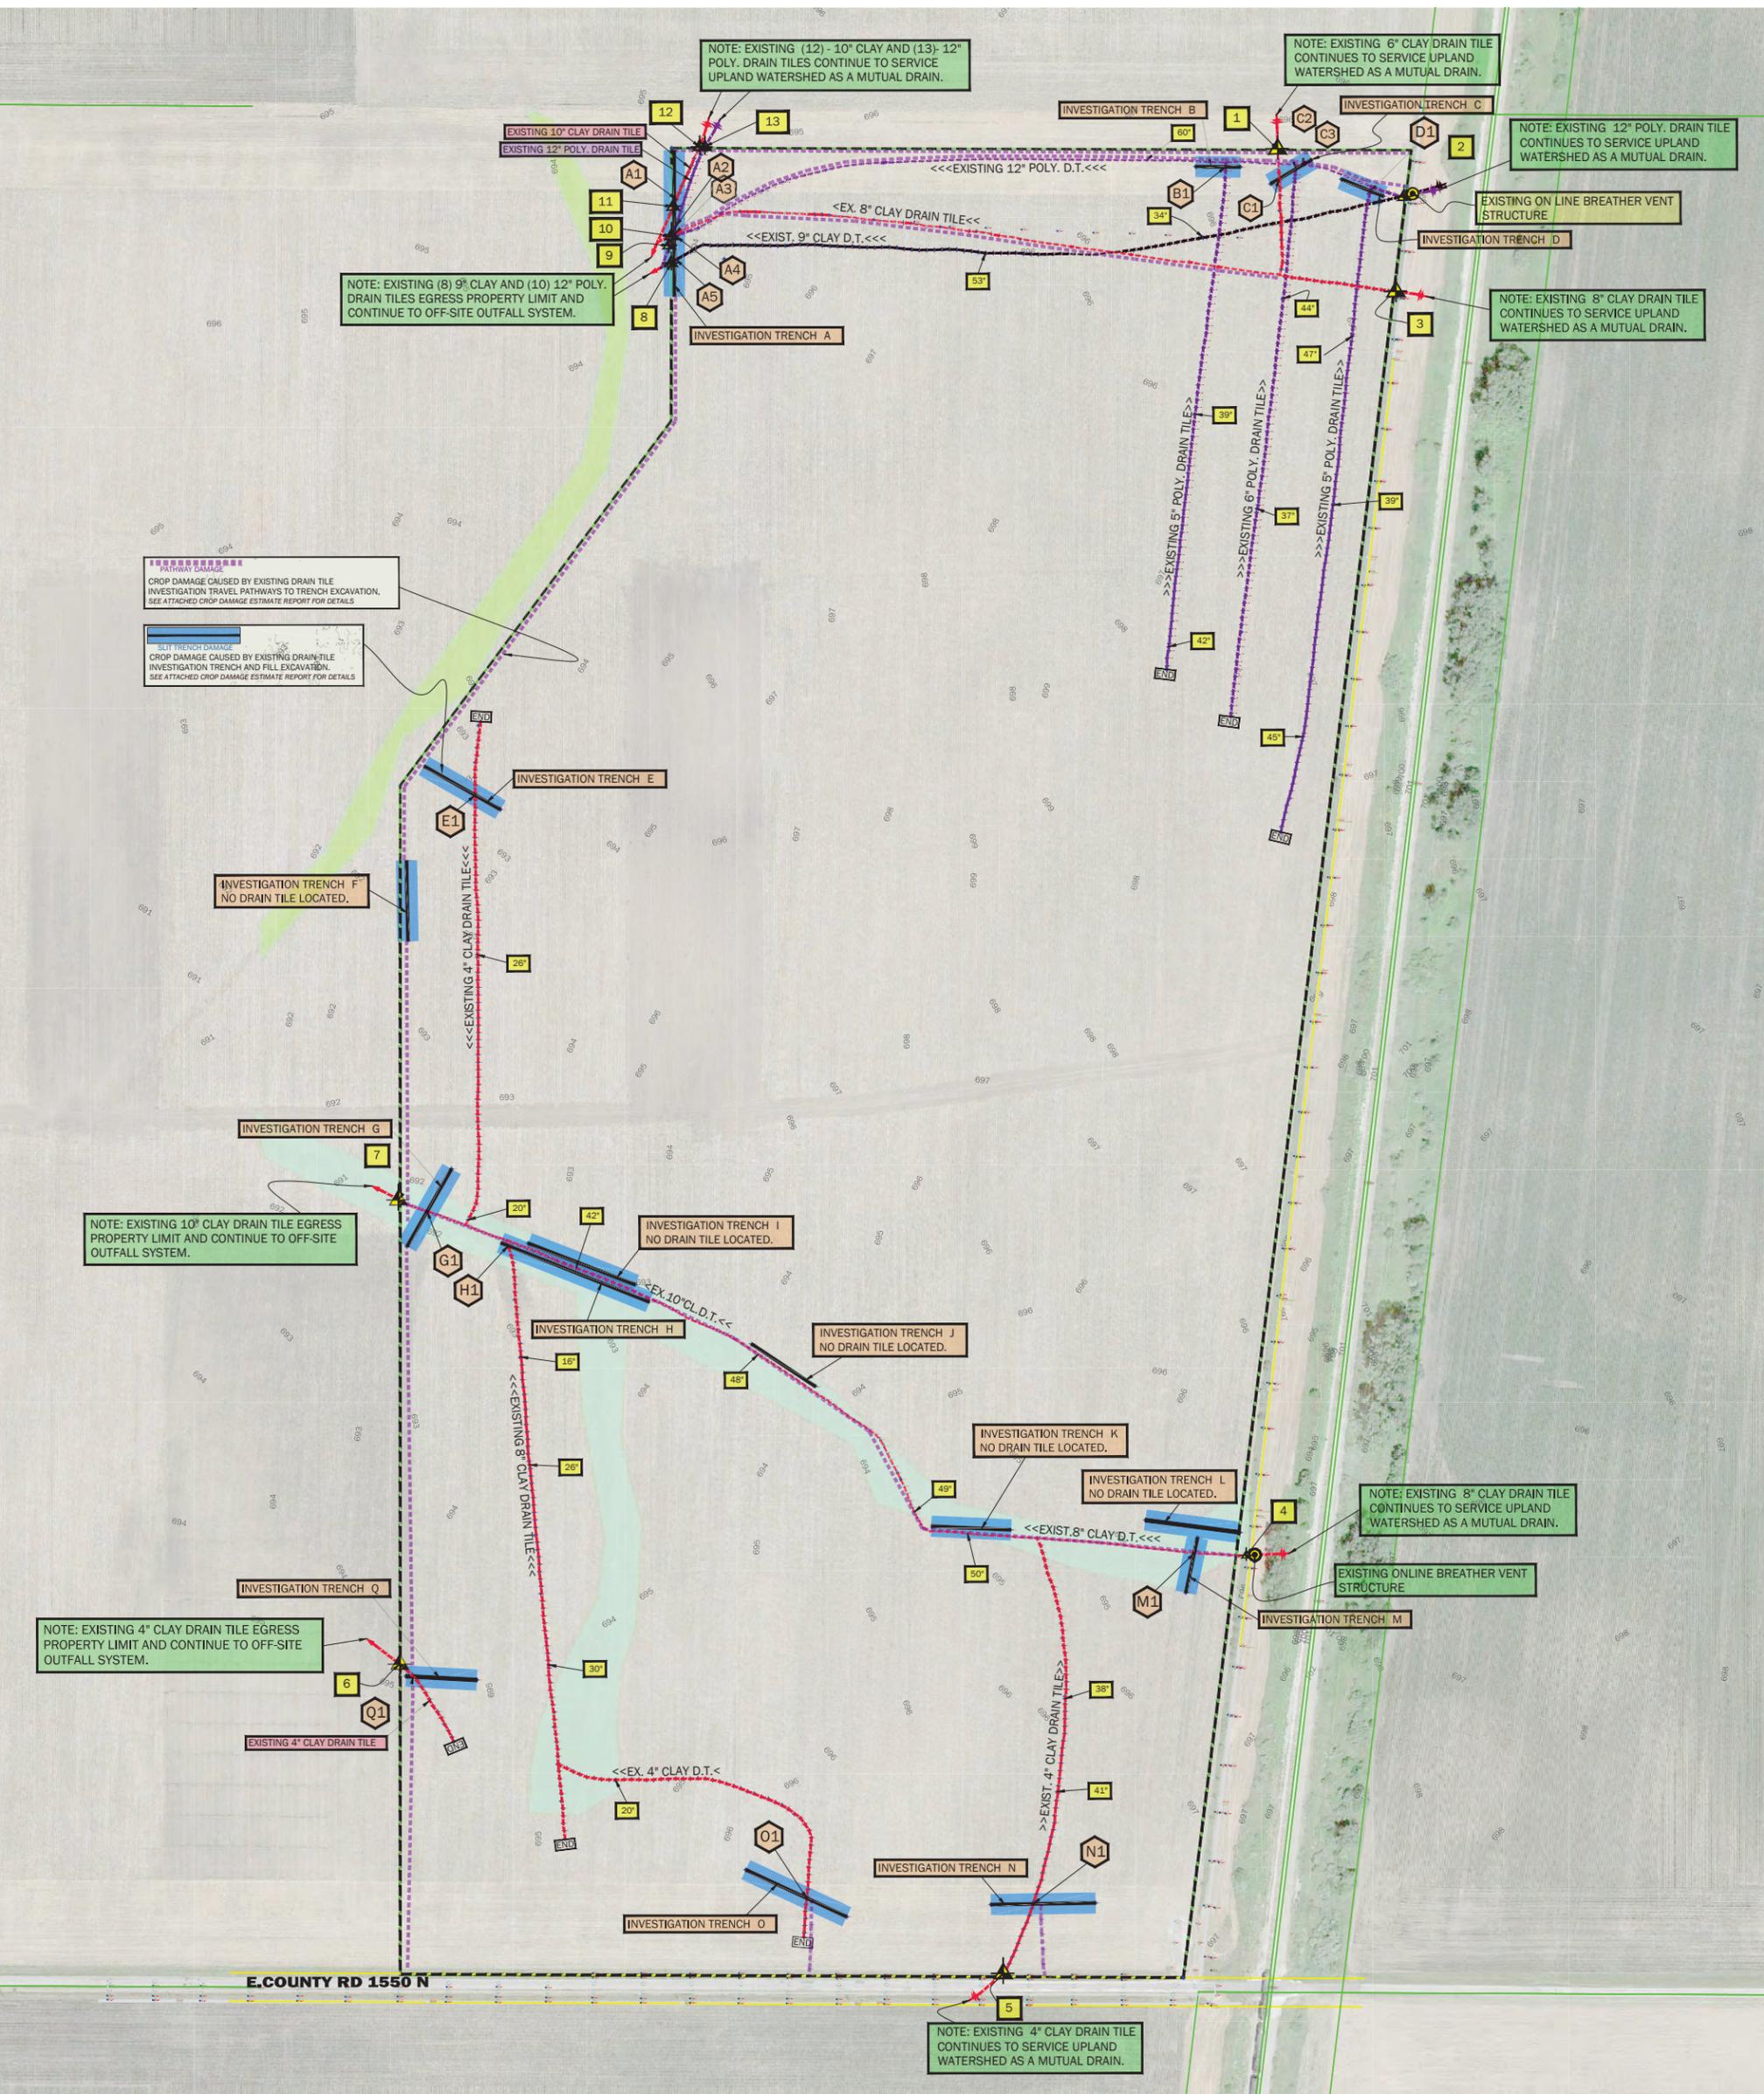
EXISTING SUBSURFACE AGRICULTURAL DRAIN TILE INVESTIGATION REPORT

DESCRIPTION CHART NO. 1A : INVESTIGATION SLIT TRENCH LOCATIONS

ID NO.	SZ.	TYPE / QUALITY	FLOW %	SILT %	DEPTH GRD/INV	FIELD NOTES:
A1	10"	CLAY / POOR	NO	50%	53"	POOR PIPE QUALITY, FAILING SYSTEM
A2	12"	PLASTIC/GOOD	10%	CLEAN	61"	ACTIVE FLOW RATE AND CAPACITY
A3	8"	CLAY / POOR	NO	100%	49"	SILT RESTRICTED / NO CAPACITY
A4	12"	PLASTIC/GOOD	10%	CLEAN	61"	ACTIVE FLOW RATE AND CAPACITY
A5	9"	CLAY / GOOD	20%	10%	50"	ACTIVE FLOW RATE AND CAPACITY
B1	5"	PLASTIC/GOOD	10%	CLEAN	62"	ACTIVE FLOW RATE AND CAPACITY
C1	6"	CLAY / GOOD	NO	20%	44"	ACTIVE FLOW RATE AND CAPACITY
C2	6"	PLASTIC/GOOD	TRACE	CLEAN	63"	ACTIVE FLOW RATE AND CAPACITY
C3	12"	PLASTIC/GOOD	5%	CLEAN	67"	ACTIVE FLOW RATE AND CAPACITY
D1	5"	PLASTIC/GOOD	5%	CLEAN	62"	ACTIVE FLOW RATE AND CAPACITY
E1	4"	CLAY / GOOD	NO	10%	31"	ACTIVE FLOW RATE AND CAPACITY
F	---	---	---	---	---	NO DRAIN TILE LOCATED
G1	10"	CLAY / POOR	15%	CLEAN	53"	ACTIVE FLOW RATE AND CAPACITY
H1	6"	N-12 / GOOD	NO	CLEAN	47"	ACTIVE FLOW RATE AND CAPACITY

I	---	---	---	---	---	NO DRAIN TILE LOCATED
J	---	---	---	---	---	NO DRAIN TILE LOCATED
K	---	---	---	---	---	NO DRAIN TILE LOCATED
L	---	---	---	---	---	NO DRAIN TILE LOCATED
M1	8"	CLAY / GOOD	10%	10%	48"	ACTIVE FLOW RATE AND CAPACITY
N1	4"	CLAY / GOOD	NO	15%	47"	ACTIVE FLOW RATE AND CAPACITY
O1	4"	CLAY / GOOD	NO	TRACE	33"	ACTIVE FLOW RATE AND CAPACITY

- EXIST. DRAIN TILE COVER MEASUREMENT, TOP OF TILE TO SURFACE
- EX. POLYETHYLENE MAINLINE OR SYSTEM PART
- EX. CLAY DRAIN TILE MAINLINE OR SYSTEM PARTS
- EX. CONCRETE DRAIN TILE MAINLINE OR SYSTEM PART
- EXISTING DRAIN TILE CONTINUES TO UPLAND WATERSHED
- EXISTING DRAIN TILE OUTLETS TO SURFACE
- EXIST. DRAIN TILE (1) INSPECTION STRUCTURE / (2) CATCH BASIN
- EXIST. DRAIN TILE (1) LOCATED END / (2) ASSUMED END
- EXISTING DRAIN TILE CONTINUES TO OFF-SITE OUTLET SYSTEM
- EXISTING DRAIN TILE FAILURE /FLOW SURCHARGE TO SURFACE
- EXISTING DRAIN TILE MAPPED BY SPECULATION AND ASSUMPTION
- EXISTING DRAIN TILE ABANDONED (NOT FUNCTIONAL)
- EXISTING DRAIN TILE "BLOWOUT" OR FAILURE
- HAND PROBE OR ELECTRONIC SCAN FOR DRAIN TILE LOCATION
- INVESTIGATION SLIT TRENCH FOR INVESTIGATION
- SPECIFIC PIT EXCAVATION FOR INVESTIGATION
- SURVEY DATA POINTS
- REPORT IDENTIFICATION NUMBER

- ID NO. POINT OF EXCAVATION FOR SPECIFIC DRAIN TILE INVESTIGATION.
- SZ. (SIZE)..... DRAIN TILE INTERNAL DIAMETER IN INCHES.
- MATERIAL / QUALITY..... TYPE OF TILE MATERIALS, PIPE QUALITY - GOOD, FAIR & POOR.
- FLOW % PERCENTAGE OF TILE DIAMETER OCCUPIED BY ACTIVE FLOW.
- RESTRICTED OR BACKED UP FLOW, SURCHARGED CONDITION
- SILT % PERCENTAGE OF TILE DIAMETER OCCUPIED BY RESTRICTIVE SILT.
- ABANDONED, FILLED WITH SILT BLOCKAGE, NO FLOW POTENTIAL
- DEPTH MEASUREMENT FROM EXISTING GROUND LEVEL TO PIPE INVERT.

- MAINLINE TILE TRUNK LINE OR MUTUAL DRAIN, COLLECTOR OF SUB-SYSTEMS.
- SUB-MAIN TILE..... SECONDARY TRUNK LINE OR RANDOM SYSTEM COLLECTOR.
- LATERAL TILE FEEDER LINE, SERVICE TILE OR SYSTEM SPUR.
- "BLOWOUT" EXISTING SYSTEM PIPE FAILURE OR RESTRICTION.
- DRAIN TILE ENDS MAINLINE, SUB-MAIN OR LATERAL PLANNED TERMINATION.
- SLIT TRENCH INVESTIGATION TRENCH, TYPICAL 2'- 0" WIDE x 6'- 0" DEPTH.

- Any existing drain tile not encountered during slit trenching or probe transect procedures will remain unknown.
 - All existing drain tiles damaged during the investigation process shall be repaired to their original state in accordance with Natural Resource Conservation Service standards for drain tile installation and repair. All existing drain tile not encountered during slit trenching procedure will remain unknown.

- Solar Field Development - It is our recommendation that all existing drain tile systems within the proposed solar field development should be replaced by "like kind" construction which will assure the location and replacement of unknown drain tile systems that were not located by this Existing Drain Tile Investigation.
